Damaged Connectors Impact the Quality of Measurements

Peter Linowitz

Keysight Technologies

National Conference of Standards Laboratories (NCSL)

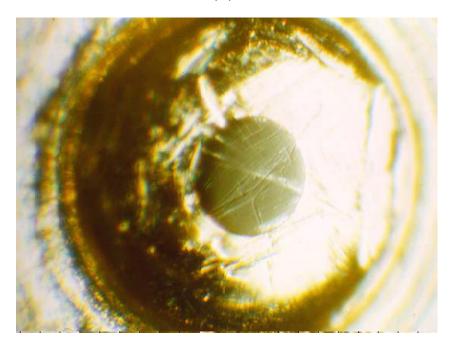
Feel of Dimensions ... (6)

• 125 µm fiber and scratches

• Elbow scratch approx. 3 µm wide

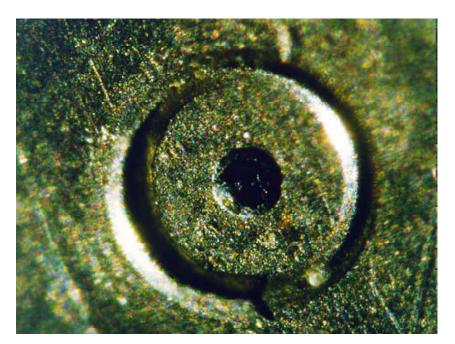
Extreme fiber damage on connector.

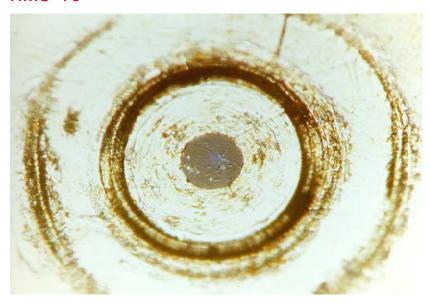
HMS-10

General example of damage:

- Scratches
- White objects are metallic particles embedded in fiber
- Pits are where metallic particles have fallen out

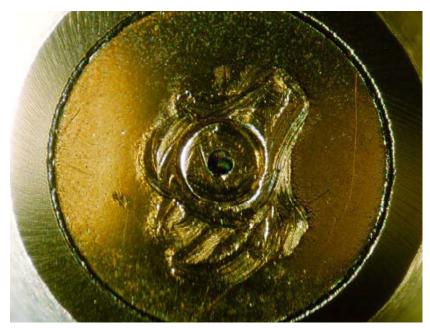
2.5 mm Ferrule

- Assume that ferrule end was 'cleaned' by probing with pin.
- Nickel/silver insert within Tungsten carbide ferrule easily scratched with pin. Insertion loss was approx. 8 dB.

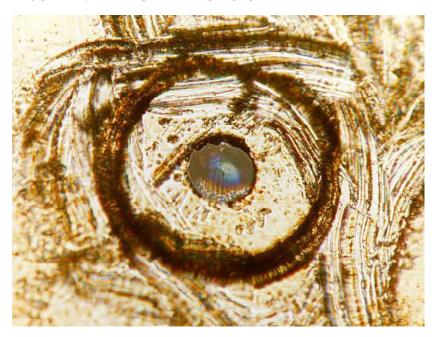
Fiber within 2.5 mm Ferrule

- Previous slide magnified.
- Note where scratch leads to broken fiber edge.
- Crescent mark across bottom of fiber is where metallic disposition has taken place when pin was drawn across surface of fiber.

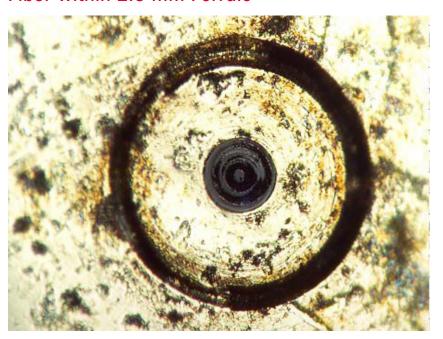
Fiber within 2.5 mm Ferrule

OTDR front panel connector/ferrule

Recessed ring effect either due to incorrect fiber inserted and rotated or missing key on correct connector. This caused extreme multiple reflections between this and the fiber. See page 14 for effects on OTDR measurement.

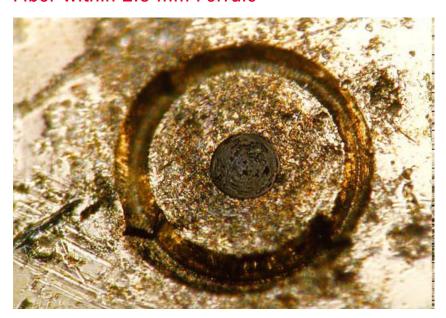
Fiber within 2.5 mm Ferrule

• After seeing this unit over a period of 1 year, the connector finally gave up.

• See page 13 for effects on OTDR measurement.

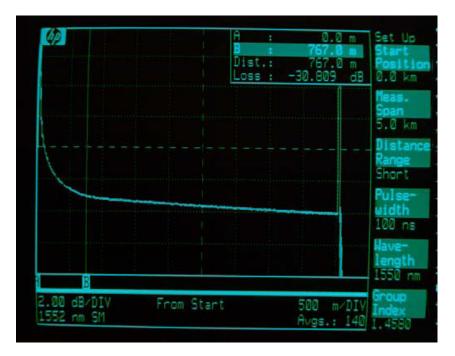
OTDR Trace

- Typical result of damaged front panel connector
- Note! Extreme back reflection at pulse launch and loss of 0.75 km before useable measurements can be made

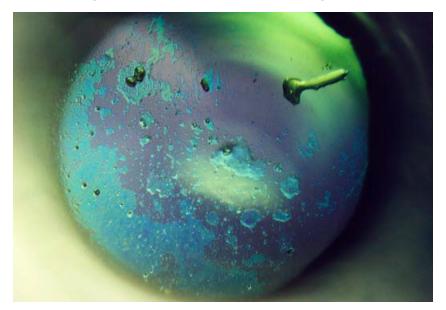
Picture through front panel connector of collimating lens.

- Lens coated with Refractive Index matching (RI) liquid which has collected particles of dust and grit.
- This unit showed approx. 10 dB insertion loss.

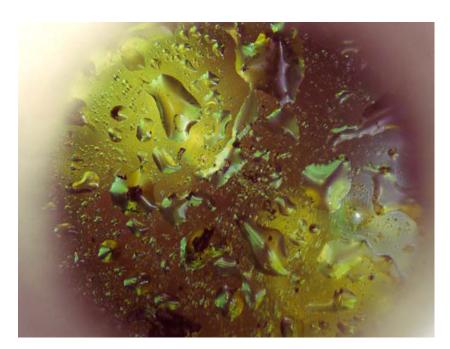
Picture through front panel connector of collimating lens. User has attempted to remove RI liquid with solvent.

- Typical globular RI liquid pattern results when solvent has evaporated.
- This unit showed approx. 20 dB insertion loss.

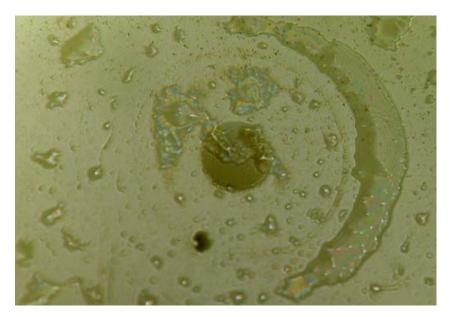
FC/PC Connector

Ceramic ferrule showing RI liquid contamination.

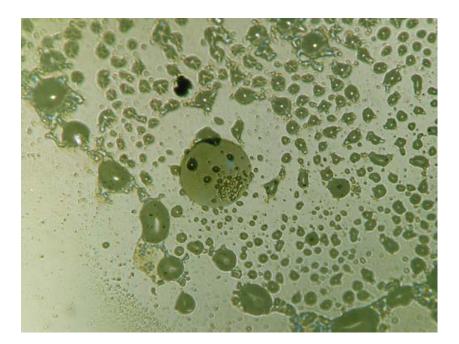
- Isopropyl alcohol (IPA) applied with cotton bud and cleaned, waved in air to evaporate IPA.
- Result: RI liquid reforms into globules.

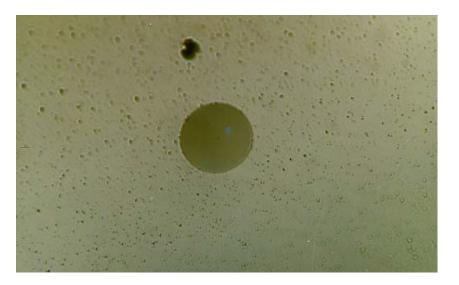
FC/PC Connector

- Again cleaned with isopropyl alcohol in some way but compressed air blown over ferrule end.
- Result: clean connector/ferrule. Marks on ferrule end are part of the ceramic material.

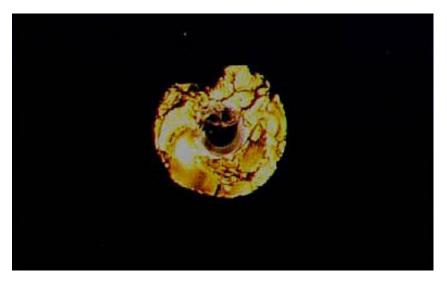
OSA Input Connector

- Multimode fiber from previous slide, back illuminated now.
- Light is traveling through the cladding, where the center of the core is nearly without any light.
- Note the scratches on the core and chipped effect across the entire surface of the fiber end face.

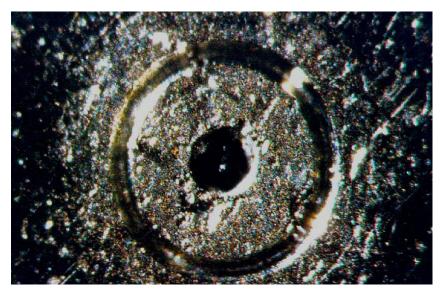
OSA Input Connector

Multimode fiber

- Front illumination.
- Scratches on the core or cladding and chipped fiber end face are hard to see.

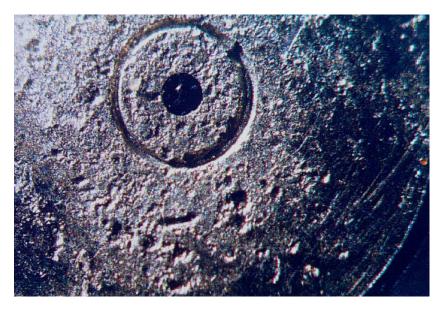
OTDR Input Connector

Singlemode fiber with even distributed dirt and dust.

- Note the fine scratches at the edge of the ferrule.
- They are generated by scrubbing the connector with other tools than lint-free cotton swaps or lens papers.

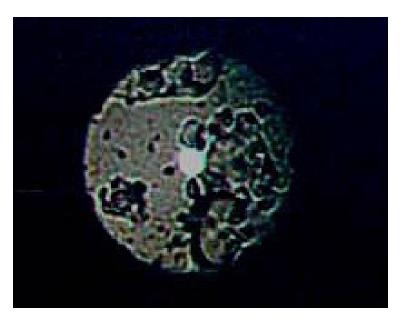
OTDR Input Connector

Singlemode fiber cladding and core of the previous slide (black) are now both visible (back illuminated).

- The core guides the most light.
- Damage is primarily on the cladding, but also on the edge of the core.

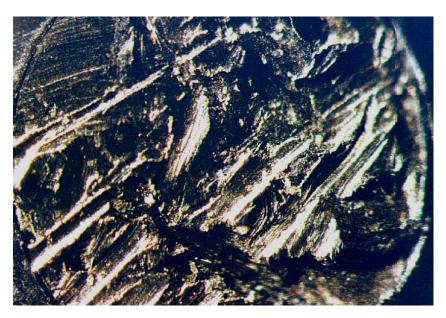
A completely damaged connector...
