Release Notes

Keysight
M8190A/M8192A
Arbitrary Waveform
Generator and
Synchronization Module

Version 5.9.1.0 Information

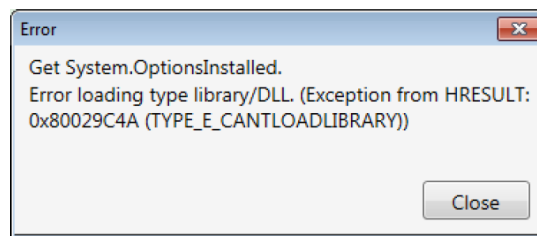
- With Agilent IO Libraries Suite 16.3 Update 2 (16.3.17914), the M8190 Soft Front Panel can't connect to the M8190 Firmware and displays this error message box:

This is not caused by M8190A/M8192A but by the IO Libraries Suite Installer. Workaround: Add following entries to the system environment variable PATH:

- 64 bit system: ;%VXIPNPPATH%VisaCom;%VXIPNPPATH64%VisaCom
- 32 bit system: ;%VXIPNPPATH%VisaCom
- With the Agilent M950xA AXIe Chassis Driver 1.2.1.6 on non-English Windows versions, a Blue Screen occurs when the firmware is started. Workaround: Either uninstall the driver
