Streamline Series VNA & PC setup procedure and its Troubleshooting tips

Keysight Technologies
11-Dec-2025

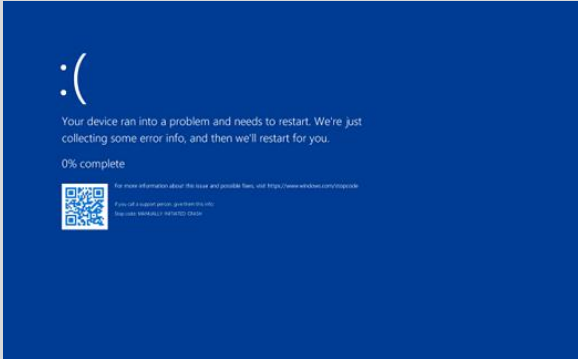
Symptom	Possible root cause	Solution
<p>#1-3 BSOD (Blue Screen Of Death) is shown</p>

<p>Go to Windows 11 BSODs Automatic Repair and advanced troubleshooting options - Microsoft Community</p> <p>Refer to Bug Check Code Reference - Windows drivers Microsoft Learn for more details.</p>

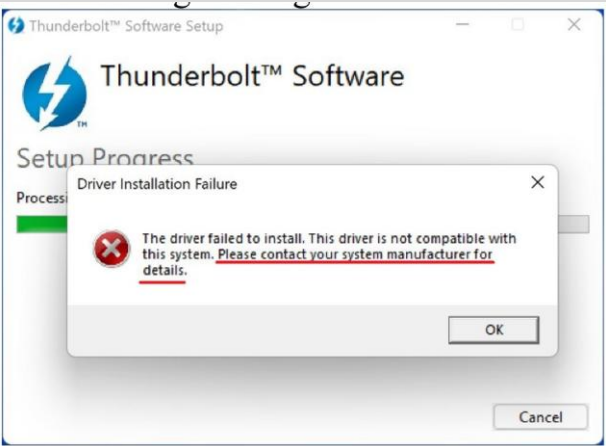
Symptom	Possible root cause	Solution
<p>#2-3-1 Driver Installation Failure is shown on Intel Gen12 CPU with Windows 11</p>

<p>For Intel Gen12 CPU, Windows 11 OS already contains the necessary driver for Thunderbolt device to work properly.</p>	<p>No action is needed.</p> <p>Refer to Troubleshooting Tips #3-7-3.</p>

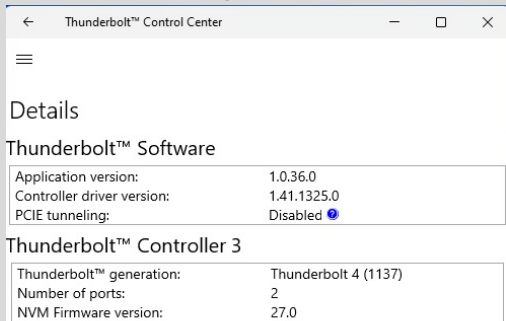
Symptom	Possible root cause	Solution										
<div>#2-3-2</div> <div>PCIe tunneling is Disabled</div> <div>

<p>Thunderbolt™ Control Center</p><p>Details</p><p>Thunderbolt™ Software</p><table><tr><td>Application version:</td><td>1.0.36.0</td></tr><tr><td>Controller driver version:</td><td>1.41.1325.0</td></tr><tr><td>PCIe tunneling:</td><td>Disabled ⓘ</td></tr></table><p>Thunderbolt™ Controller 3</p><table><tr><td>Thunderbolt™ generation:</td><td>Thunderbolt 4 (1137)</td></tr><tr><td>Number of ports:</td><td>2</td></tr><tr><td>NVM Firmware version:</td><td>27.0</td></tr></table><p>When PCIe tunneling is disabled, some Thunderbolt™ devices, including external GPUs and storage drives, may not work properly. PCIe tunneling settings may be changed in BIOS.</p></div> <div>PCIe tunneling setting in BIOS might be incorrect.</div> <div><div><div>Step-1:</div><div>If you are setting up with desktop-PC, confirm the PCIe Thunderbolt card is installed to the appropriate slot which supports PCIe tunneling.</div></div><div><div>Step-2:</div><div>If the symptom still occurs, go to PC BIOS setting menu and enable PCIe tunneling.</div></div><div>[samples of BIOS setting]</div><div><div>Dell Desktop PC BIOS (UEFI)</div><div>BIOS Setup > Integrated devices > Disable USB4 PCIe Tunneling > Off</div><div>

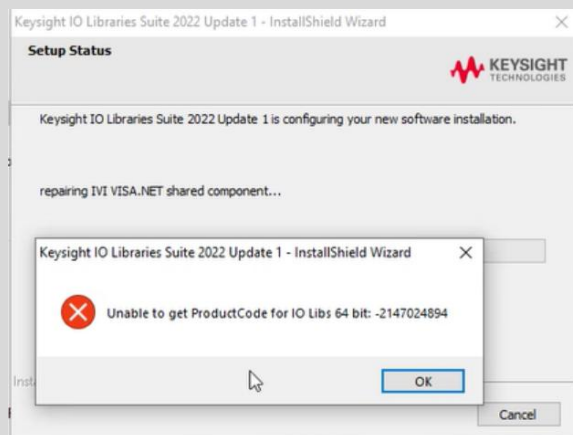
#2-4-3
Unable to get ProductCode for IO
Libs 64 bit error is shown

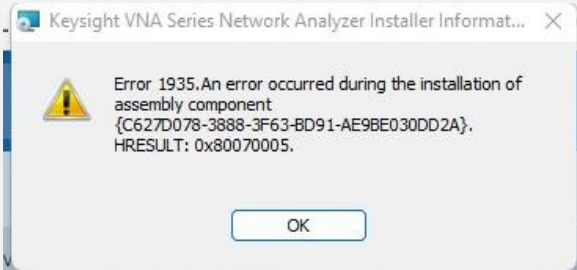
#2-5-2 Error 1935 is shown while installing VNA firmware.

During the VNA firmware installation, required permissions are missing, or .Net Framework setting is not correct.	<ul style="list-style-type: none">① Re-boot the PC and install the latest VNA firmware again. Make sure the VNA firmware is installed with “Run as administrator” capability.② If the symptom still occurs, disable any anti-virus, anti-spyware or firewalls while installing VNA firmware.③ If the symptom still occurs, go to Troubleshooting tips #2-4-2. <p>For more details, go to Download Microsoft .NET Framework Repair Tool from Official Microsoft Download Center</p> <ul style="list-style-type: none">④ If the symptom still occurs, go to Troubleshooting tips #1-2.

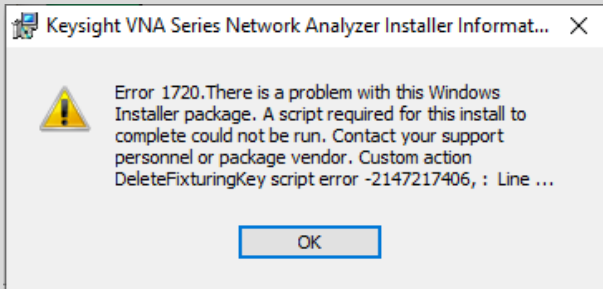
Symptom	Possible root cause	Solution
<p>#2-5-3 Error 1720 is shown while installing VNA firmware</p>

<p>There is a problem with Windows Installer Package.</p>	<p>Go to Error 1720: There is a problem with this Windows Installer package. A - Microsoft Community</p> <p>If the symptom still occurs, go to Troubleshooting tips #1-2.</p>

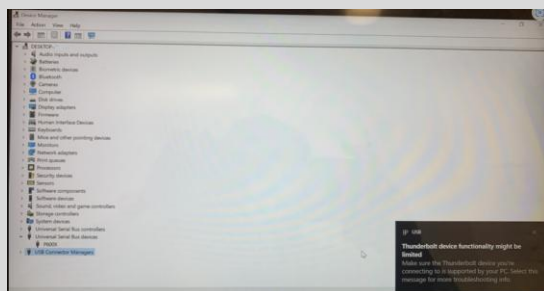
#3-1
Thunderbolt device functionality might be limited is shown in Device Manager

Thunderbolt device functionality might be limited
Make sure the Thunderbolt device you're connecting to is supported by your PC. Select this message for more troubleshooting info.

Replace USB-C cable with the Thunderbolt 3 cable included in the Streamline Series VNA

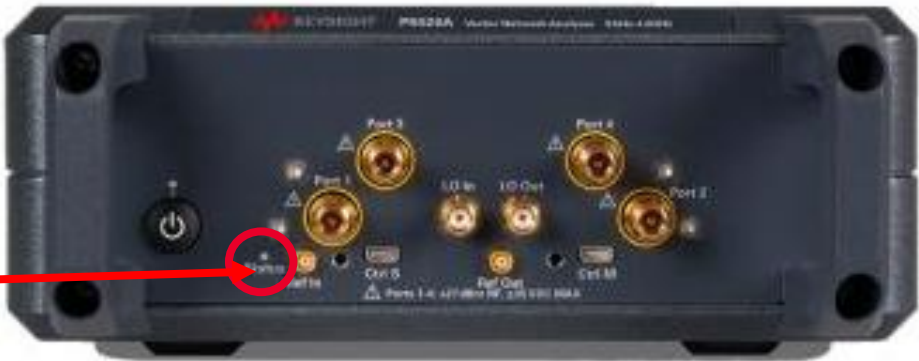
3-3-2. Instrument Status LED does not turn Green

Symptom	Possible root cause	Solution
#3-3-2-1 Glowing amber	Power is ON, but firmware is not running.	<ul style="list-style-type: none">① Check if VNA firmware is working correctly.② If not, go to Troubleshooting tips2-5③ Check if the cable between Streamline Series VNA and PC is connected correctly④ If not, replace the cable⑤ If the symptom still occurs, return it to Keysight for repair.

#3-3-2-2 Glowing red	PC battery is not maintained in a fully charged condition. Or A hardware error has occurred, or the VNA firmware is not installed or corrupted in the PC.	<ul style="list-style-type: none">① Make sure AC/DC adapter for the PC is connected.② Check if VNA firmware is installed correctly.③ If not, go to Troubleshooting tips 2-5④ If the symptom still occurs, check if Keysight IO Libraries Suites is installed correctly.⑤ If not, go to Troubleshooting tips 2-4⑥ If the symptom still occurs, return it to Keysight for repair.

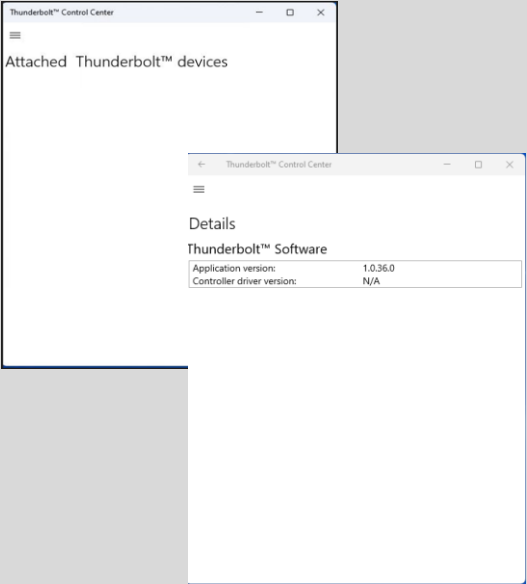
Symptom	Possible root cause	Solution
<p>#3-7-3 P600X is not shown in Thunderbolt Control Center application on PC of Windows 11 OS .</p>

<p>P50xxB/P93xxB is connected to PC of Gen12 or later CPU with Windows 11 OS through USB4 connection manager.</p>	<p>This is not an issue on PC of Gen12 or later CPU with Windows 11 OS, when Keysight Connection Expert shows the required devices. No action is required.</p> <p>Introduction to the USB4 connection manager in Windows Microsoft Learn</p>

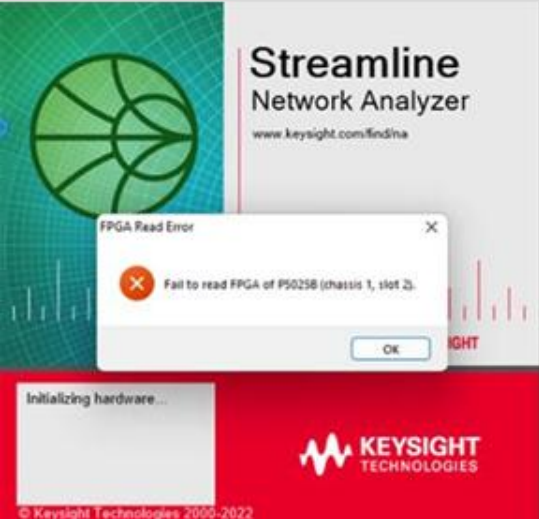
Symptom	Possible root cause	Solution
<p>#3-10-1 Fail to read FPGA of Pxxxxx (chassis x, slot x) is shown while Initializing hardware.</p>

<p>VNA firmware was not able to read FPGA on Analog Module</p>	<p>Go to Troubleshooting Tips #3-10-4</p>

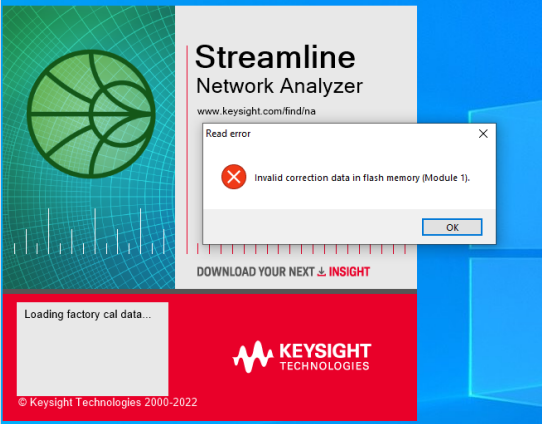
Symptom	Possible root cause	Solution
<p>#3-10-2 Invalid correction data in Flash memory (Module1) is shown while loading factory cal data.</p>

Factory calibration data is corrupted.	Return it to Keysight for calibration

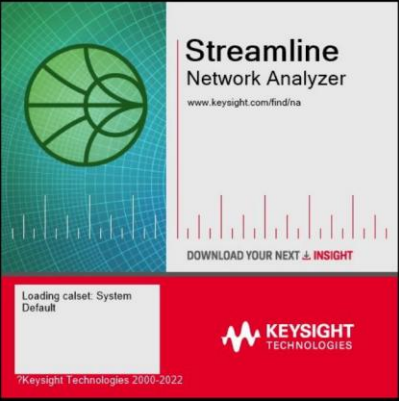
Symptom	Possible root cause	Solution
<p>#3-10-3 VNA firmware halts at “Loading Calset”</p>

Combination issue between VNA firmware and HPP5.3	Install VNA firmware A.15.75.22 or newer

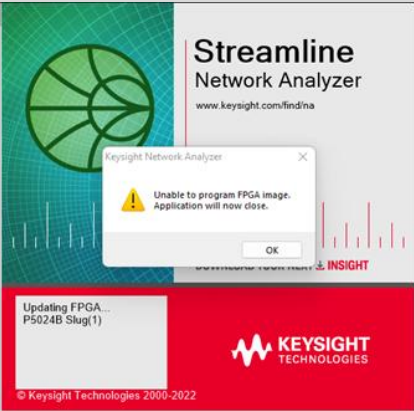
Symptom	Possible root cause	Solution
<p>#3-10-4 “Unable to program FPGA image. Application will now close” message is shown, while updating VNA FPGA.</p>

<p>When FPGA image in VNA is different from the one in VNA firmware, VNA firmware attempts to load the FPGA image to VNA chassis. During this process, a time out error may occur.</p> <p>The root cause of this issue is due to declined Thunderbolt signal quality on PCIe Thunderbolt card for Desktop PC or Thunderbolt cable.</p>	<p>Step-1:</p> <ul style="list-style-type: none">① Install VNA firmware A.19.30.21 or newer② Launch Network Analyzer (See 3-10)

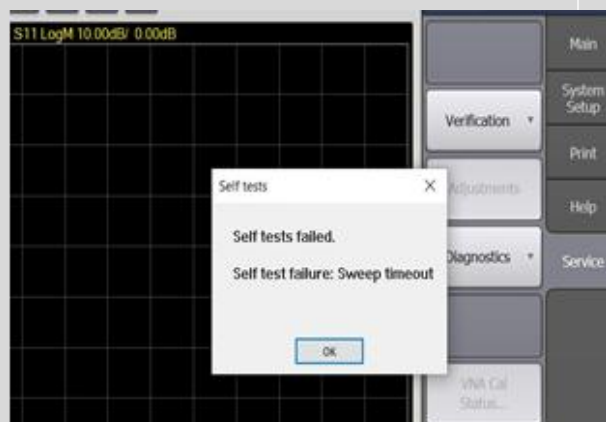
“Self test failure: Sweep timeout” error message is shown

Interconnect cables for LO or control cable is not connected properly or broken.

- ① Check if the control cable (Black) is connected properly. If the connection is missing or loosened, connect it and tighten it with the nuts as shown in the image below.
- ② If the symptom still occurs, replace the control cable.

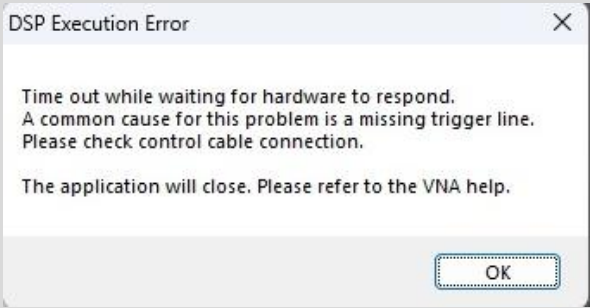
Symptom	Possible root cause	Solution
<p>#3-10-10 DSP Execution Error is shown</p>

<p>When DSP cannot receive the whole measurement data within the specified time, this error message is shown.</p> <p>There are some root causes found.</p> <p>#1. Command list size is bigger than FPGA processing capability</p> <p>#2. Contact failure due to</p> <ul style="list-style-type: none">• PCIe connector lubricant• control cable connector contamination• control cable physical stress.• solder residual on backplane board• flux residual on backplane board	<p>Step1: Check if control cable is connected properly. Go to Troubleshooting tips #3-10-5.</p> <p>Step2: If the symptom still occurs, try Workaround for #1. Workaround for #1 If user measures multiple sweeps per channel, VNA firmware sends one command list per channel. Keysight workaround proposal is to send one command per sweep. Ask Keysight for more details.</p> <p>Step3: If the symptom occurs continuously, return it to Keysight for repair.</p>

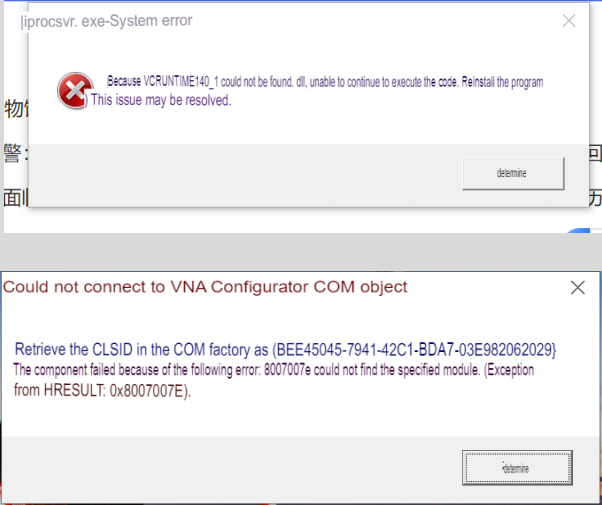
Symptom	Possible root cause	Solution
<p>#3-10-11 DLL & COM error is shown.</p>

<p>Microsoft Visual C++ 2015-2019 versions are missing or corrupted.</p>	<p>Download and install x64 for Visual C++ 2015/2017/2019 from Latest supported Visual C++ Redistributable downloads Microsoft Learn</p> <p>Refer to VCRUNTIME140_1.dll Missing: where to get? - Microsoft Community</p>

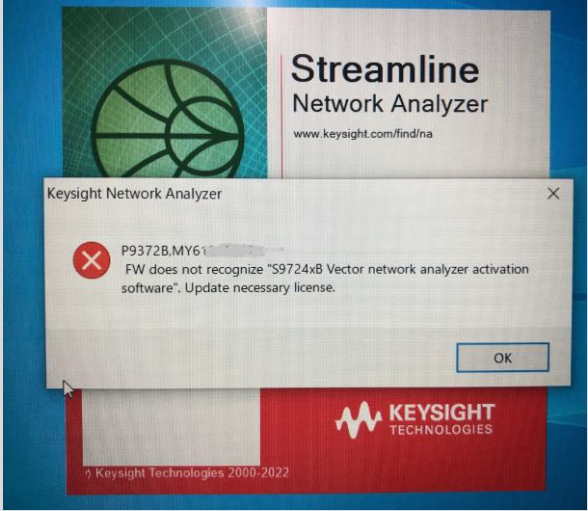
Symptom	Possible root cause	Solution
<p>#3-10-12</p> <p>FW does not recognize “S97824xB Vector network analyzer activation software” Update necessary license pop-up is shown.</p>

<p>FW bug to check the required license</p>	<p>Install VNA firmware A.15.60.05 or newer</p>

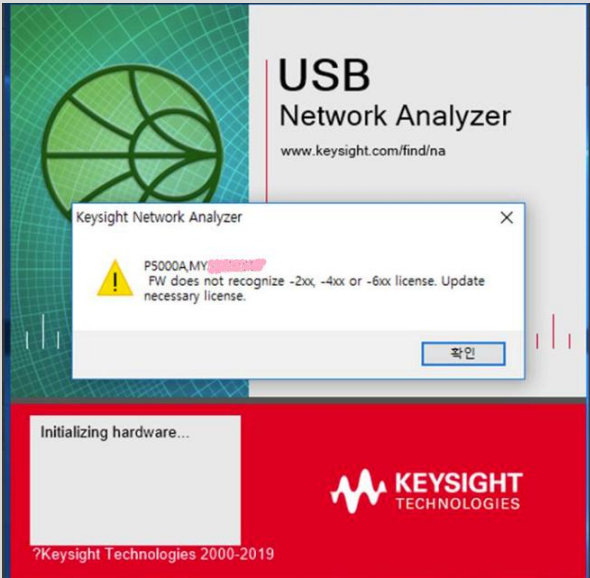
Symptom	Possible root cause	Solution
<p>#3-10-13 FW does not recognize -2xx,-4xx or -6xx license. Update necessary license pop-up is shown.</p>

<p>KLM license is expired</p>	<p>Check the license in Keysight License Manager Update necessary license, if the license is expired.</p>

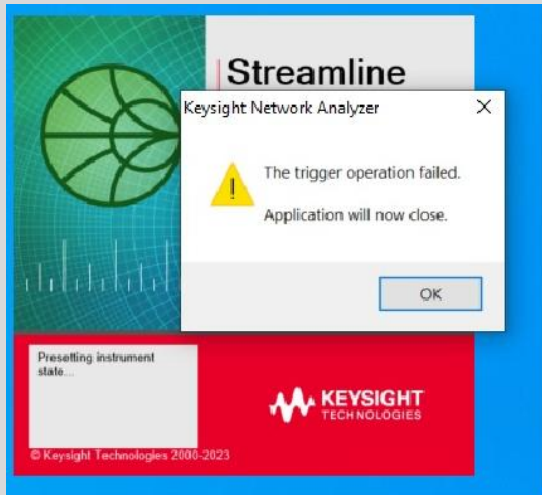
#3-10-15
The trigger operation failed.
Application will now close error is shown.

Interconnect cables for LO or control cable is not connected properly or broken.

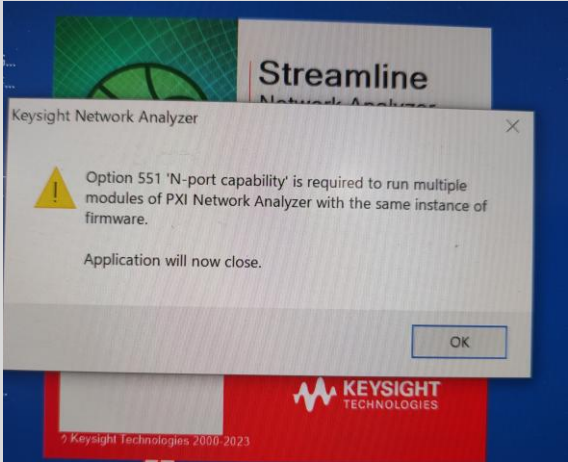
Symptom	Possible root cause	Solution
<p>#3-10-16 Option 551 'N-port capability' is required error is shown.</p>

<p>S97551B-1FP license is not loaded to Keysight License Manager.</p>	<p>Go to Troubleshooting tips #3-9-2</p>

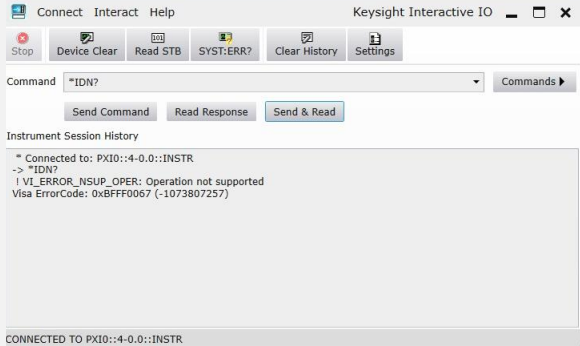
Symptom	Possible root cause	Solution
#3-11-1 Device Licenses Changed dialog is not shown.	Agilent License Service is not working	Go to Troubleshooting tips #3-5-1
#3-11-2 *IDN? shows ! VI_ERROR_NSUP_OPER: Operation not supported Visa ErrorCode: 0xBFFF0067 (-1073807257)

Remote Interface is not set up correctly	Go to 3-11. Communicate remotely using LAN (TCPIP)
