SERVICE INFORMATION for SW upgrade with Service Pack for 81200 and 81250

81250 rev 4.50 SP3 (14.10.2002)

81200 rev 3.52 SP1(22.8.2001)

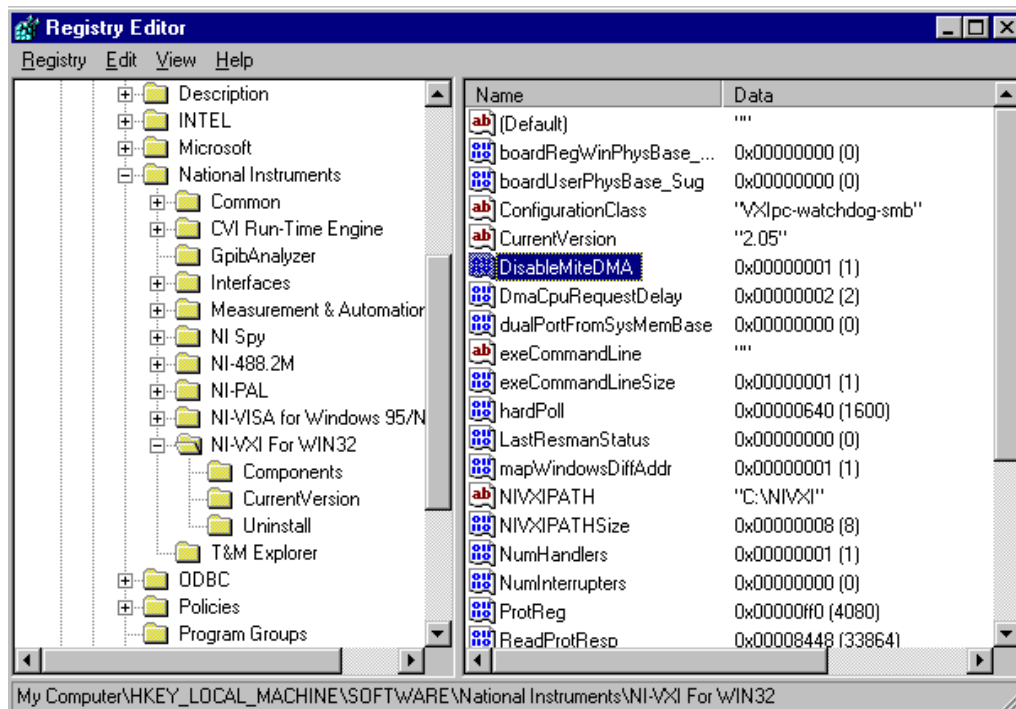
In order to upgrade the current SW rev on an embedded PC it is helpful to optimize the PC speed.

- 1) Go to start ->RUN-> regedit->
- 2) HKEY_LOCAL_MACHINE \ SOFTWARE \ National Instruments \ NI-VXI For WIN32 \
- 3) **DisableMiteDMA** and change the value from **0 to 1**

See picture:
