AXI Conquers Hidden Joint Defects

By Jeremy Jessen

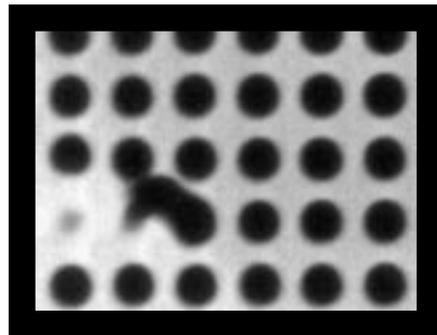
Figure 1. Solder bridges

Solder bridges form when solder wicks across one or more pins (Figure 1). AXI identifies this defect in BGA pins by measuring the grayscale surrounding the joint. However, with CGAs, the more solder used on the pins creates a shading effect for X-ray imaging. The shading reduces the brightness of an X-ray image, resulting in possible false solder-bridge defect indictments. Solder bridges can be inspected, but because of excessive shading in some component types, solder-bridge inspection must be disabled.

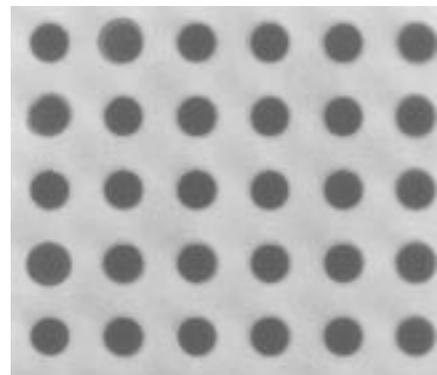
Figure 2. Improper joint formation

ness of the pin is analyzed for insufficient solder. The diameter will be larger at the mid-ball than its closest neighbors when the joint is open due to improper joint formation (Figure 2). The diameter and thickness measured off of the pin will determine insufficient solder.

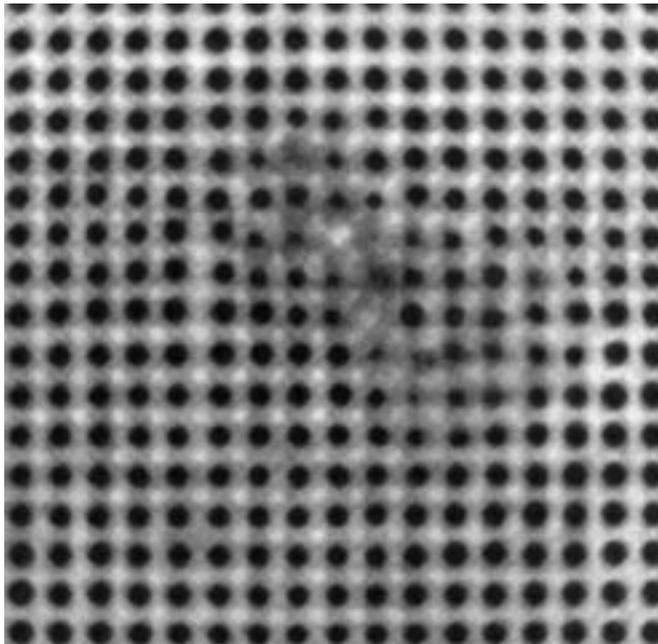
Figure 3. Opens due to damage prior to placement and insufficient solder paste.

During this period, AXI indicted 1,978 BGA pins and 195 CGA pins, which were validated by the manufacturer as true solder defects. The CGA pin defects identified were all opens that needed to be removed and replaced. Much of the opens of the CGA were due to pin damage prior to placement and insufficient solder paste (Figure 3). All of these defects had occurred near the center of the CGA package.
