Revision history for M8190A/M8192A

December, 10th 2014

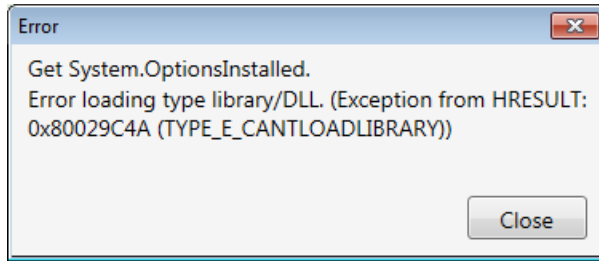
- With Agilent IO Libraries Suite 16.3 Update 2 (16.3.17914), the M8190 Soft Front Panel can't connect to the M8190 Firmware and displays this error message box:

This is not caused by M8190A/M8192A but by the IO Libraries Suite Installer.

Workaround: Add following entries to the system environment variable PATH:

- 64 bit system: ;%VXIPNPPATH%VisaCom;%VXIPNPPATH64%VisaCom
- 32 bit system: ;%VXIPNPPATH%VisaCom
- With the Agilent M950xA AXIe Chassis Driver 1.2.1.6 on non-English Windows versions, a Blue Screen occurs when the firmware is started.
