Keysight M8190A/M8192A Arbitrary Waveform Generator

Version 5.3.2.1 Information

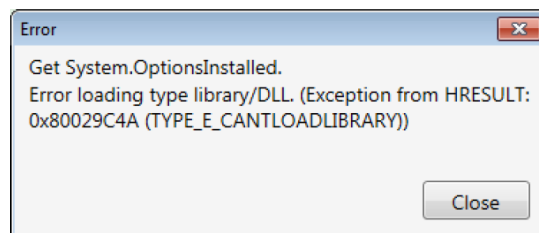
- With Agilent IO Libraries Suite 16.3 Update 2 (16.3.17914), the M8190 Soft Front Panel can't connect to the M8190 Firmware and displays this error message box:

This is not caused by M8190A/M8192A but by the IO Libraries Suite Installer. Workaround: Add following entries to the system environment variable PATH:

- 64 bit system: ;%VXIPNPPATH%VisaCom;%VXIPNPPATH64%VisaCom
- 32 bit system: ;%VXIPNPPATH%VisaCom
