Release Notes

**Keysight**  
**M8190A/M8192A**  
**Arbitrary Waveform**  
**Generator and**  
**Synchronization Module**

## Version 5.5.1.0 Information

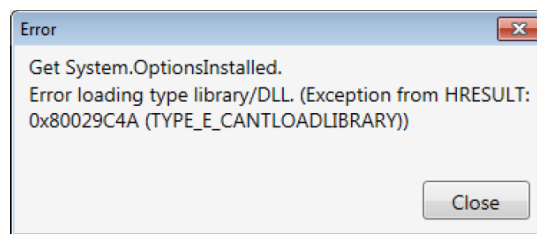
- With Agilent IO Libraries Suite 16.3 Update 2 (16.3.17914), the M8190 Soft Front Panel can't connect to the M8190 Firmware and displays this error message box:

This is not caused by M8190A/M8192A but by the IO Libraries Suite Installer. Workaround: Add following entries to the system environment variable PATH:

- 64 bit system: ;%VXIPNPPATH%VisaCom;%VXIPNPPATH64%VisaCom
- 32 bit system: ;%VXIPNPPATH%VisaCom
- With the Agilent M950xA AXIe Chassis Driver 1.2.1.6 on non-English Windows versions, a Blue Screen occurs when the firmware is started. Workaround: Either uninstall the driver
