Damaged Connectors Impact the Quality of Measurements

Peter Linowitz

Keysight Technologies

National Conference of Standards Laboratories (NCSL)

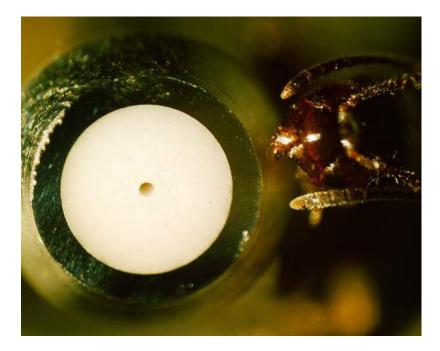
Feel of Dimensions ... (4)

- Same scale as previous slide
- This time FC/PC and head of an ant
- The center circle inside the white area is 125 $\mu m!$

• The core itself is only a fraction of it, 9 µm. Seen as the red dot in the center

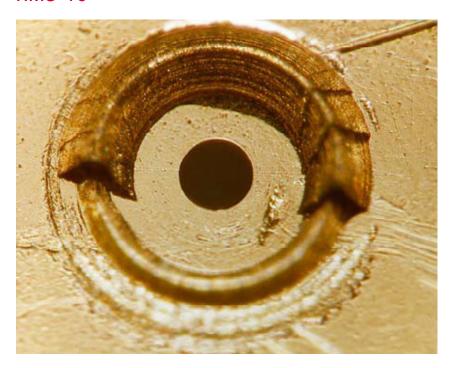
HMS-10

Good fiber in connector.

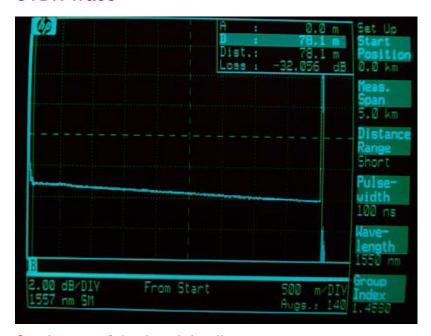
OTDR Trace

Good trace of 4.5 km delay line

Note good launch into a good fiber, i.e. minimum backreflection at connector interface.

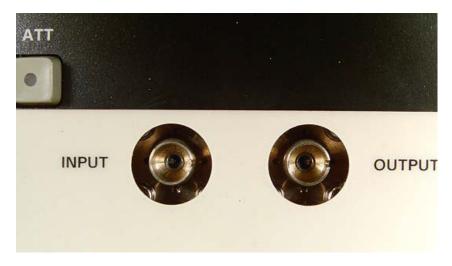
Optical Interfaces

Front panel

Note collimating lenses (bluish color).
