Streamline Series VNA & PC setup procedure and its Troubleshooting tips

Keysight Technologies
11-Dec-2025

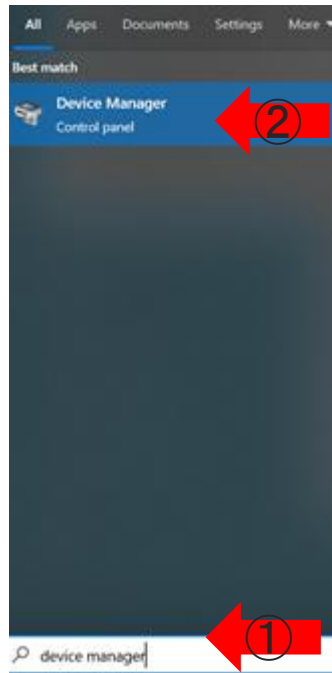
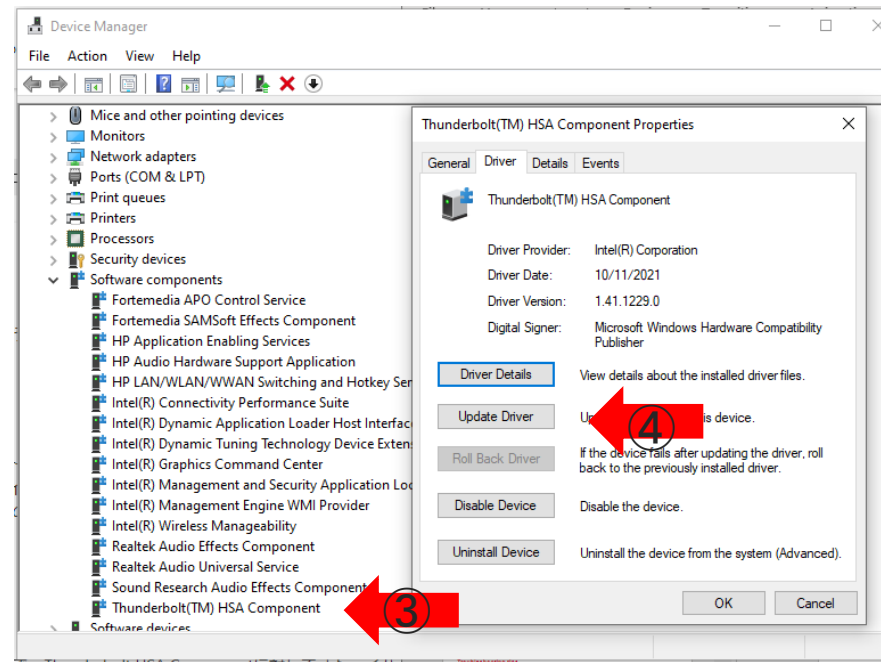
Symptom	Possible root cause	Solution
#2-3-1 (for CPU Gen11 or below with Win11 OS & any CPU Gen with Win10 OS) Thunderbolt Control Center is not shown from the Windows Start menu.	Cannot download Thunderbolt Software (Thunderbolt Control Center app) via Microsoft Store	Step-1: Update Thunderbolt driver ① Enter Device Manager at Windows Search ② Select Device Manager ③ Navigate to Software Components > Thunderbolt™ HSA Component ④ In the Driver tab, choose Update Driver ⑤ If Thunderbolt Control Center app still cannot be installed, ask Intel to support Step-2: If the symptom still occurs, go to Error 0x803FB005 While Installing Thunderbolt Control Center App

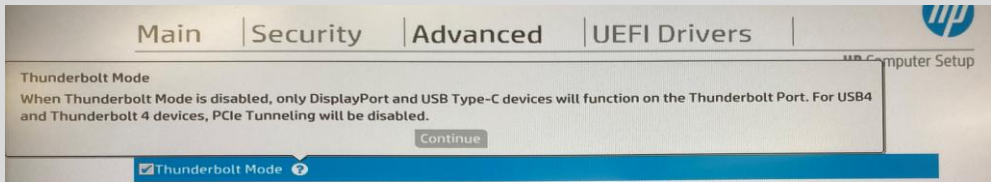
Symptom	Possible root cause	Solution										
<div>#2-3-2</div> <div>PCIe tunneling is Disabled</div> <div>

</div></div></div>	Application version:	1.0.36.0	Controller driver version:	1.41.1325.0	PCIe tunneling:	Disabled ⓘ	Thunderbolt™ generation:	Thunderbolt 4 (1137)	Number of ports:	2	NVM Firmware version:	27.0

</div></div><div><div>HP Laptop PC BIOS (UEFI)</div><div>HP Computer Setup > Advanced > Thunderbolt Options > Enable Thunderbolt Mode</div><div>

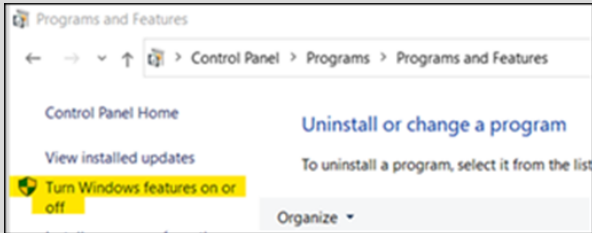
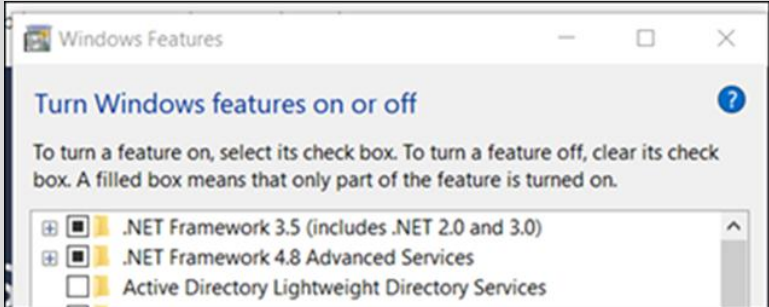
Symptom	Possible root cause	Solution
#2-4-2 .NET Framework 3.5 is not enabled		<ul style="list-style-type: none">① Enter Control Panel at Windows Search② Navigate to Programs > Programs and Features > Turn Windows Features on or off③ Enable the .NET Framework 3.5④ Re-boot the PC <p>For more details, go to https://docs.microsoft.com/en-us/dotnet/framework/install/dotnet-35-windows</p>

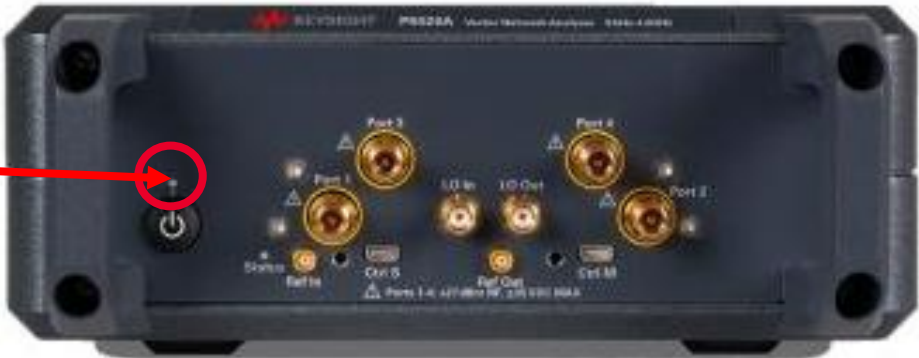
Power LED

Symptom	Possible root cause	Solution
#3-3-1-1 Not glowing amber when power adapter is connected to VNA	Power adapter or power line in the VNA is broken.	Return it to Keysight for repair
#3-3-1-2 Blinking red	Power adapter does not supply enough power	<div>① Check if proper power adapter is used (See 3-2). If KPN 0950-6128 is used to Streamline Series VNA 4-/6- port model, replace it with KPN 0950-6166.</div> <div>② Retry powering on the VNA. If the symptom still occurs, return it to Keysight for repair.</div>
#3-3-1-3 Glowing red	PC does not recognize the VNA	<div>① Check the power on sequence. 1.Connect the cable between PC and the VNA (See 3-1) 2. Power on the VNA (See 3-2, 3-3) 3. Power on the PC (3-4)</div> <div>② If the symptom still occurs, return it to Keysight for repair.</div>

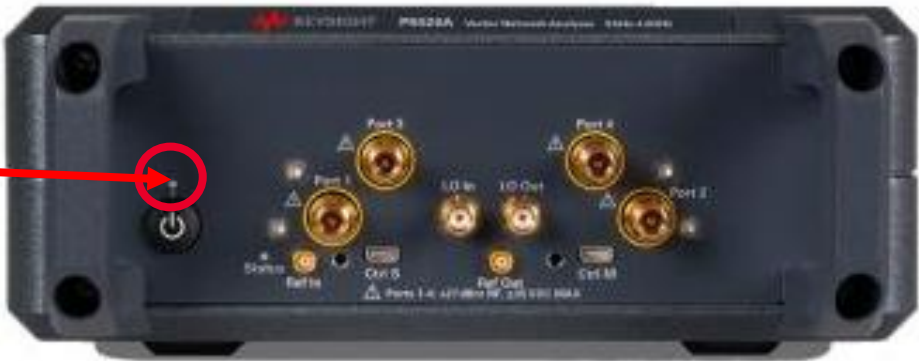
Power LED

Symptom	Possible root cause	Solution
#3-3-1-4 Once glowing green for a few seconds, then shutdown automatically Impacted model: 2-port VNA only	VNA firmware version A.15.60.05 or newer has a function to shutdown automatically when in-rush voltage drop event is detected. [This is intended behavior]	<div>① Check if VNA firmware version A.15.55.14 or newer. If VNA firmware version is A.15.60.05 or newer, the firmware has a function to shutdown automatically when in-rush voltage drop event is detected.</div> <div>② Retry powering on the VNA. If the symptom still occurs, return it to Keysight for repair.</div>
#3-3-1-5 Glowing blue	Chassis FPGA update failed.	Return it to Keysight for repair

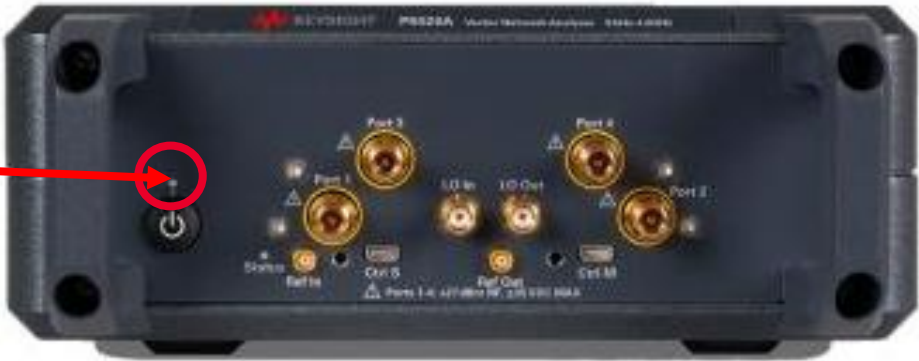
Power LED

Symptom	Possible root cause	Solution
#3-3-1-6 VNA chassis power button LED turned from Green to Red when USB/Thunderbolt cable is connected.	VNA firmware is equipped with current surge detection function to shutdown automatically when surge is detected. [This is intended behavior]. Abrupt surge (transient) during power on stage lead to the false alarm and the chassis is automatically switched off.	① Update VNA firmware to version A.16.70.00 or newer. VNA chassis IVI-C and IVI.NET driver version 1.1.10 and above resolve the false alarm. ② Retry powering on the VNA. If the symptom still occurs, return it to Keysight for repair.
[Power LED status] Refer to https://helpfiles.keysight.com/csg/pxivna/Front_Panel/P937xA_Front_Panel.htm

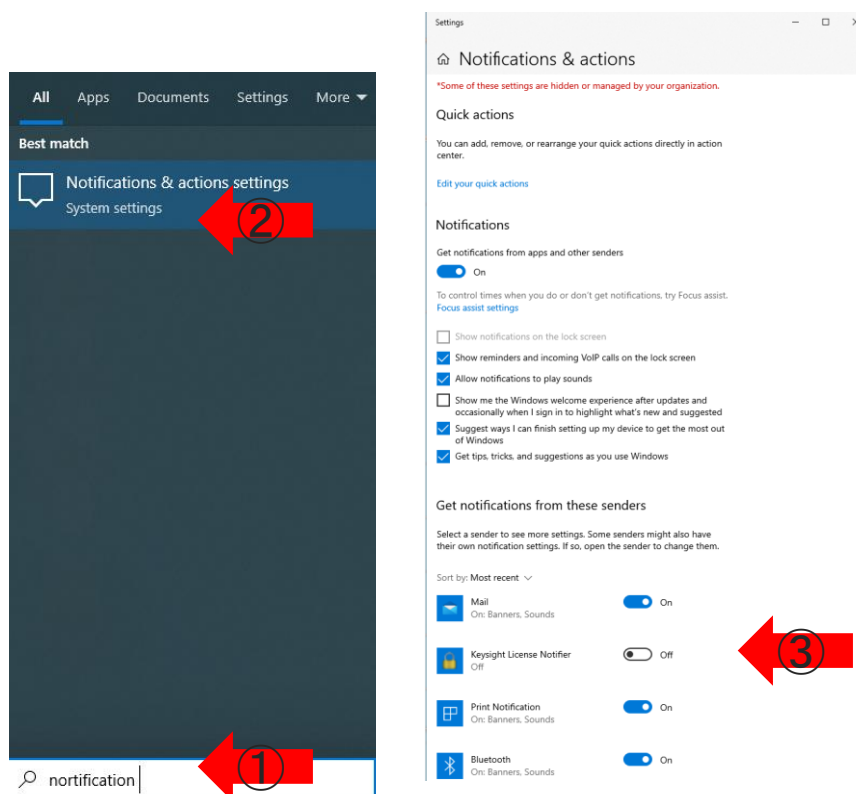
Symptom	Possible root cause	Solution
#3-5-1 Device Licenses Changed dialog is not shown	#1 Notifications for Keysight License Notifier turns off	① Enter Notification at Windows Search ② Select Notifications & actions settings ③ Turn on Keysight License Notifier

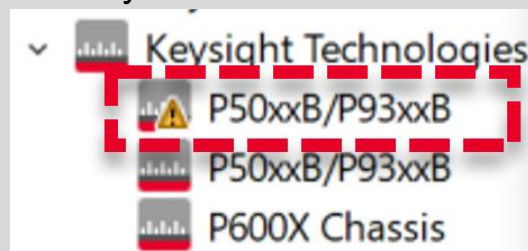
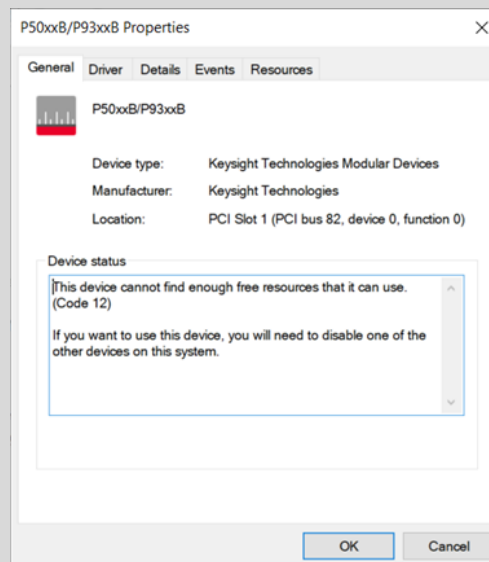
Possible root cause

PC cannot allocate enough free Kernel memory resource for PCIe

To solve this issue, registry edit is required with TH_PCIE.zip

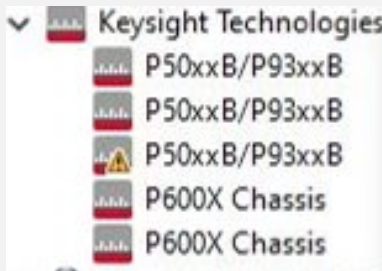
Symptom	Possible root cause	Solution
<p>#3-6-2 For A model with 1 module and B model with 1 module, Code 12 error is shown in Device Manager</p>

PC cannot allocate enough free Kernel memory resource for PCIe	Use another PC in Thunderbolt PC and Streamline Series VNA B model compatibility list
<p>#3-6-3 For 2 VNA operation with star topology or with daisy topology, Code 12 error is shown in Device Manager</p>

PC cannot allocate enough free Kernel memory resource for PCIe	Go to Troubleshooting Tips #3-6-1

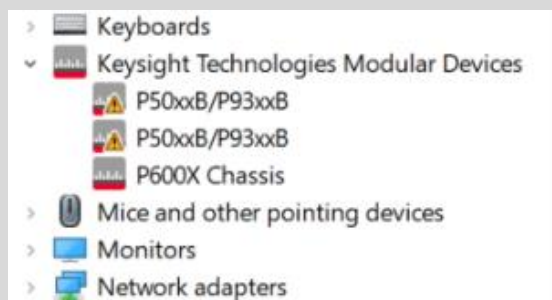
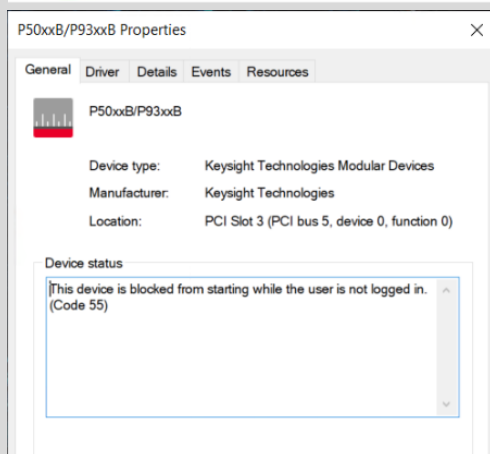
#3-6-4

For B model, Code 55 error is shown in Device Manager

B model is blocked from enumeration, due to a Group policy / MDM policy to protect from DMA attack.

You may also set Intel Virtualization Technology for I/O (VT-d) to Disabled in the BIOS, if Kernel DMA Protection cannot be disabled.

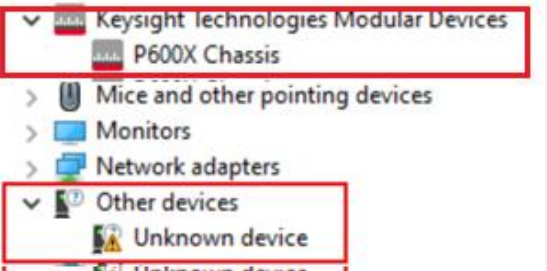
Symptom	Possible root cause	Solution
<p>#3-6-5 Keysight VNA icon is not shown</p>

This is not an issue. No action is required.
<p>#3-6-6 No VNA device(s) is/are shown under Keysight Technologies Modular Devices, but VNA device(s) is/are shown under Other devices</p>

<p>Windows does not recognize VNA device(s) correctly, since P50xx drivers are not installed correctly.</p> <p>[Known Issue on A15.75.19 for Streamline Series VNA (P50xxA/B, P93xxA/B)]: The unit will not be detected if you install the firmware from scratch. The driver for Chassis is not installed at this version.</p>	Go to Troubleshooting Tips #2-5-1

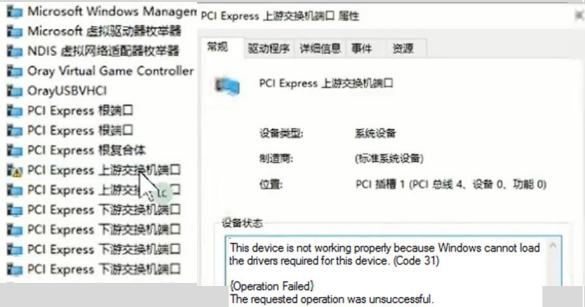
Symptom	Possible root cause	Solution
<div>#3-6-8</div> <div>

</div> <div>For B models, Thunderbolt control center detects and recognizes the instrument correctly.</div> <div>In Device Manager, the B model is not correctly recognized. Under “System Devices” > PCI Express Upstream/ Downstream Port shows Code31 error.</div>	<div>Operating System runs out of PCI bus numbers. Typically, the computer BIOS configures a limited bus-number range for PCI Express bridge device. When an expansion chassis that contains a PCI Express complex switch together with a deep device hierarchy is added to the computer, the OS runs out of available bus numbers. Therefore, the system cannot start devices in the expansion chassis.</div> <div>Fail to attach PCI Express expansion chassis - Windows Client Microsoft Learn</div>	<div>To solve this issue, perform the following: This requires two-stage solutions: First, remove Code31 error. Secondly, remove Code12 error. (Code12 may appear after Code31 is resolved)</div> <div>Note: 1. The listed steps are to be performed at end user’s own risk.</div>

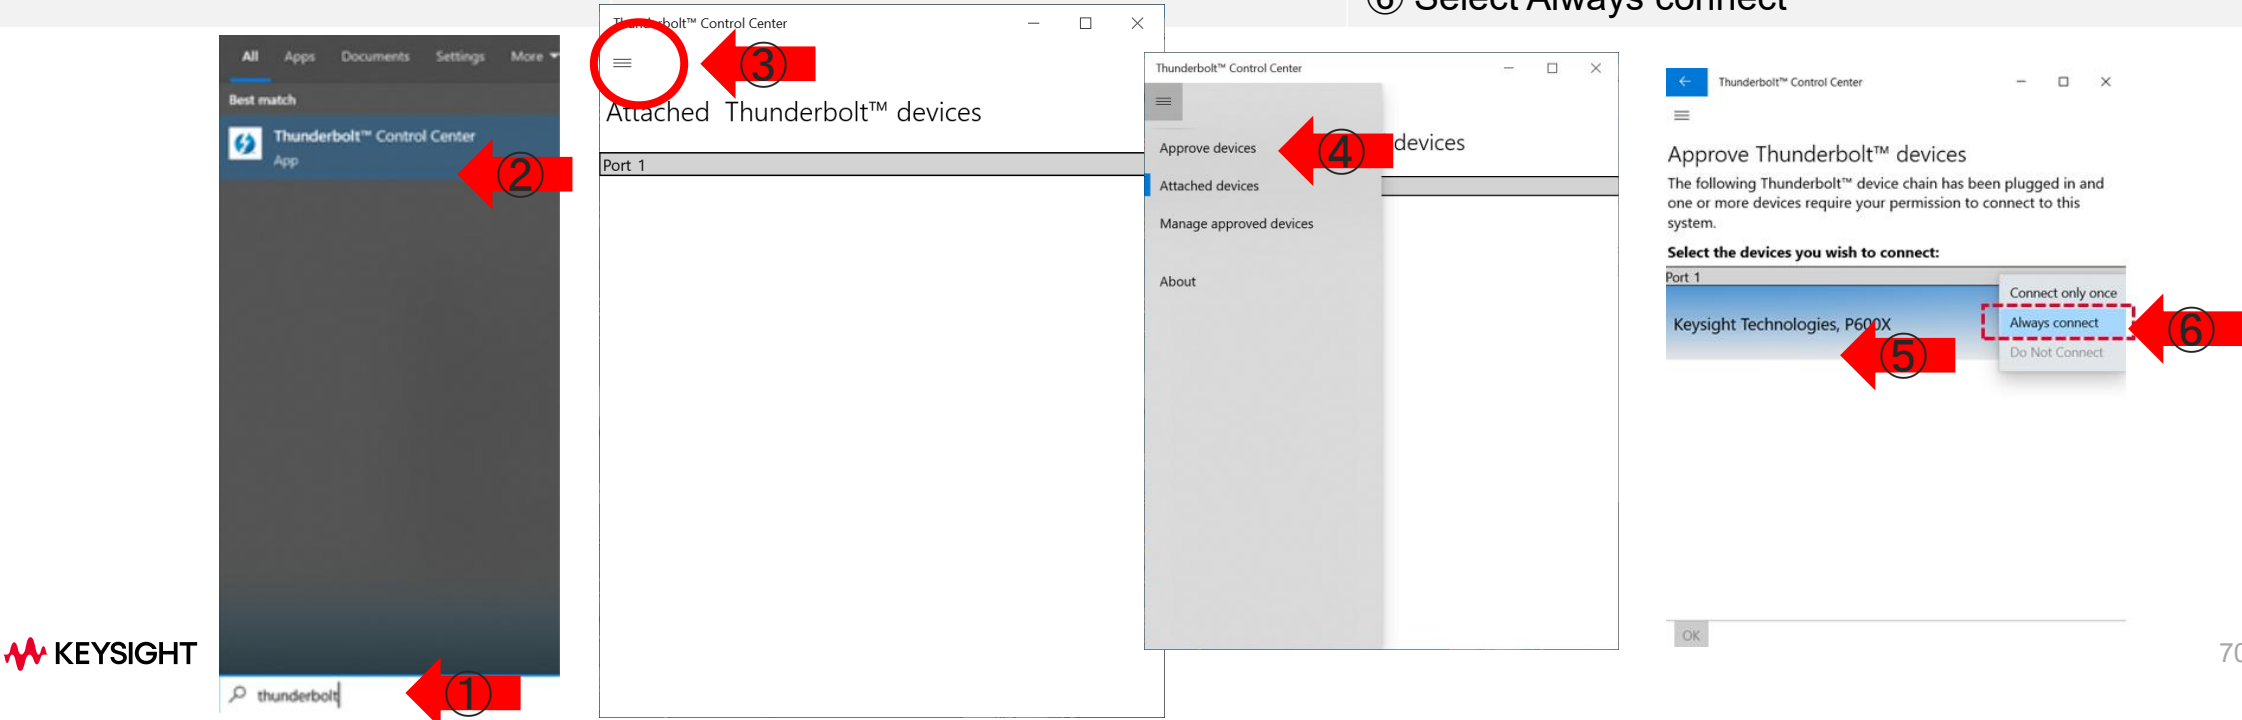
Symptom	Possible root cause	Solution
#3-7-1 P600X is not shown	Chassis drivers are missing or broken	Go to Troubleshooting tips 2-5
#3-7-2 P600X is shown, but is not connected	Old version of Thunderbolt Control Center app requests user to approve to connect P600X as Thunderbolt device	<div>① Enter Thunderbolt at Windows Search</div> <div>② Select Thunderbolt Control Center</div> <div>③ Select hamburger menu</div> <div>④ Select Approve devices</div> <div>⑤ Select Keysight Technologies, P600X</div> <div>⑥ Select Always connect</div>

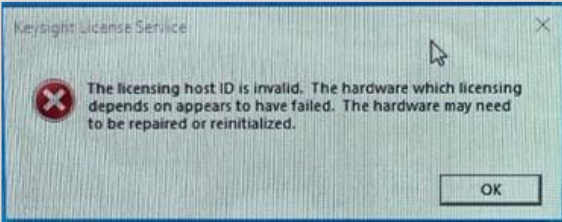
Symptom	Possible root cause	Solution
<p>#3-9-4 The licensing host ID is invalid.</p>

<p>Go to Troubleshooting tips #1-2 Step-3</p>

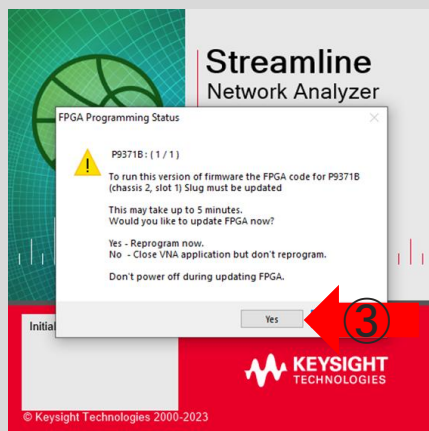
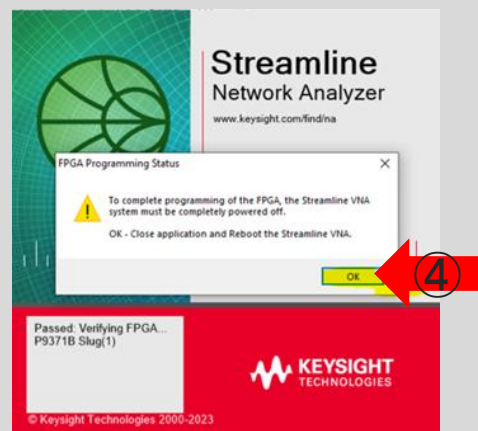
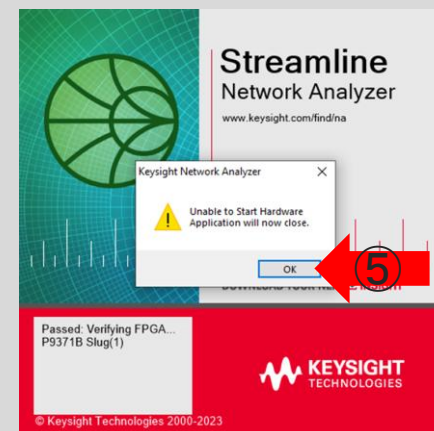
<p>When FPGA image in VNA is different from the one in VNA firmware, VNA firmware attempts to load the FPGA image to VNA chassis. During this process, a time out error may occur.</p> <p>The root cause of this issue is due to declined Thunderbolt signal quality on PCIe Thunderbolt card for Desktop PC or Thunderbolt cable.</p>	<p>Step-1:</p> <ul style="list-style-type: none">① Install VNA firmware A.19.30.21 or newer② Launch Network Analyzer (See 3-10)

- ⑦ FPGA Programming Status pops up, then click Yes
- ⑧ FPGA Programming Status pops up and click OK, then launch Network Analyzer (See [3-10](#)).
- ⑨ The following message pops up, then click OK

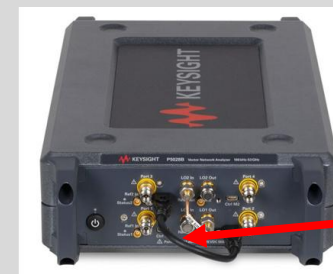
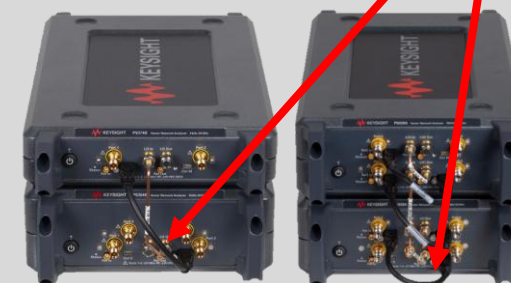
“Self test failure: Sweep timeout” error message is shown

Interconnect cables for LO or control cable is not connected properly or broken.

- ① Check if the control cable (Black) is connected properly. If the connection is missing or loosened, connect it and tighten it with the nuts as shown in the image below.
- ② If the symptom still occurs, replace the control cable.

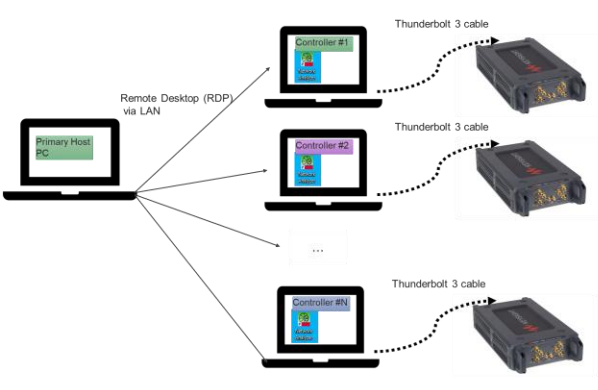
Symptom	Possible root cause	Solution
<p>#3-10-7 [Streamline Series VNA B model only] When user tries to access Streamline B model remotely via Remote Desktop (remote logon after controller PC reboot), Streamline B model cannot be recognized until user manually logon the controller PC with physical keyboard.</p>

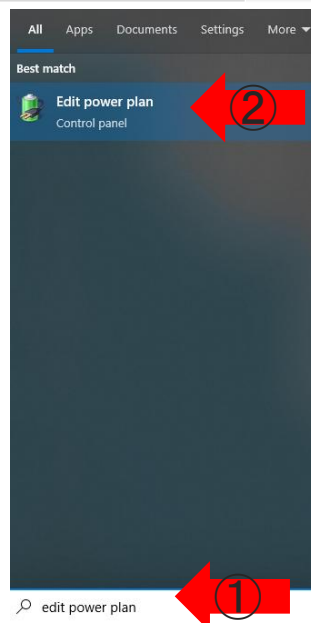
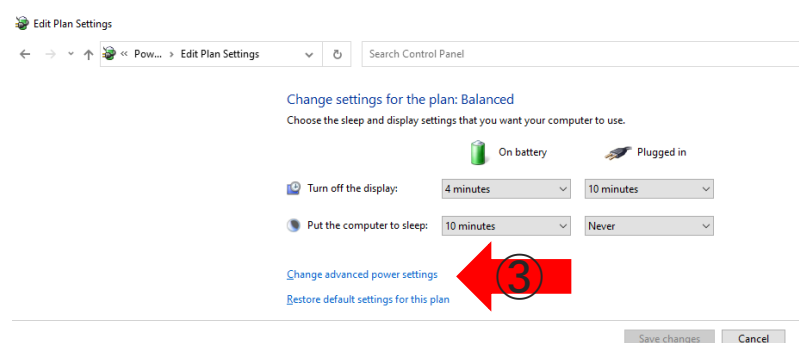
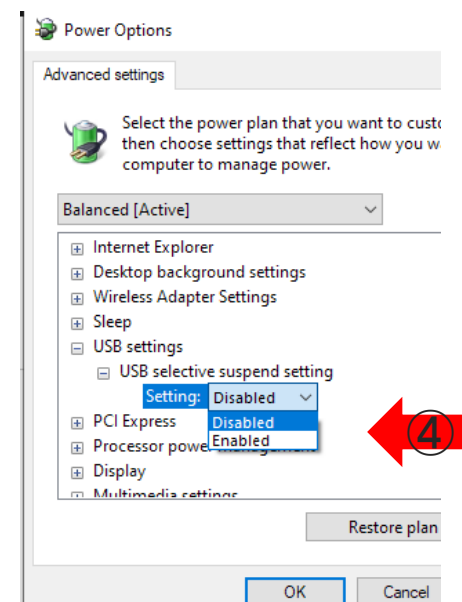
#3-10-9
VNA shuts down intermittently, after running for an extended period of time. Sometimes error like “Self test failure: Module test Pxxxx (Chassis x, Slot x) is shown

Another possible cause is Windows power settings interfering with VNA operation

- ① Enter Edit power plan at Windows Search
- ② Select Edit power plan
- ③ Select Change advanced power settings
- ④ Navigate to USB settings > USB selective suspend setting and turn this Disabled:

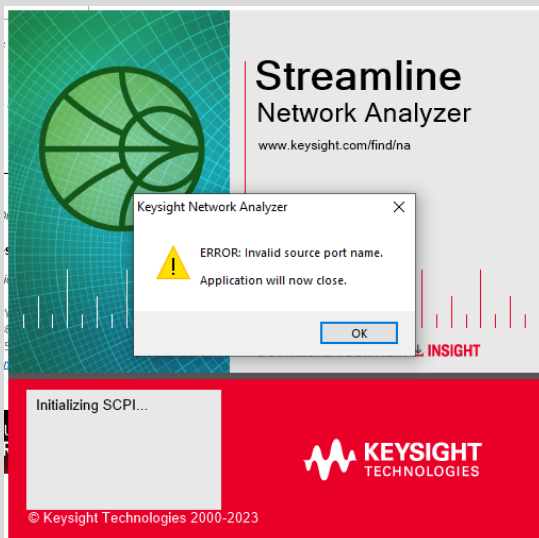
#3-10-14
Invalid source port name error is shown.

VNA firmware detects a different number of physical source ports than the installed option

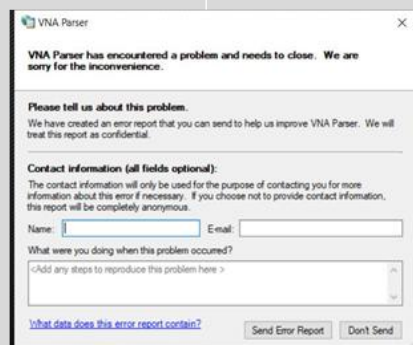
During USB Chassis FPGA Update, “Failed to retrieve model number from VNAParser.exe, application will exit.” error and “VNA Parser has encountered a problem” error are shown.

Go to [Troubleshooting Tips#3-10-4](#) Step-2.
