Keysight 2-Port/4-Port N524xA to N524xB and N5264A to N5264B Model PNA-X Upgrade Kit - Installation Guide

To Upgrade 2-Port/4-Port “A” models to 2-Port/4-Port “B” models

This is the Installation Note for the PNA-X N524xA Series Microwave Network Analyzers and N5264A Microwave Receiver.

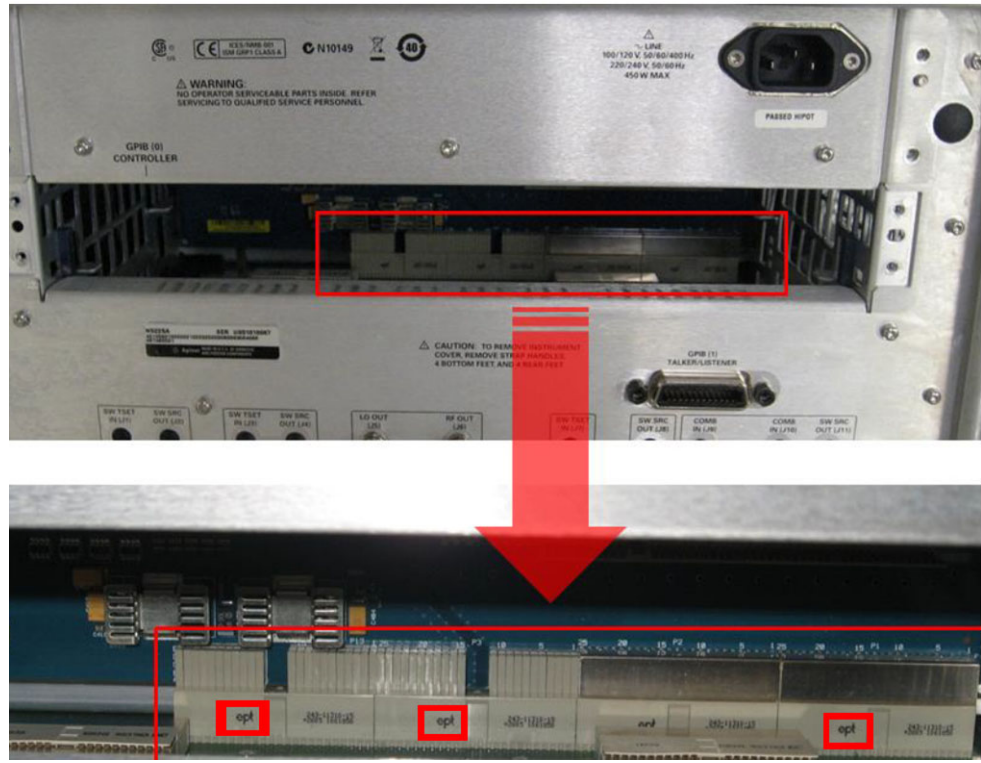
EPT labeled motherboards need to be replaced prior to proceeding with the upgrade (i.e., See image this note). Learn more, refer to the following Service Notes: N5221A-02A, N5222A-02A, N5224A-01A, N5225A-02A, N5227A01A, N5241A-03A, N5242A-07A, N5244A-03, N5245A-04A, and N5247A-02A.

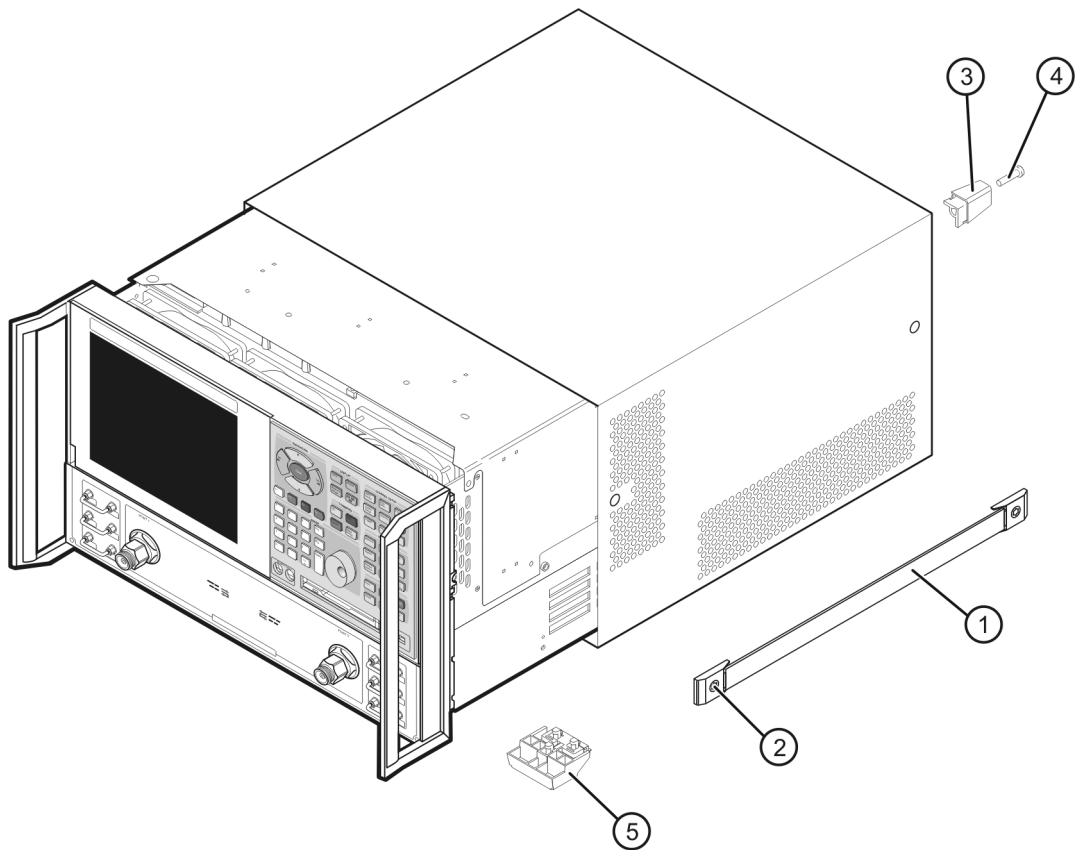
Figure 1

1. Turn OFF the analyzer and disconnect the power cord.
2. With a T-20 TORX driver, remove the strap handles (item ①) by loosening the screw (item ②) on each end of each handle.
3. With a T-20 TORX driver, remove the four rear panel feet (item ③) by removing the center screws (item ④).
4. Slide the four bottom feet (item ⑤) off the cover.
5. Slide the cover off of the frame.

Outer Cover Removal (Instruments Vary—Example Only)

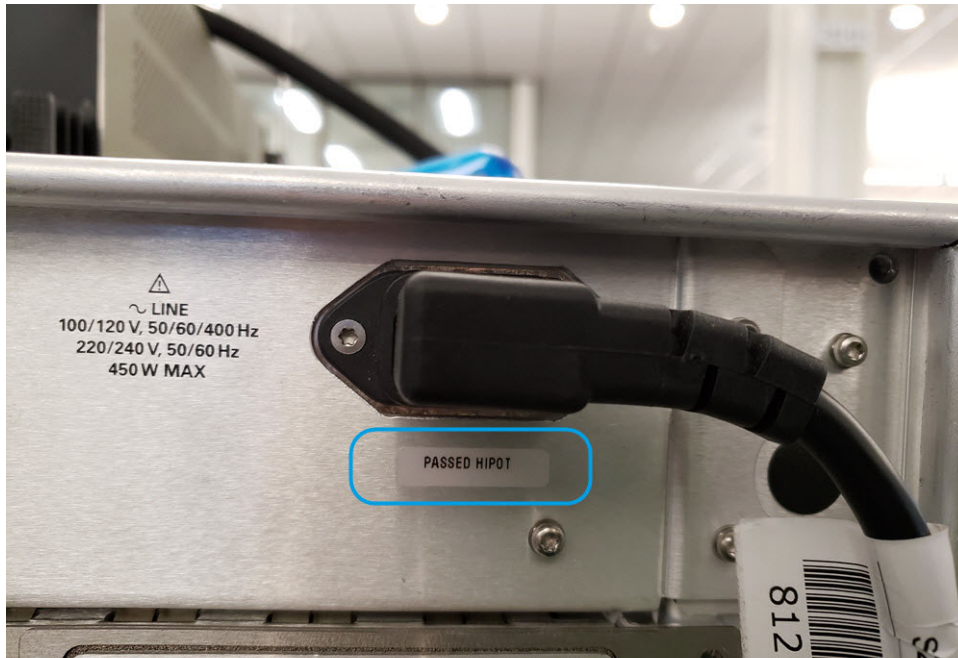
Figure 2

Hi-Pot Sticker on the Power Supply Cover

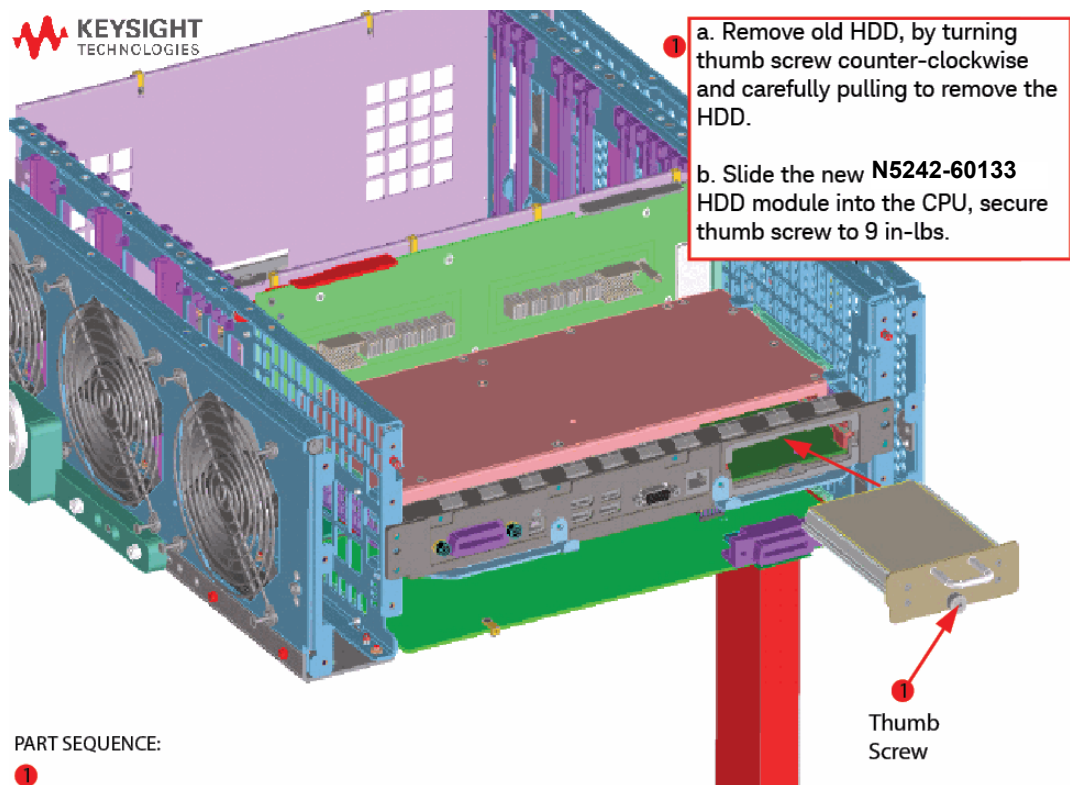
Figure 3

Service Center's Solid-State Disk Drive Assembly (SSDA) with A.10.40 or above (N5242-60135/N5242-60137 Win 10 OS SSDA installation is similar)

If a instrument currently has Windows XP OS: Install the *service center's* version 7 CPU (W1312-60211) and Windows 7 OS SSDA (N5242-60133) into the analyzer by referring to **Figure 3 on page 35** and to your instrument's Service Guide's Chapter 7 “Repair and Replacement Procedures” on www.keysight.com.

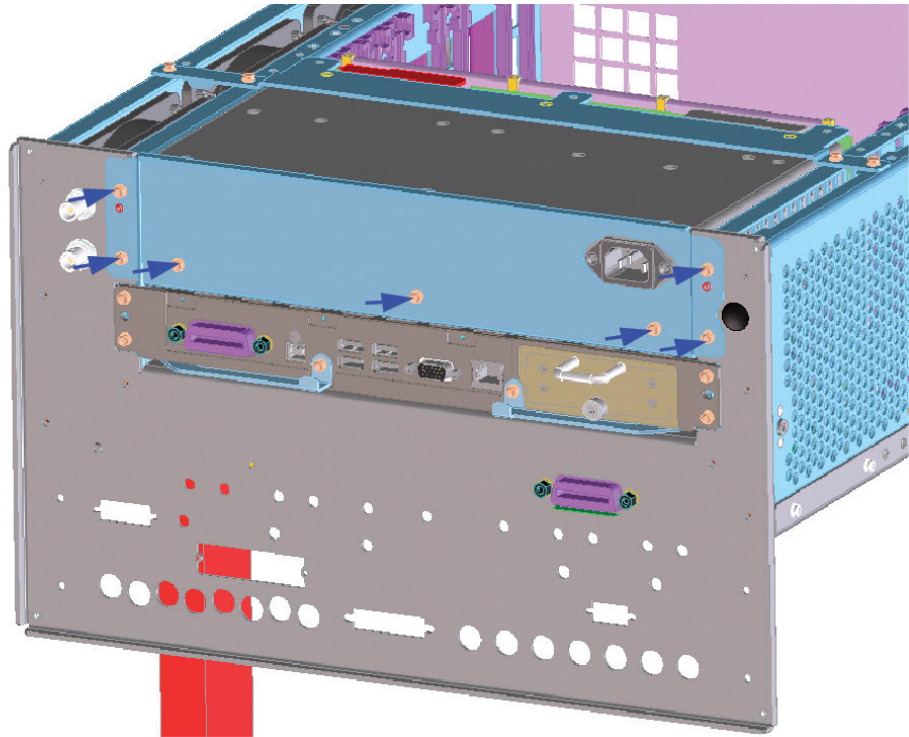
Figure 4

Install the Power Supply Cover (N5240-00012) with reused screws (x7)

1
Install Power supply Rear
Panel Bracket N5240-
00012, Secure with screws
0515-0372 X7. Torque to 9
in-lbs.

Refer to **Figure 4** and **Figure 5** for this step.

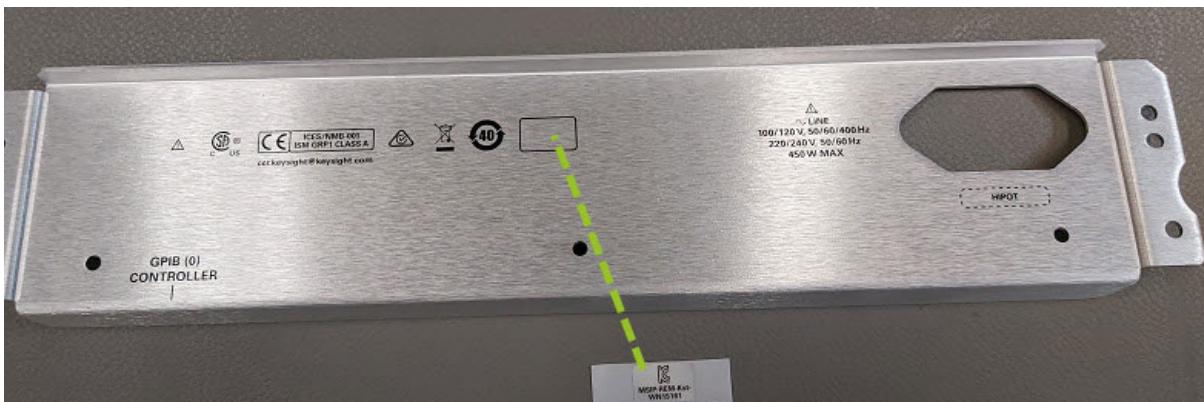
Figure 5

Install the KCC label (N5240-80041)

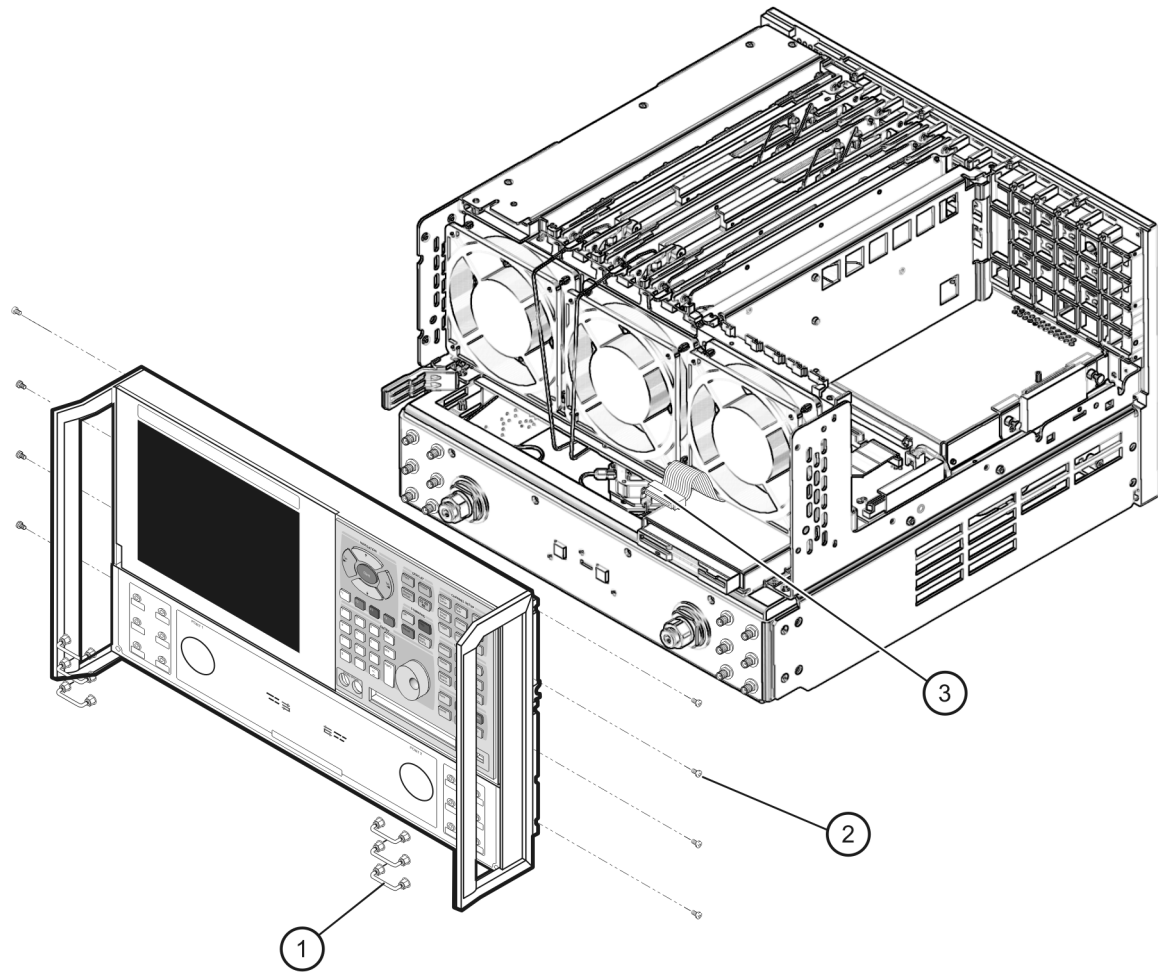
3. Slide the front panel over the test ports and other front panel connectors.
4. Disconnect the front panel interface ribbon cable (item ③). The front panel is now free from the analyzer.

Figure 5-6 Front Panel Assembly Removal (Instruments Vary—Example Only— Shown)

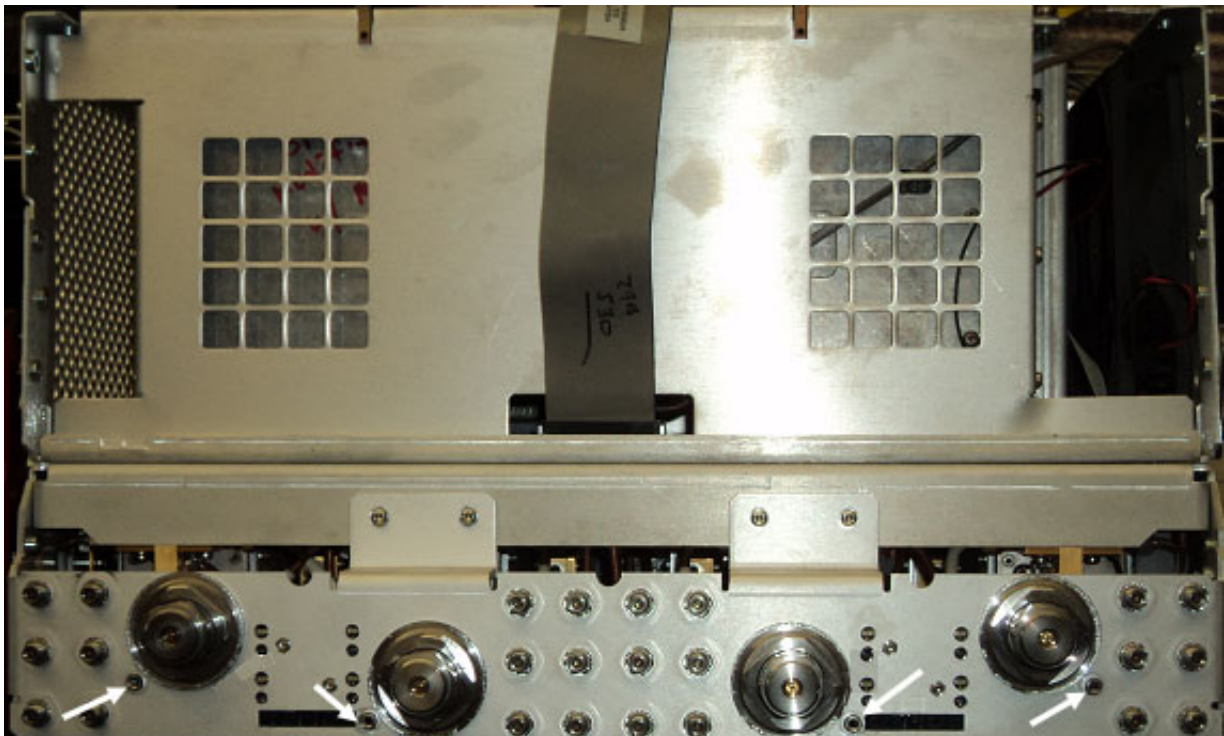
Figure 6 Verifying the front subpanel screw holes

IMPORTANT! If your front panel has the screw holes shown in **Figure 6** on **page 39**, skip this step.

This section is only required, if the front subpanel is missing the four screw holes as shown in **Figure 6**. If you need to order a subpanel, refer to **“Getting Assistance from Keysight”** on page 6.

If your subpanel is missing the four screw holes indicated in **Figure 6**, then you need to replace the subpanel. Contact Keysight to order a new subpanel and refer to the Service Guide for your instrument that can be downloaded from www.keysight.com.

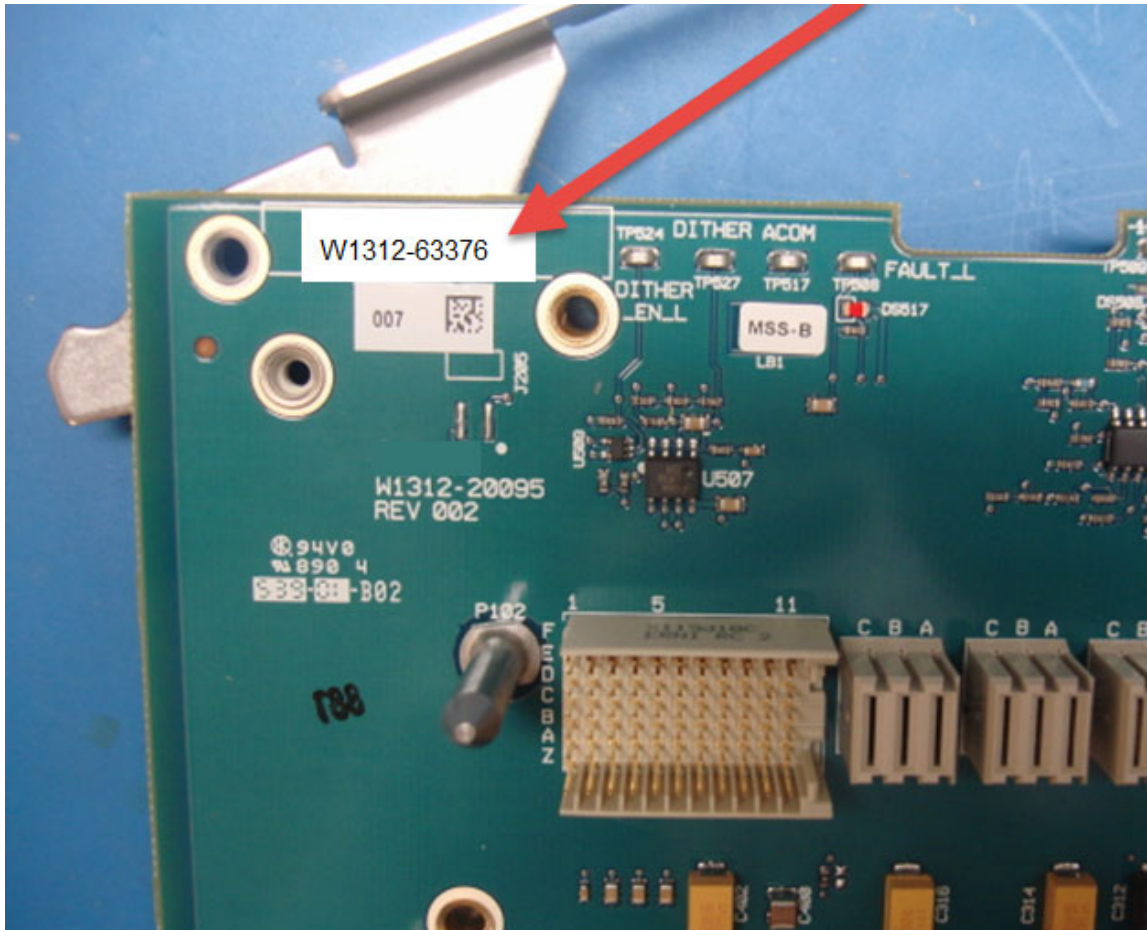
Figure 7

Verifying the midplane board number part number is: W1312-63376—Top Side View

This section is only required if the Midplane board is not a W1312-63376 part number. If your midplane board does not require this modification, skip this process and continue to the next step. After this section is completed, your midplane board will be a W1312-63376 midplane board. Refer to **Figure 7 on page 42.**

Verify that the sticker has the “W1312-633762 part number. Refer to **Figure 7**.

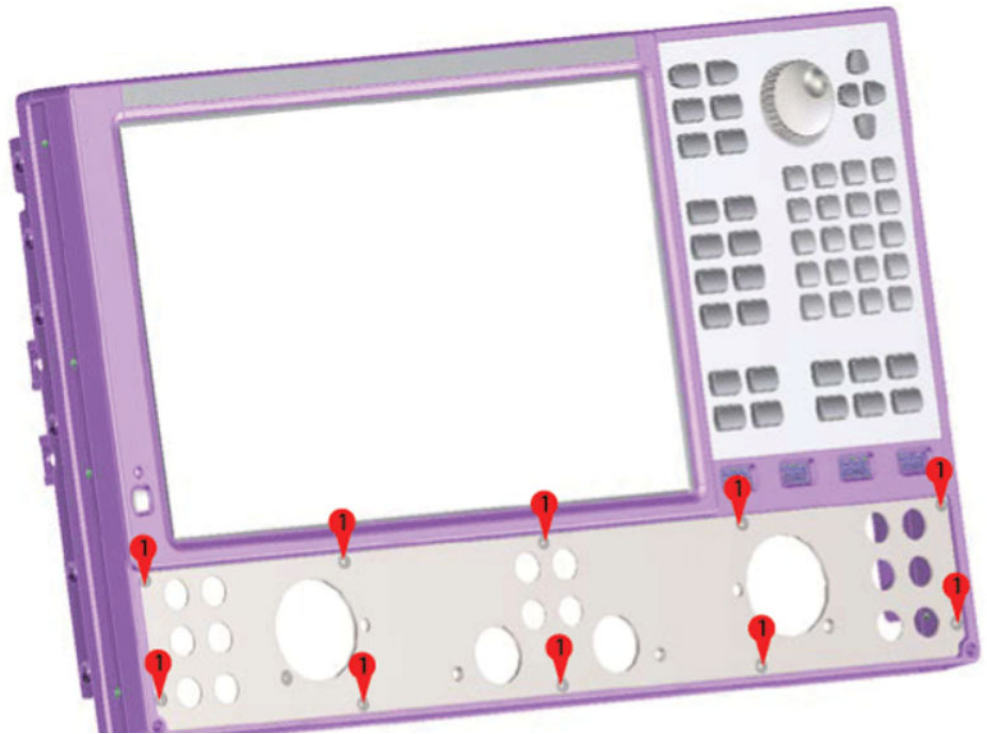
Figure 8

Install the new lower dress panel onto the new front panel using the 10 flat head screws (0515-1946) provided.

Front Dress Panel Installation

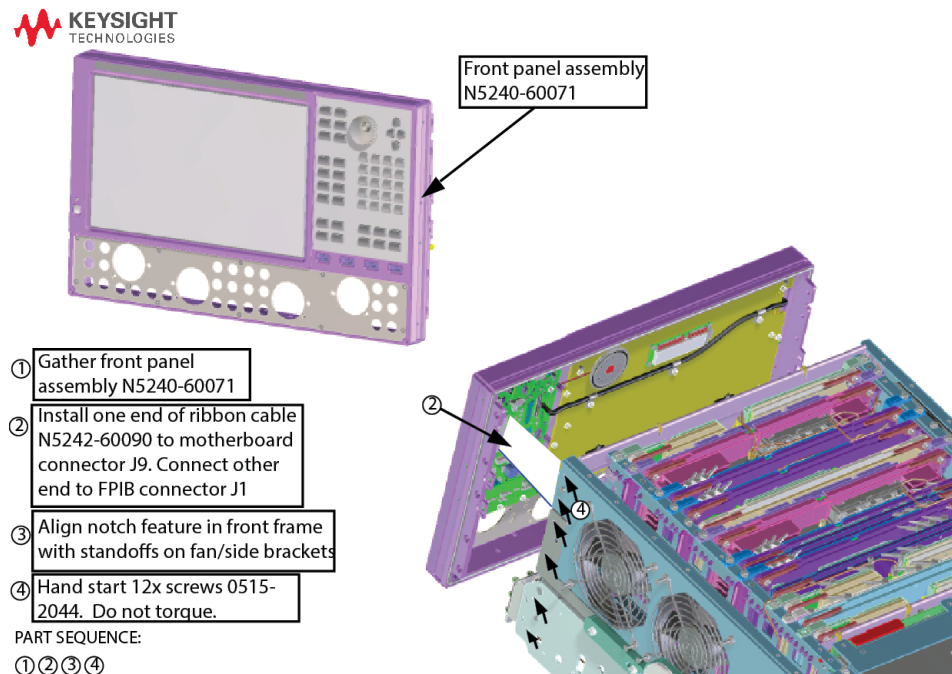
1. Reconnect the ribbon cable (item ②) to the A1 front panel interface board. Refer to [Figure 9](#).
2. Slide the front panel over the test port connectors. Ensure that the ribbon cable (item ②) connectors are seated.

Figure 9 New Front Panel Assembly Installation

3. Hand start the twelve 0515-2044 screws (item ②) in the sides of the frame. Use new screws from the kit and those retained earlier. Do not torque. Refer to [Figure 9 on page 45](#) and [Figure 10](#).
4. Install 0515-1946 (x4) screws (item ①) into lower front panel. Do not torque. Refer to [Figure 10](#).

5. Torque the twelve 0515-2044 screws in the order shown in [Figure 9 on page 45](#).
6. Torque the two 0515-1946 (x4) screws (2-port) or four 0515-1946 screws (4-port) to 9 in-lbs. 4-port is shown, refer to [Figure 10](#).

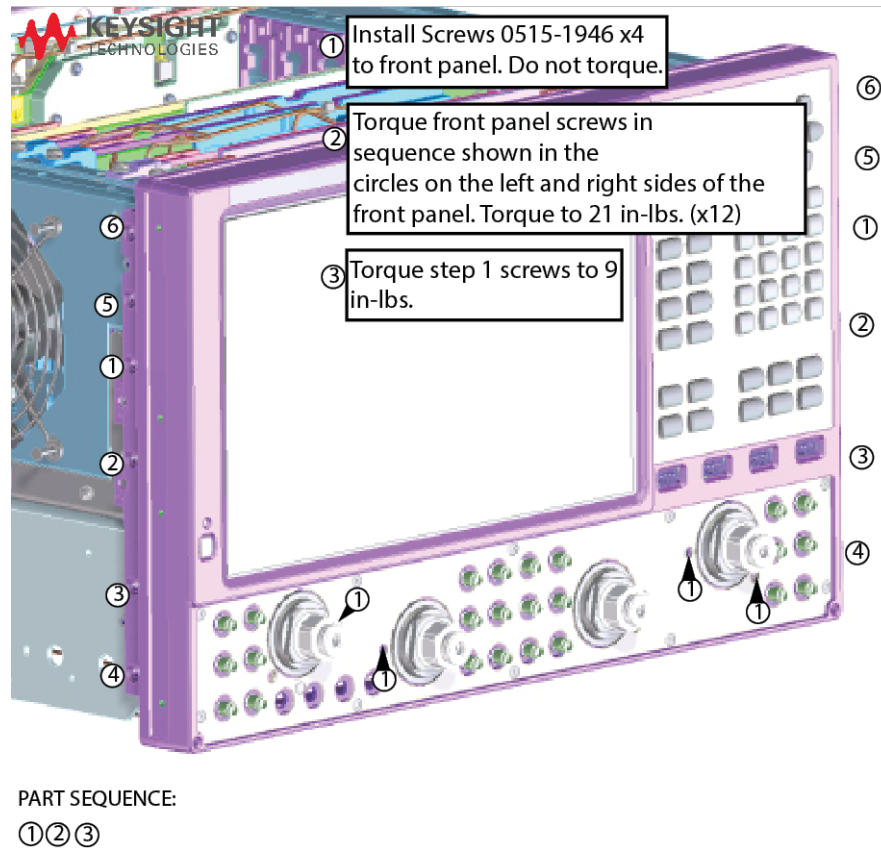
Figure 10

New Front Panel Assembly Torque Screws

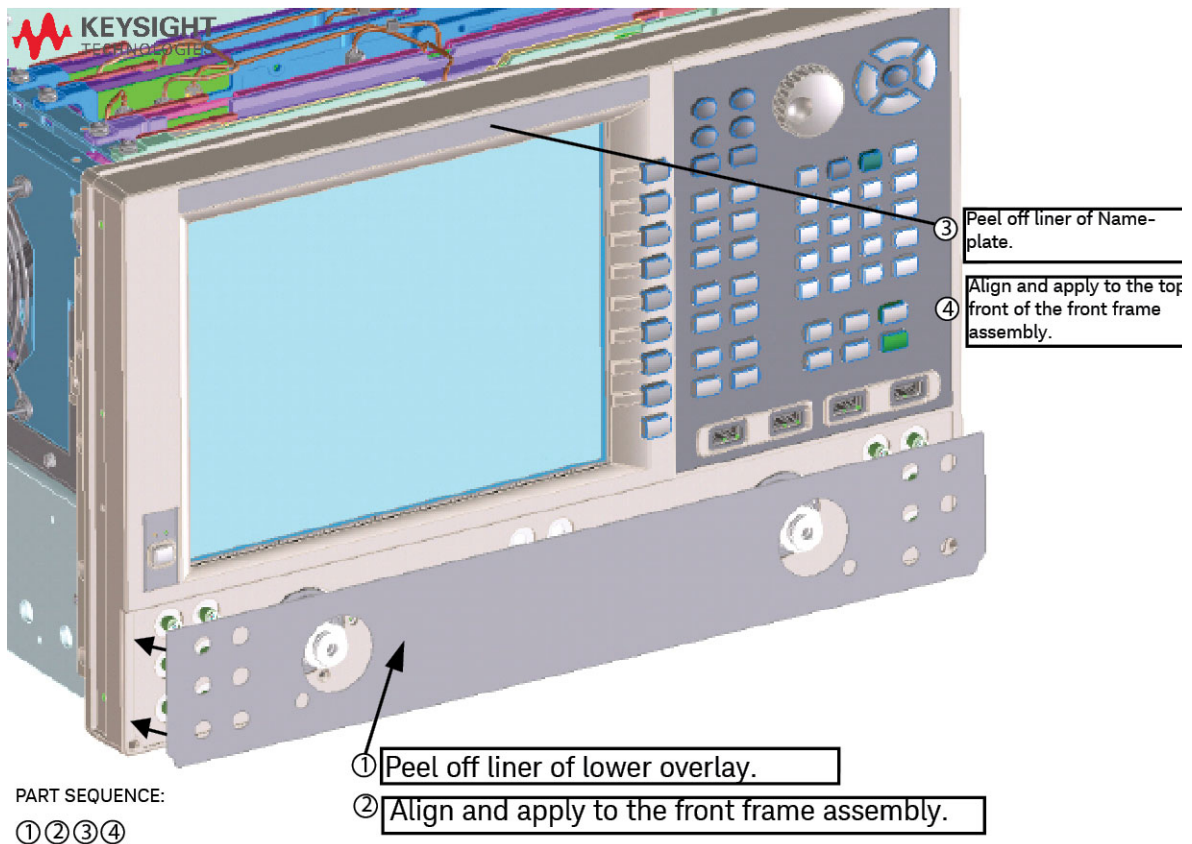
7. Install each of the overlays as follows (refer to **Figure 11**):

- Remove the protective backing to expose the adhesive.
- Carefully align the overlay to its location and gently position it.
- Once the overlay is properly positioned, press it firmly into place.

Figure 11 Front Panel Overlays Installation

There should also be a nameplate overlay included with the kit that matches your new analyzer; the same number as the old one except it will be a “B” model. There are multiple overlays provided in the kit; be sure that you use the proper one for your analyzer. If there is not an overlay that matches your analyzer, contact Keysight. Refer to **“Getting Assistance from Keysight” on page 6** of this installation note. Refer to **Figure 11 on page 47.**

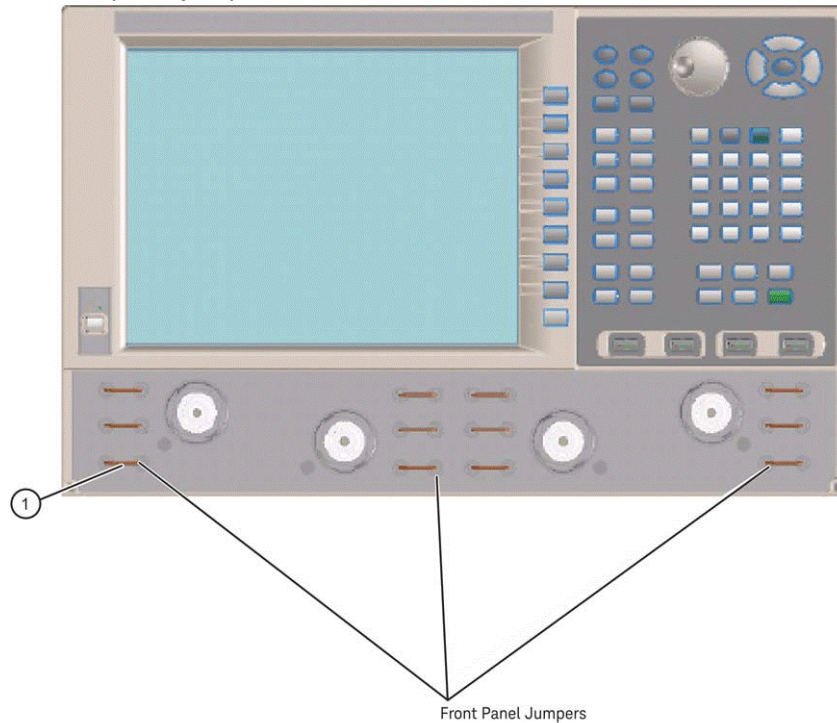
Figure 12

8. If equipped with front panel jumpers, reinstall the semi-rigid jumpers (Figure 12) on the front panel using a 5/16 inch torque wrench set to 8 in-lbs (N5247B only) and 10 in-lbs (N5241/2/4/5/9B).
9. If available, install the jumper covers (not shown).

Install front panel jumpers

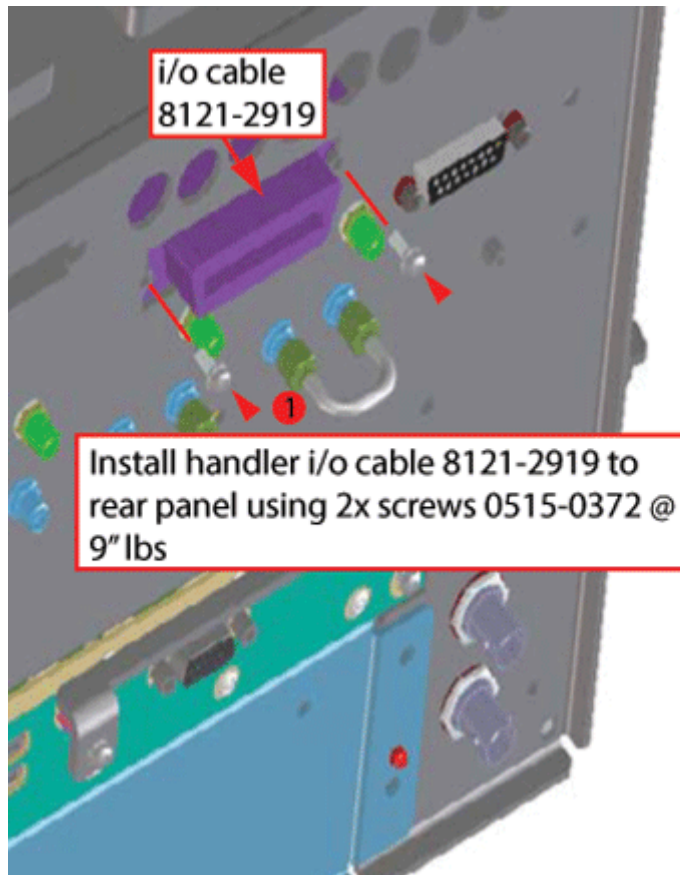
Figure 13

Install the Handler I/O Cable (8121-2919 and 0515-0372 (x2))

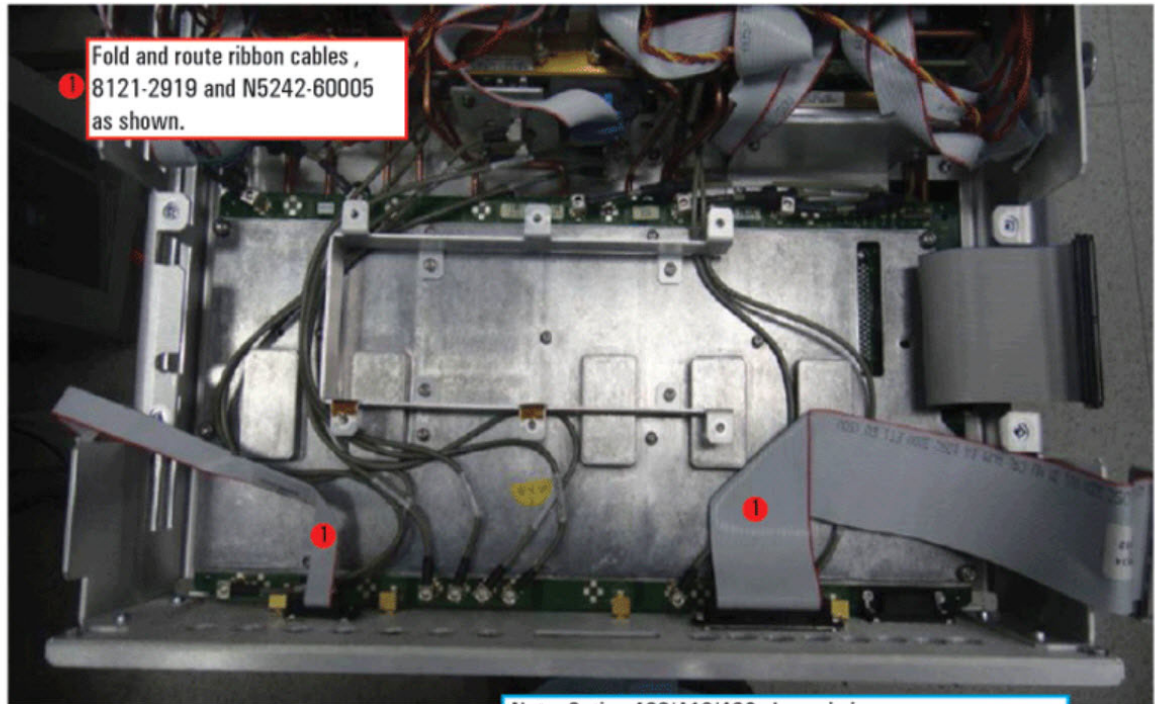
Figure 14 Fold the Handler I/O Cable (8121-2919 and N5242-60005)

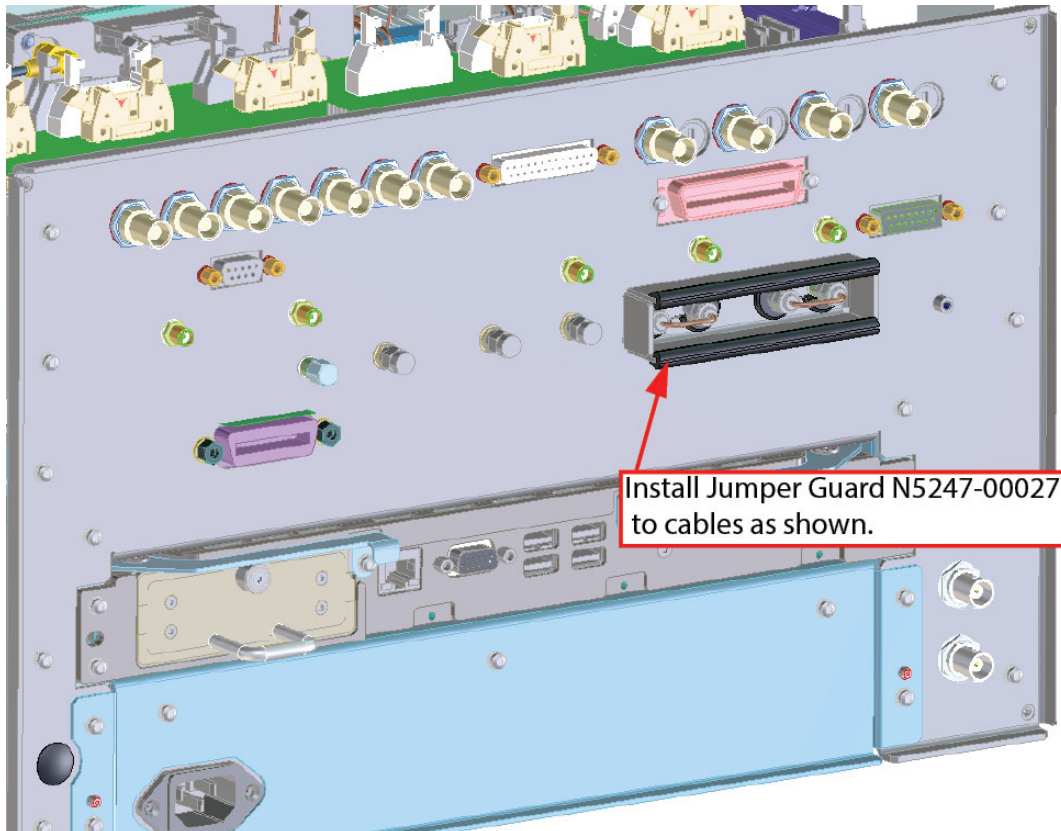
Install the dual cable rear guard (N5247-00027) over the two semi-rigid cables on the rear panel of the instrument.

Figure 15 Install the Dual Cable Rear Guard (N5247-00027)

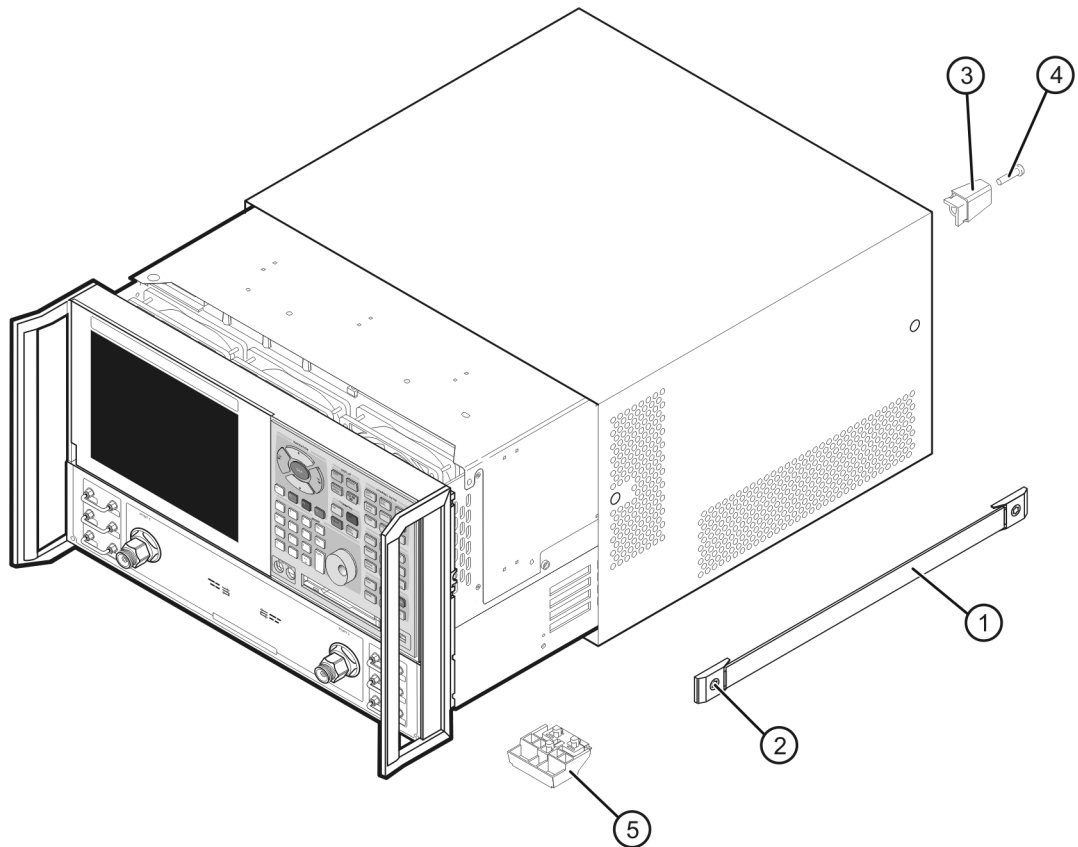
Figure 16

Outer Cover Reinstallation

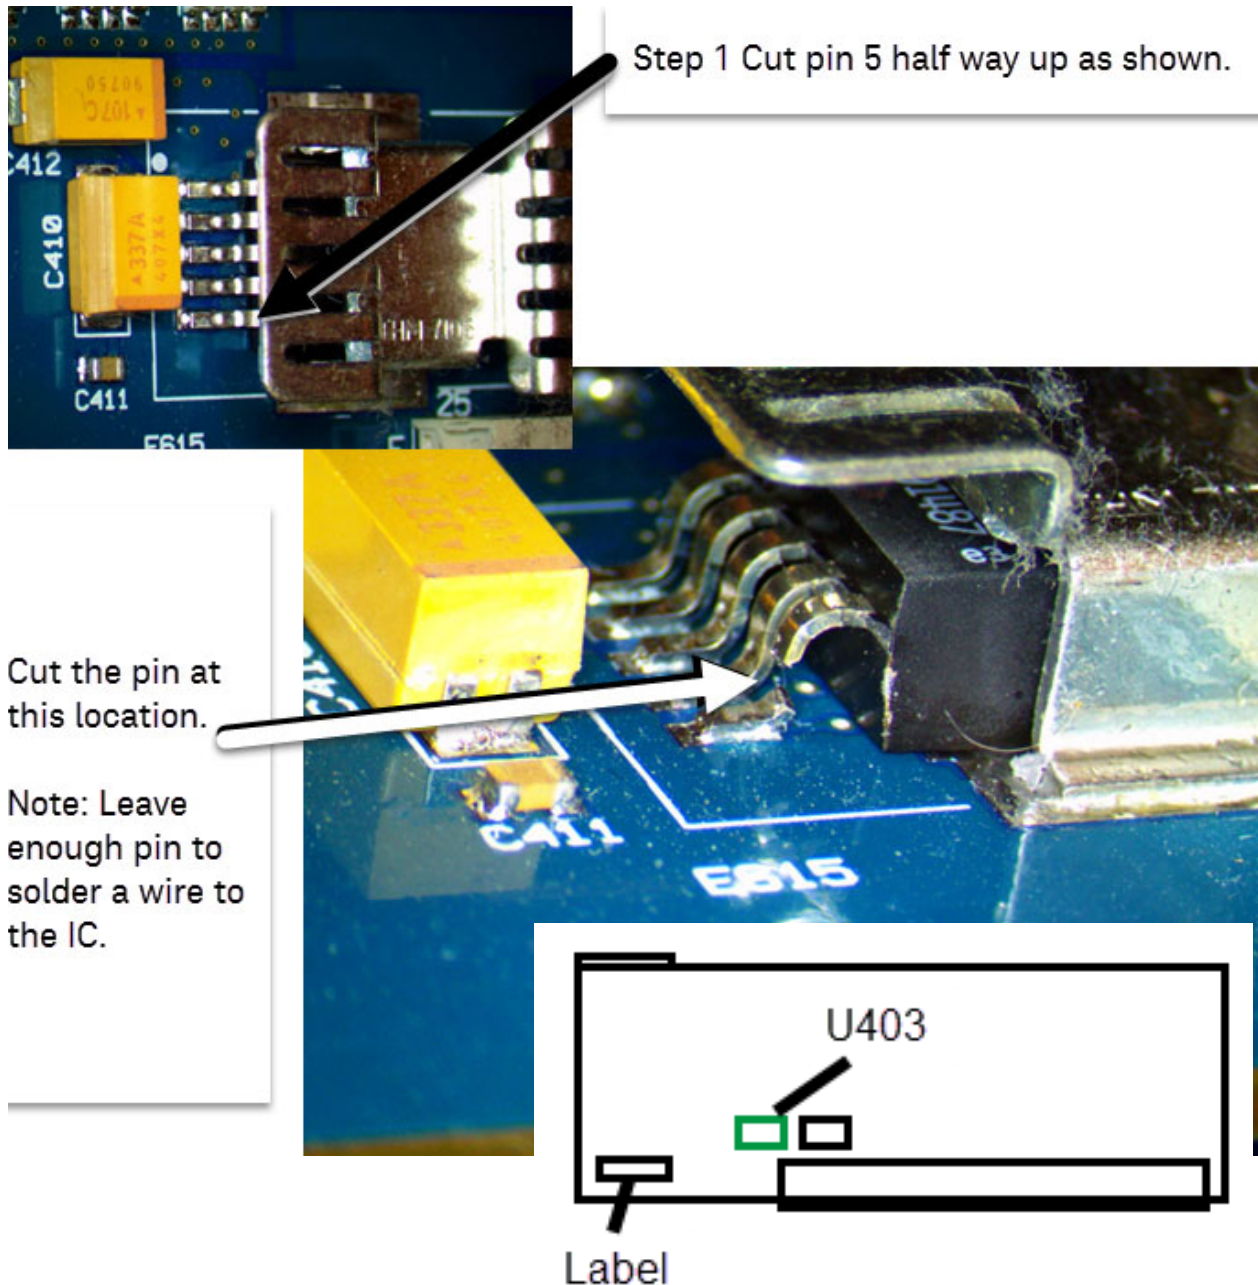
1. To remove your midplane board, refer to the Service Guide for your instrument that can be downloaded from www.keysight.com.
2. Cut pin 5 on U403, so that half of the lead is left near on the IC. Refer to [Figure A-1](#).

Figure A-1 Step 1 Cut pin 5 half way up as shown—Top Side View

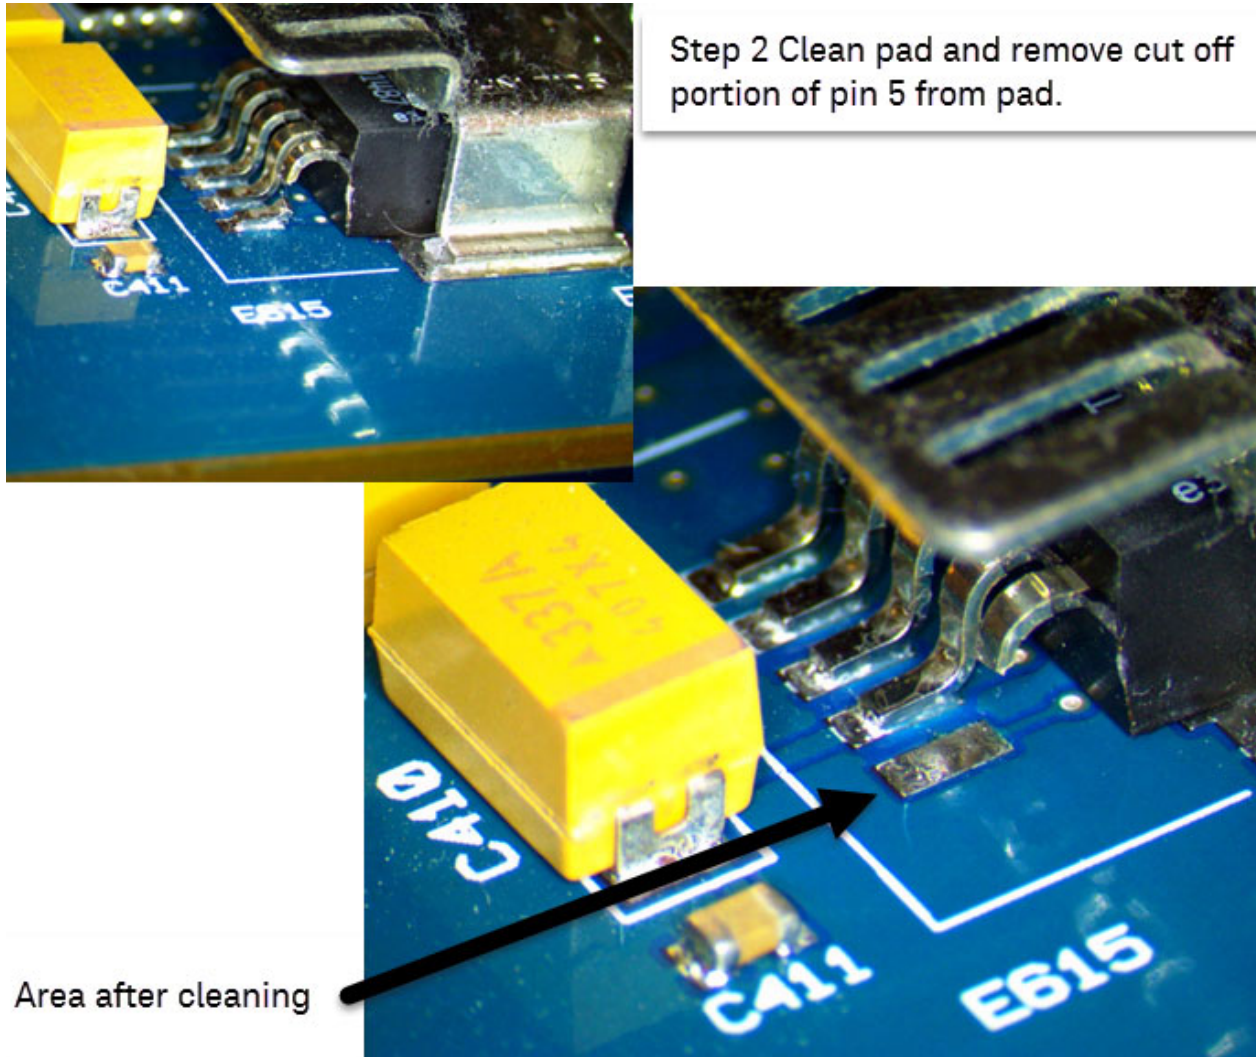
3. Clean pad and remove cut off portion of U403–pin 5 from the pad. Refer to **Figure A-2**.

Figure A-2 Cleaning the pad for pin 5—Top Side View

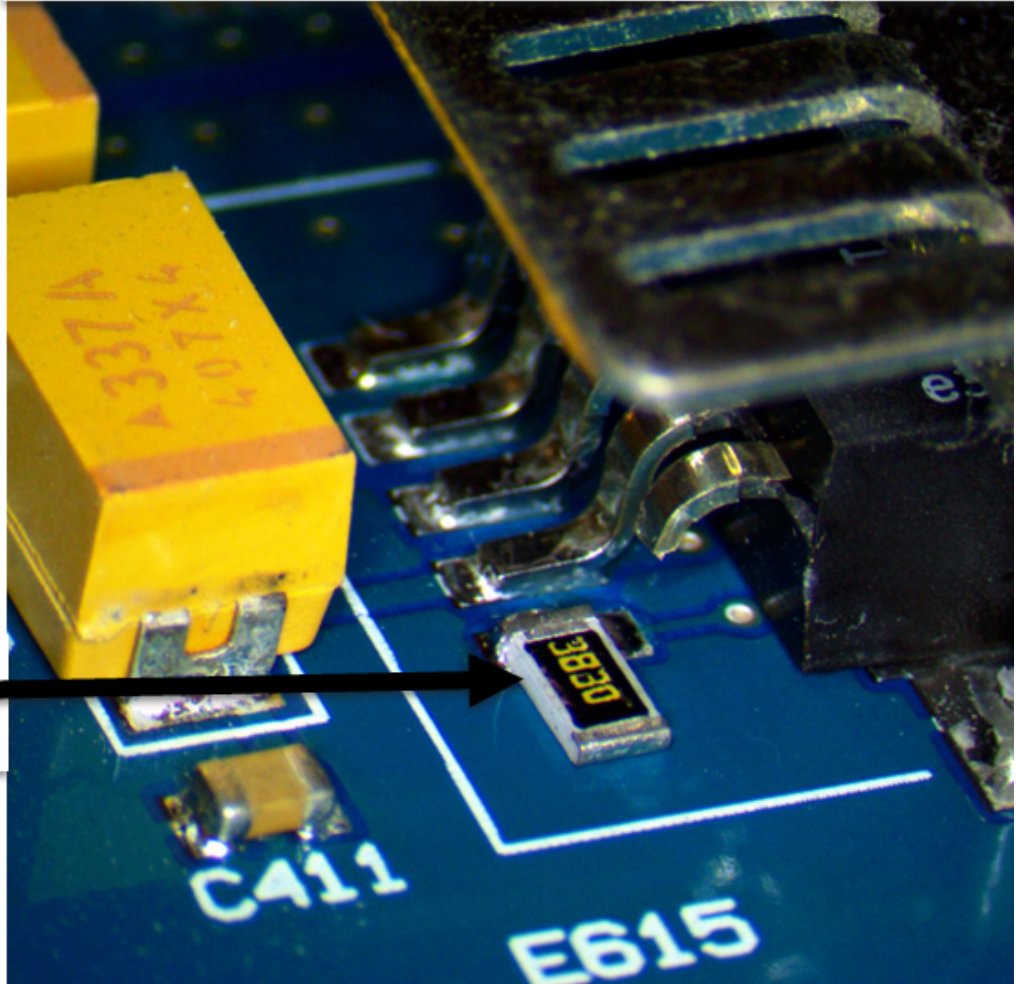
Figure A-3

4. Add 383 ohm resistor as shown. Refer to [Figure A-3](#).

Step 3 Add 383 ohm resistor as shown.

383 ohm
0699-1429

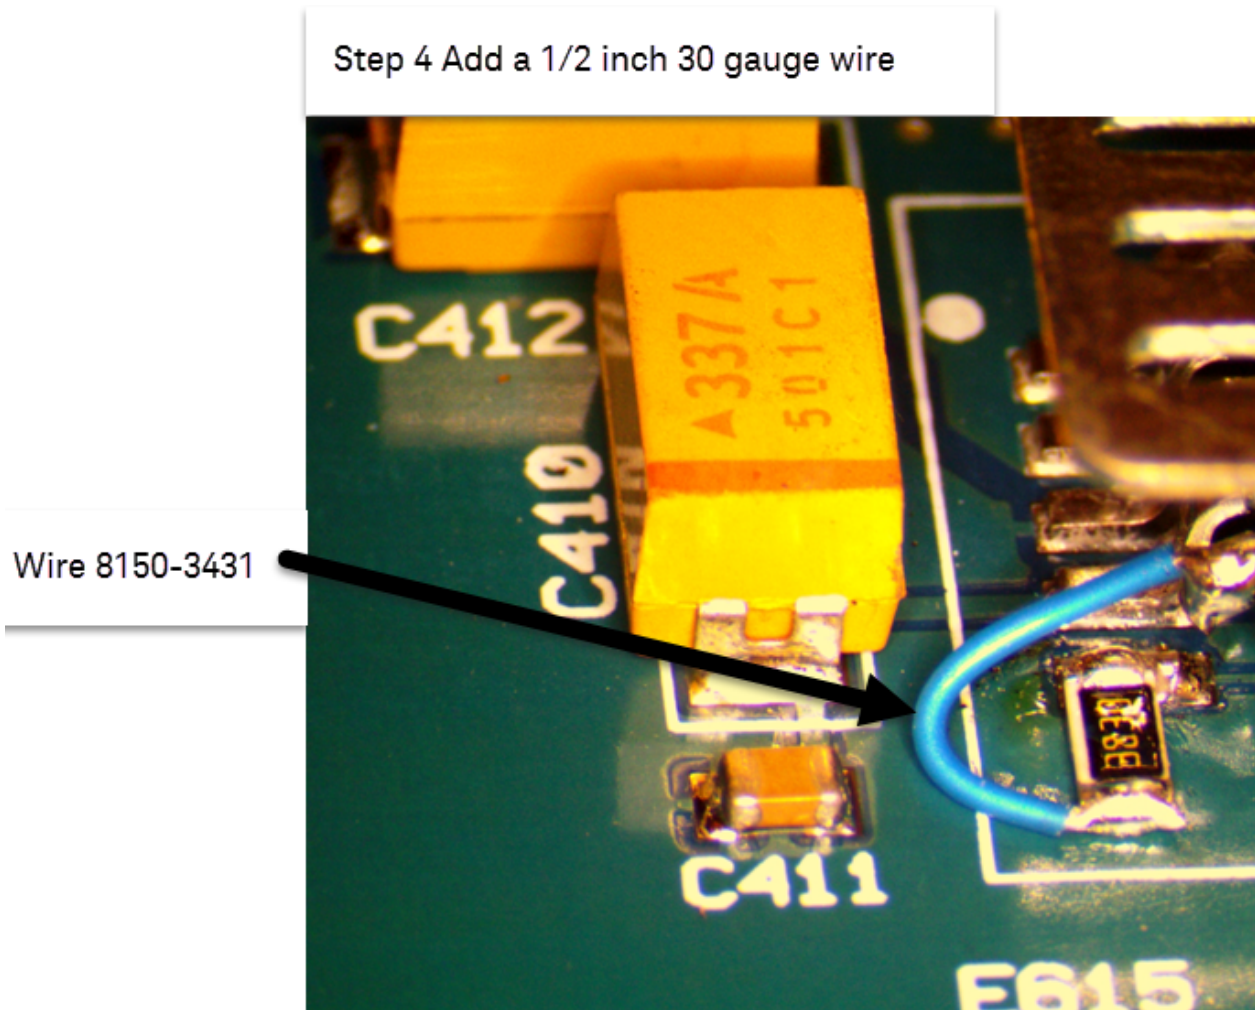
Figure A-4

5. Add a 1/2 inch 32 gauge wire. Refer to **Figure A-4**.

Add a 1/2 inch 32 gauge wire—Top Side View

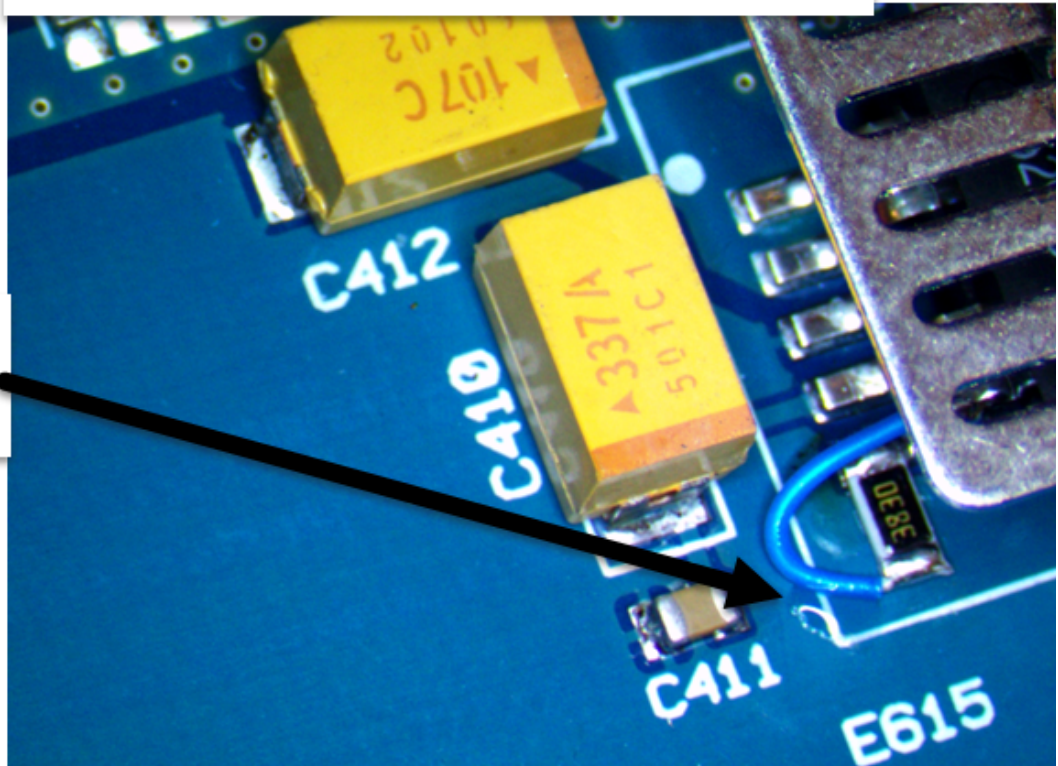
Figure A-5

6. Add glue as shown to hold the wire in place. Refer to [Figure A-5 on page 73](#).

Step 5 Add glue as shown to hold the wire in place.

Loctite 545
0470-0954
