Keysight 2-Port/4-Port N524xA to N524xB and N5264A to N5264B Model PNA-X Upgrade Kit - Installation Guide

To Upgrade 2-Port/4-Port “A” models to 2-Port/4-Port “B” models

This is the Installation Note for the PNA-X N524xA Series Microwave Network Analyzers and N5264A Microwave Receiver.

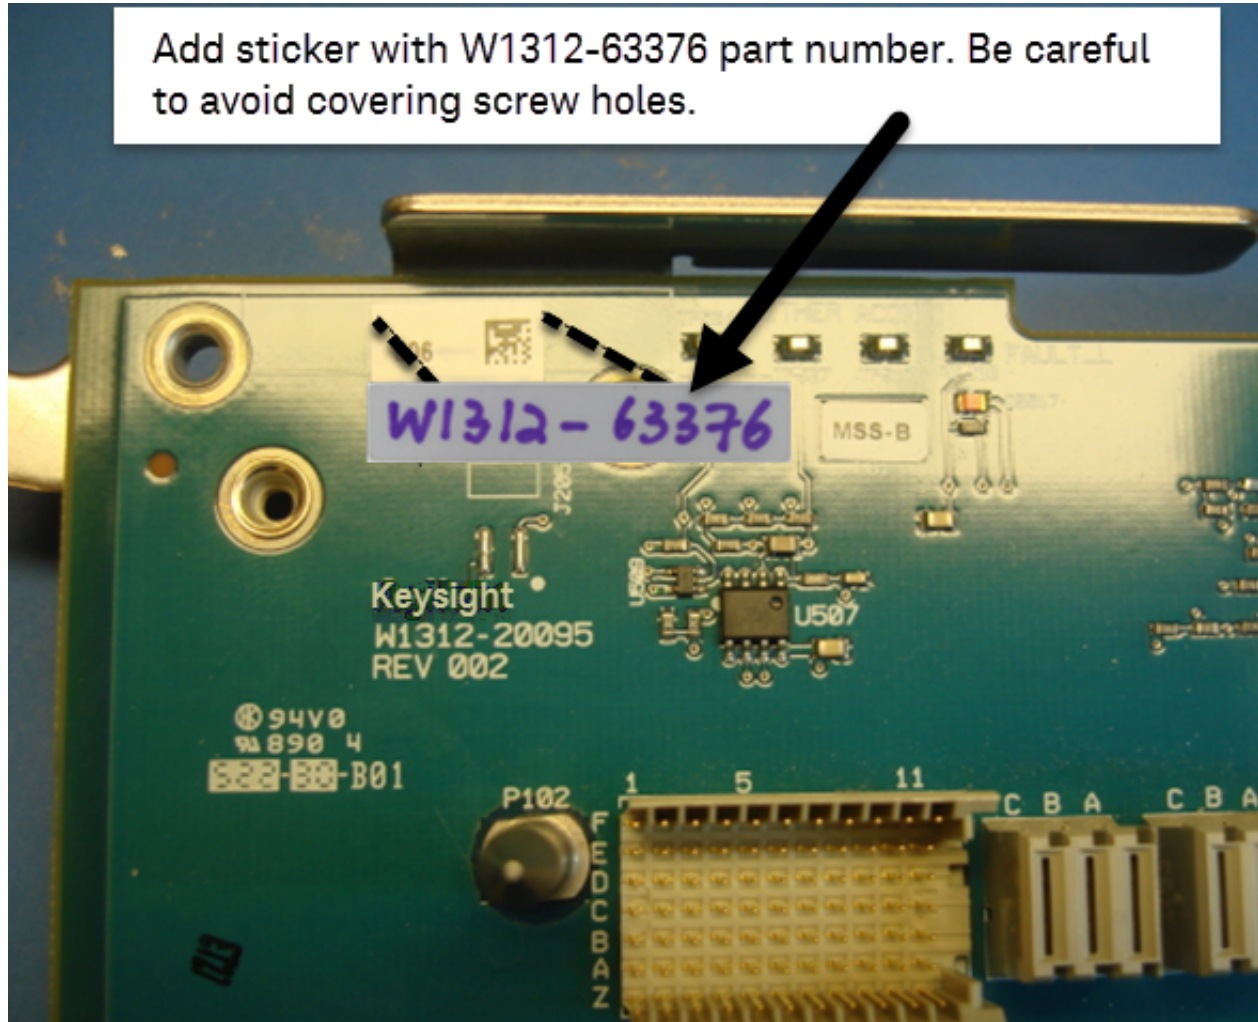
7. Add the W1312-63376 sticker. Verify that the sticker does not interfere with the PCA screw holes. Refer to **Figure A-6**.

Figure A-6 Adding sticker to new board number W1312-63376—Top Side View

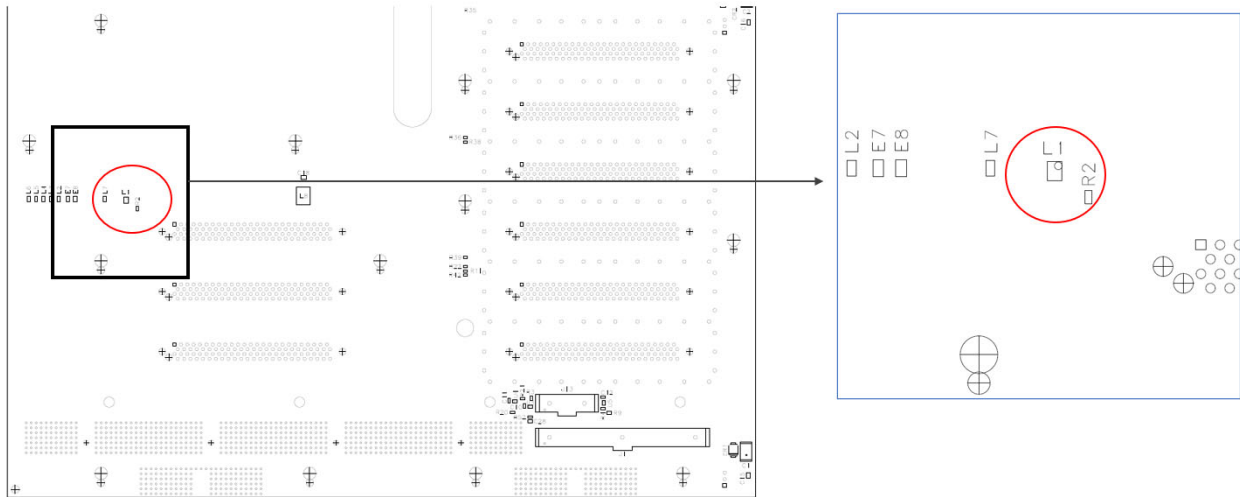
Figure A-1 Locate L1 on System Motherboard

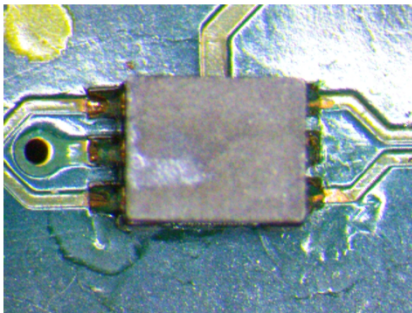
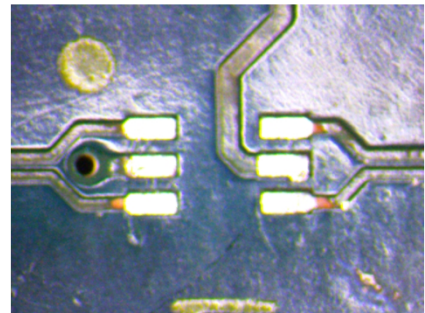
Figure A-2 Remove L1 and Clean Traces

- L1 is a 6 pin part with no ground pin on the belly
- It can be removed by using two soldering irons on either side of the part

Remove L1 and clean area →

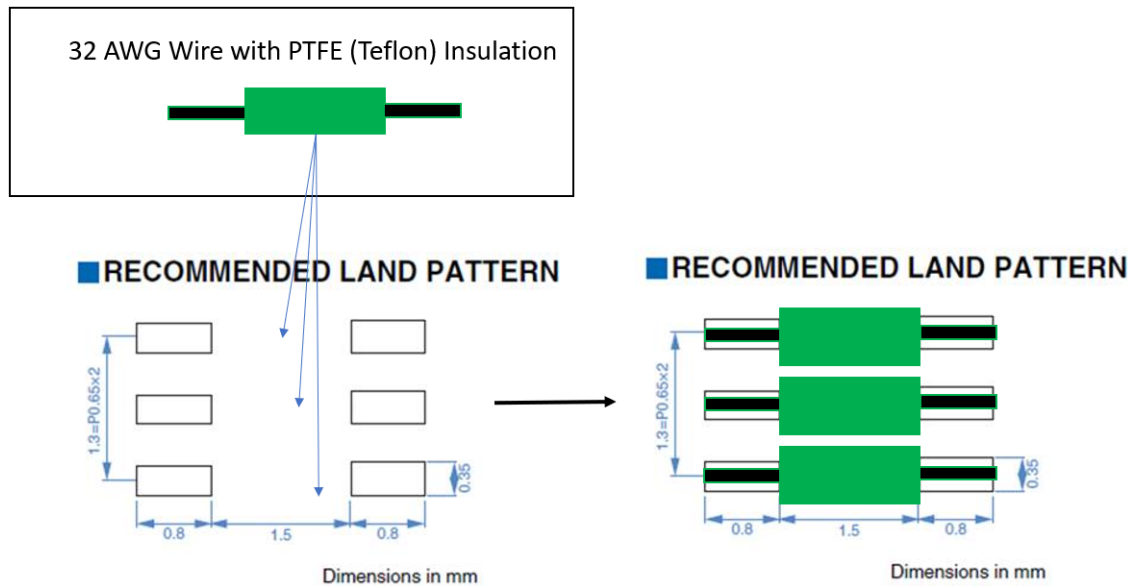
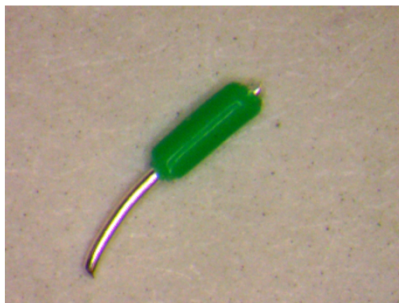
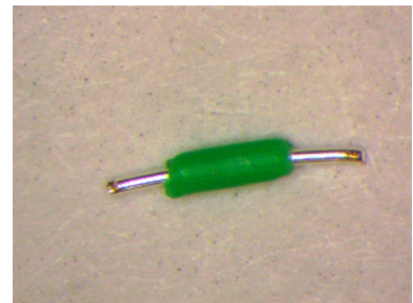
Figure A-3 Prepare Green Wire (x3)

- Wire (N5240-60111) will come in with slight curve
- Insulation will not be centered

Push insulation to center
and straighten as needed

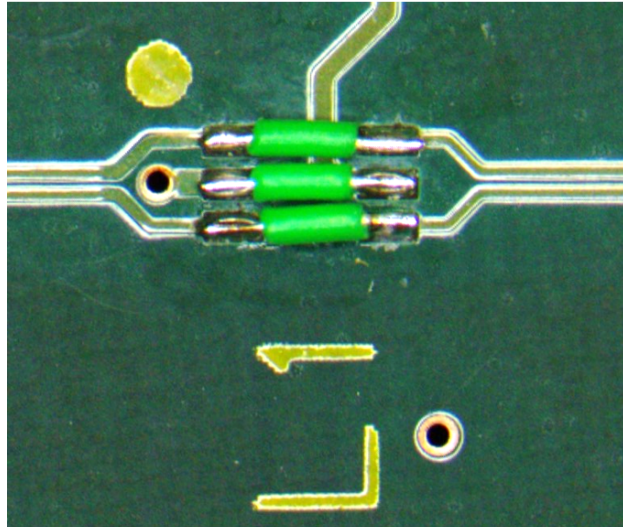
Figure A-4 Solder Green Wires (x3) to Motherboard

- Start with the wire near the dot (this is the most important wire as it crosses over a ground trace).
- It is easier to pre-tin the pad before placing the wire onto it.
- The wire gets hot rapidly so one side can come loose while soldering the other.

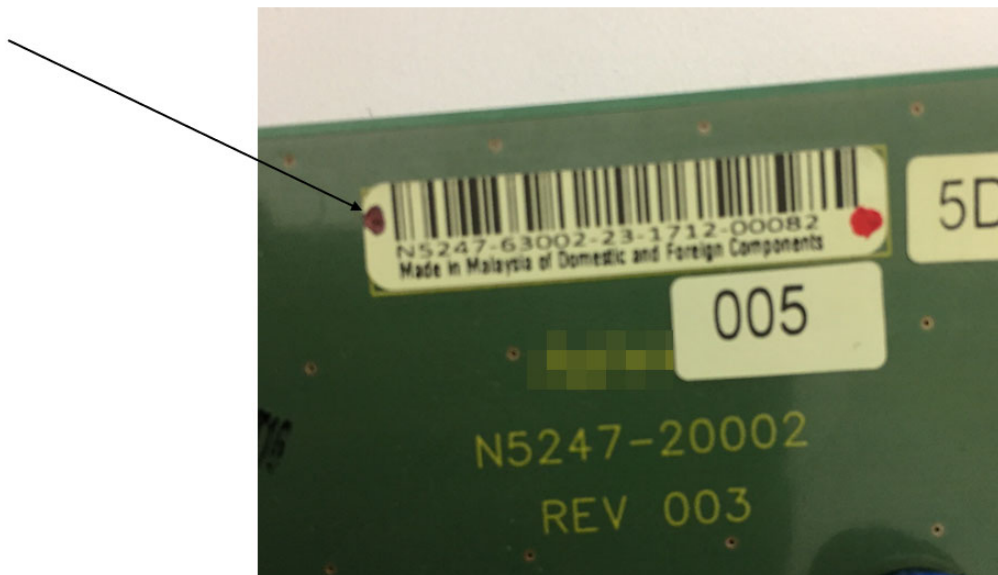
Figure A-5 Mark the Motherboard Serial Number Label With a Black Dot

- Place a small black circle to the left of the serial number to show that L1 has been removed
- Make a note on the assembly document that this L1 has been removed **"L1 Removed"**

6. Mark motherboard as shown with black dot. Refer to [Figure A-5 on page 81](#).
