# Keysight 2-Port/4-Port N522xA to N522xB Model PNA Upgrade Kit - Installation Guide

To Upgrade 2-Port/4-Port “A” models to  
2-Port/4-Port “B” models:

This is the Installation Note for the PNA-X N522xA Series Microwave Network Analyzers.

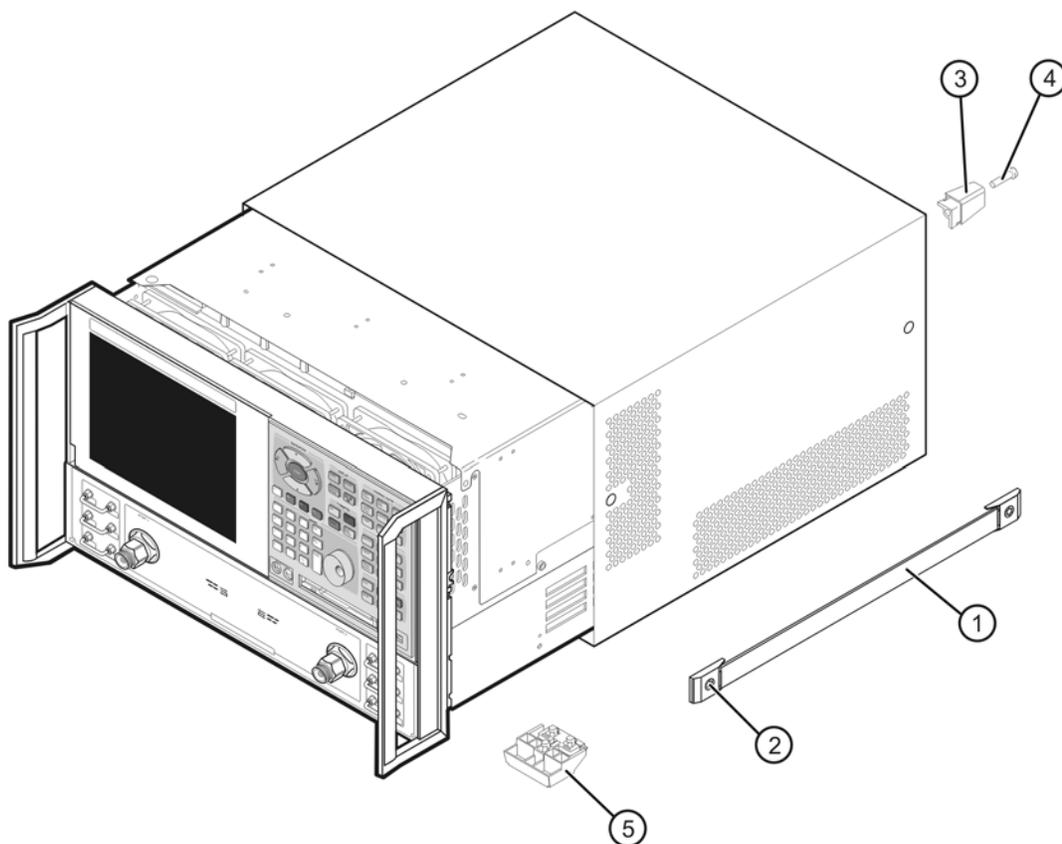
Figure 1

1. Turn OFF the analyzer and disconnect the power cord.
2. With a T-20 TORX driver, remove the strap handles (item ①) by loosening the screw (item ②) on each end of each handle.
3. With a T-20 TORX driver, remove the four rear panel feet (item ③) by removing the center screws (item ④).
4. Slide the four bottom feet (item ⑤) off the cover.
5. Slide the cover off of the frame.

Outer Cover Removal (Instruments Vary—Example Only)

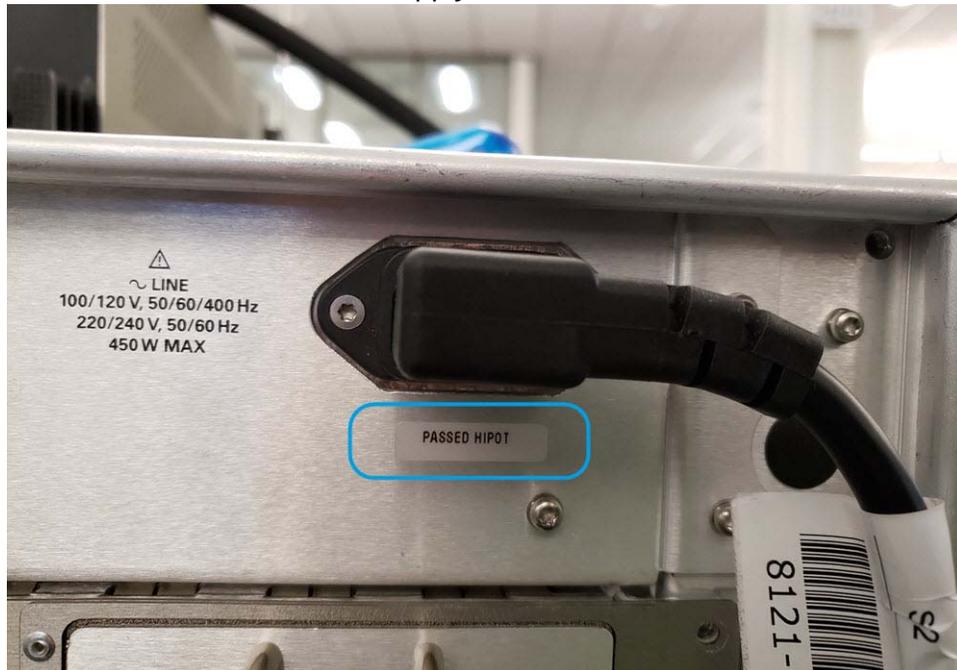
Figure 2

Hi-Pot Sticker on the Power Supply Cover

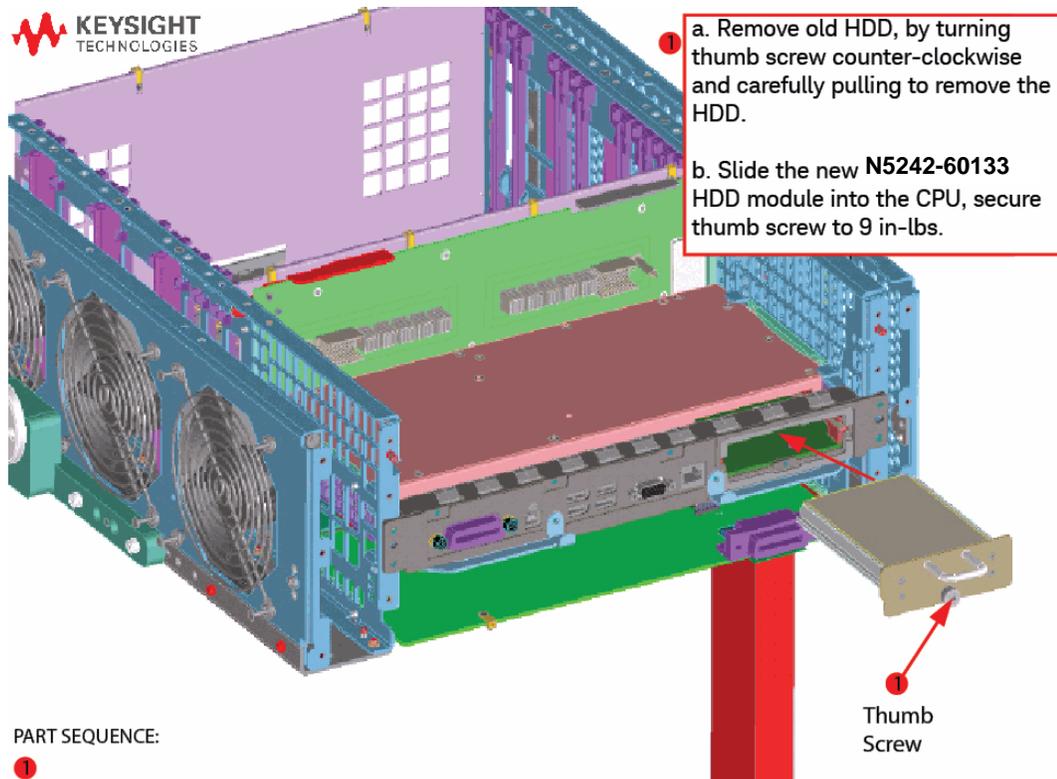
Figure 3

Service Center's Solid-State Disk Drive Assembly (SSDA) with A.10.40 or above (N5242-60135/N5242-60137 Win 10 OS SSDA installation is similar)

**If a instrument currently has Windows XP OS:** Install the *service center's* version 7 CPU (W1312-60211) and Windows 7 OS SSDA (N5242-60133) into the analyzer by referring to **Figure 3 on page 31** and to your instrument's Service Guide's Chapter 7 “Repair and Replacement Procedures” on [www.keysight.com](http://www.keysight.com).

1. Install the new SSDA in the analyzer by reversing the Hard Disk Drive Removal procedure in the Service Guide for your model. Refer to **Figure 3 on page 31** and to your instrument's Service Guide on [www.keysight.com](http://www.keysight.com).

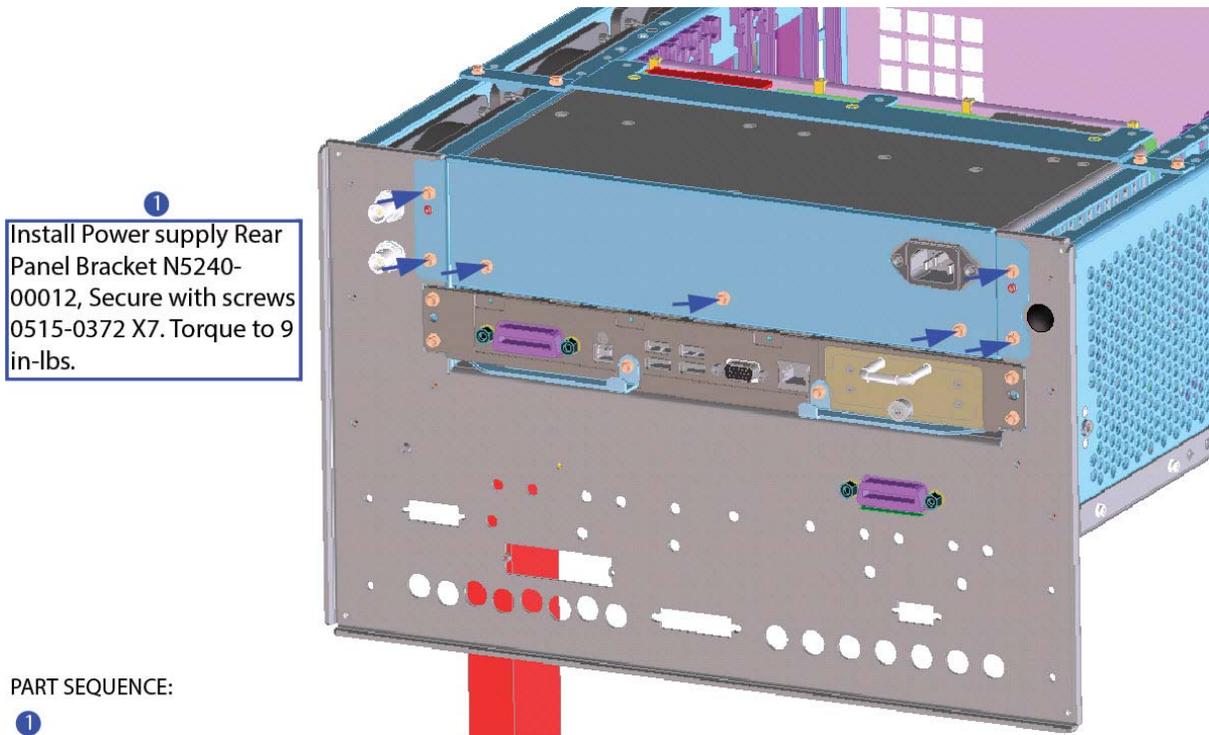
1. Install the new power supply cover by reusing the 0515-0372 (x7) screws.
2. Install the KCC label (N5220-80001) as shown.

Figure 4 Install the Power Supply Cover (N5240-00012) with reused screws (x7)

Refer to **Figure 4** and **Figure 5** for this step.

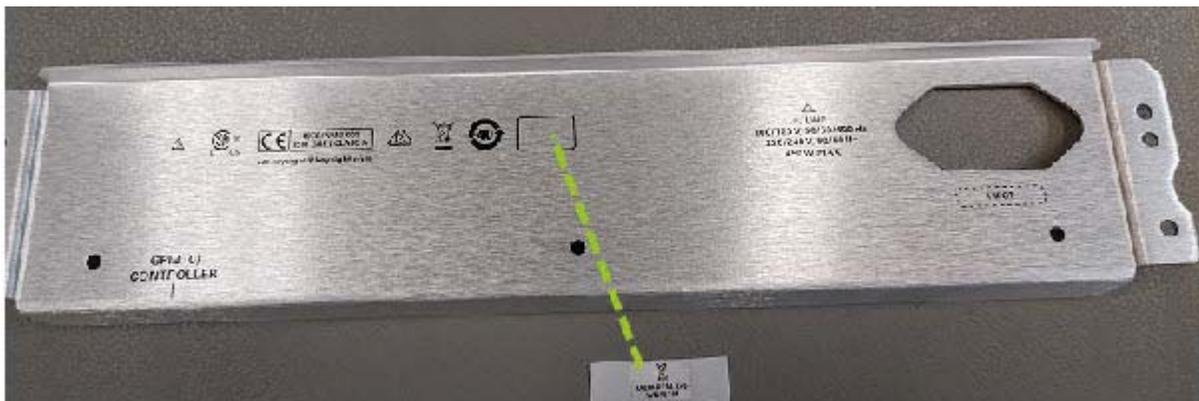
Figure 5 Install the KCC label (N5220-80001)

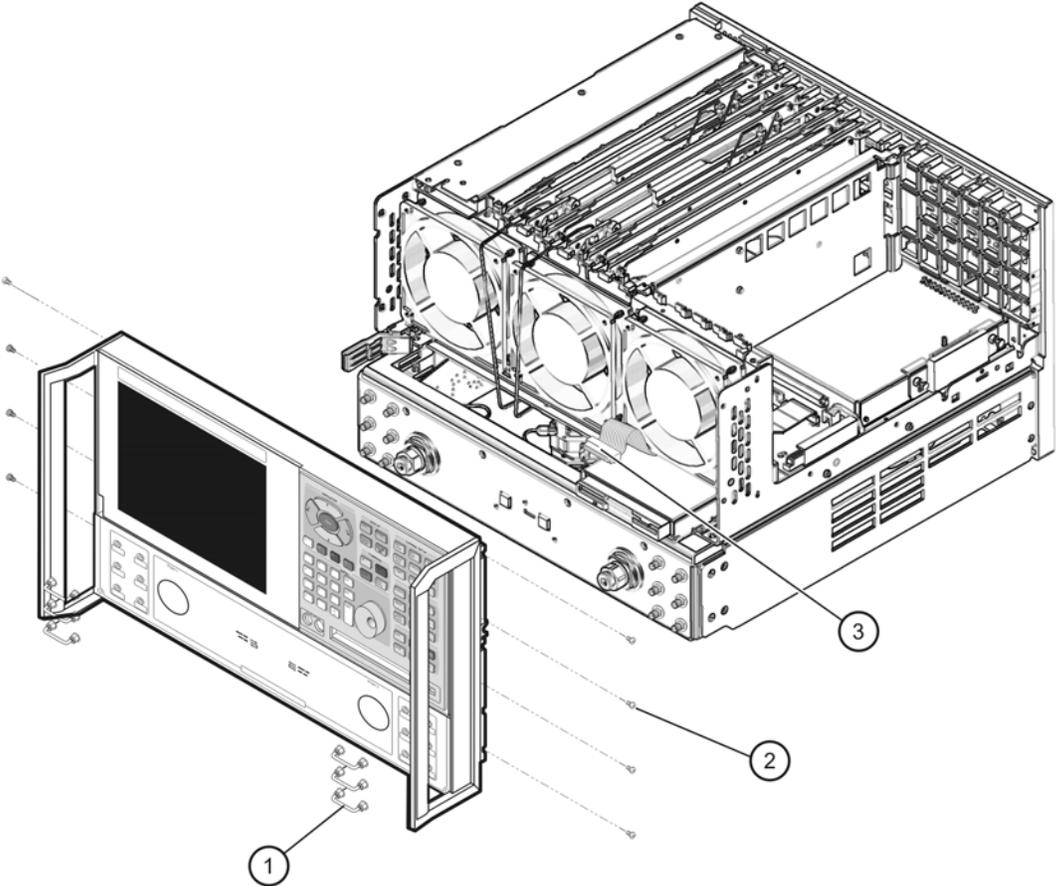
Figure 6 Front Panel Assembly Removal ((Instruments Vary–Example Only– Shown))

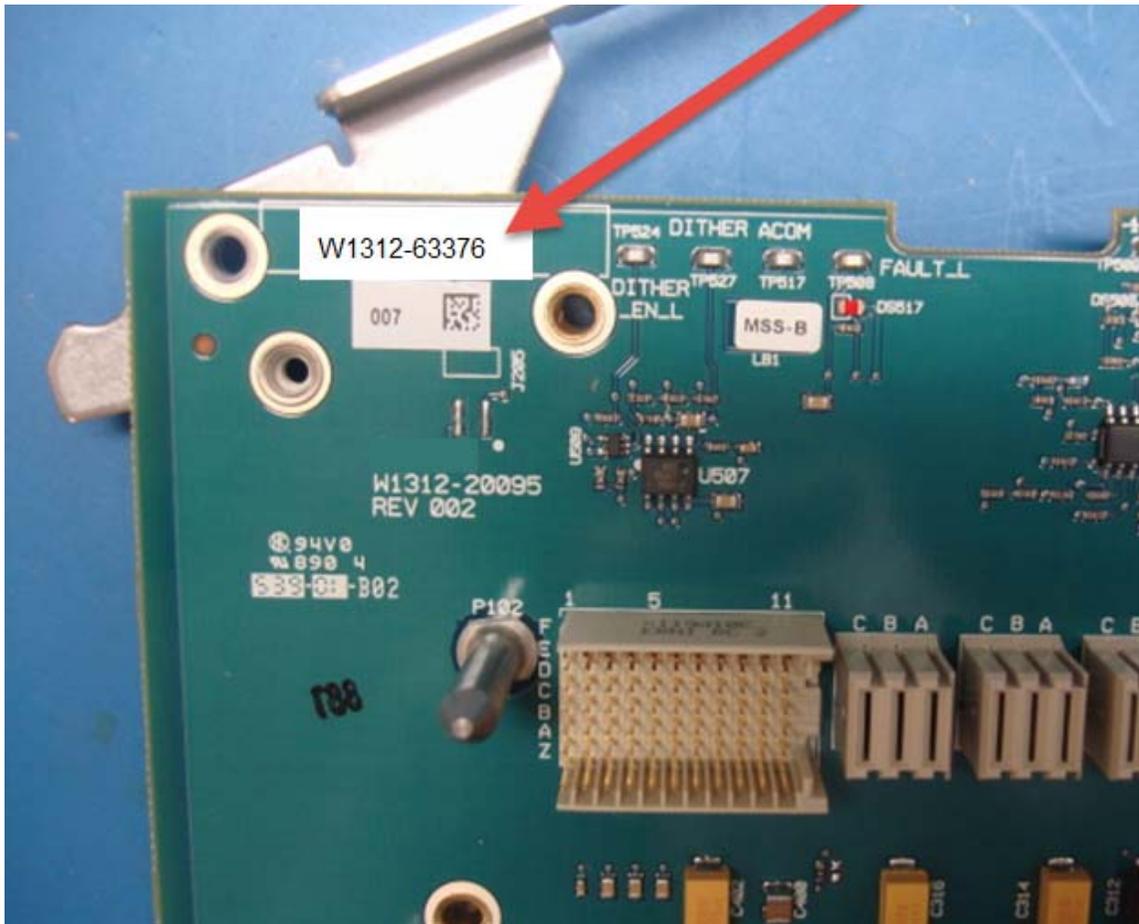
Figure 7

Verifying the midplane board number part number is: W1312-63376—Top Side View

This section is only required if the Midplane board is not a W1312-63376 part number. If your midplane board does not require this modification, skip this process and continue to the next step. After this section is completed, your midplane board will be a W1312-63376 midplane board. Refer to **Figure 7 on page 36.**

Verify that the sticker has the “W1312-63376” part number. Refer to **Figure 7**.

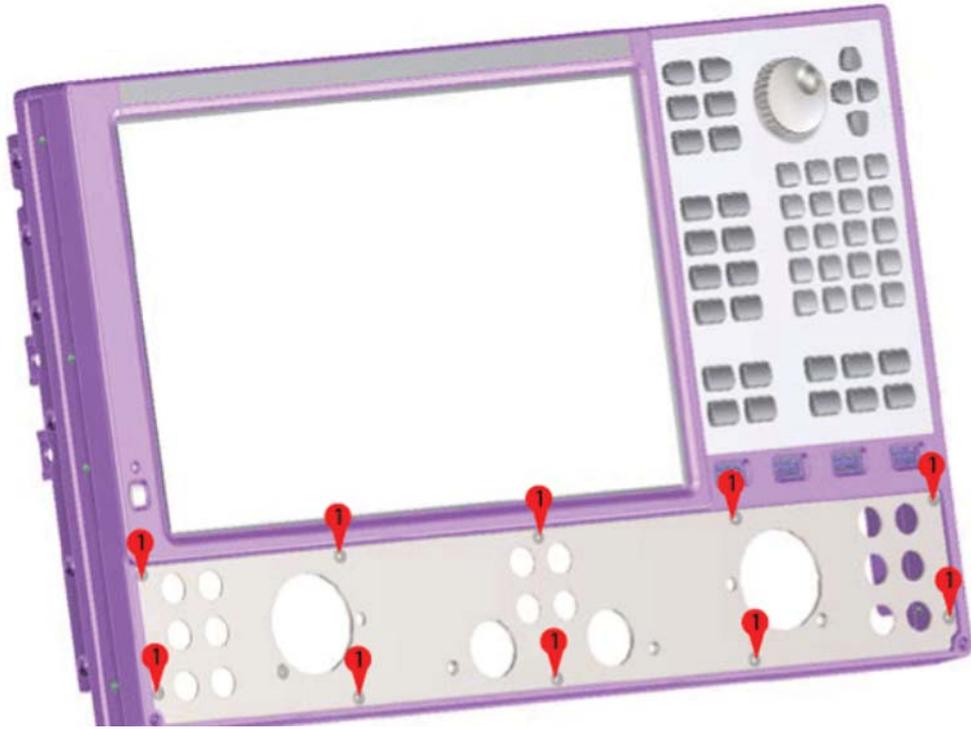
Figure 8

Front Dress Panel Installation

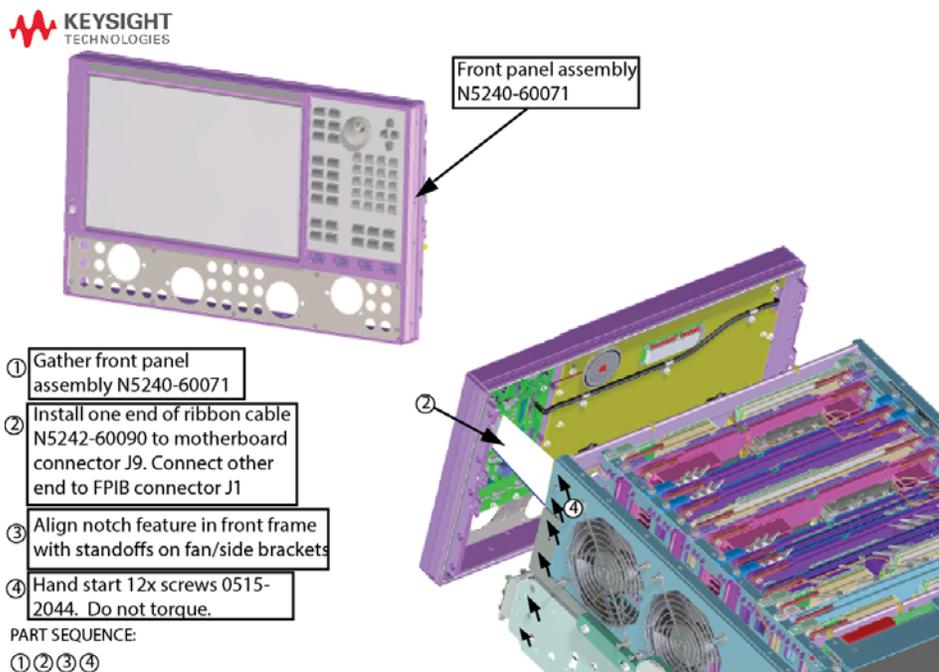
1. Reconnect the ribbon cable (item ②) to the A1 front panel interface board. Refer to [Figure 9](#).
2. Slide the front panel over the test port connectors. Ensure that the ribbon cable (item ②) connectors are seated.

Figure 9 New Front Panel Assembly Installation

3. Hand start the twelve 0515-2044 screws (item ②) in the sides of the frame. Use new screws from the kit and those retained earlier. Do not torque. Refer to [Figure 9 on page 39](#) and [Figure 10](#).
4. Install 0515-1946 (x4) screws (item ①) into lower front panel. Do not torque. Refer to [Figure 10](#).

5. Torque the twelve 0515-2044 screws in the order shown in [Figure 9 on page 39](#).
6. Torque the four 0515-1946 (x4) screws to 9 in-lbs. Refer to [Figure 10](#).

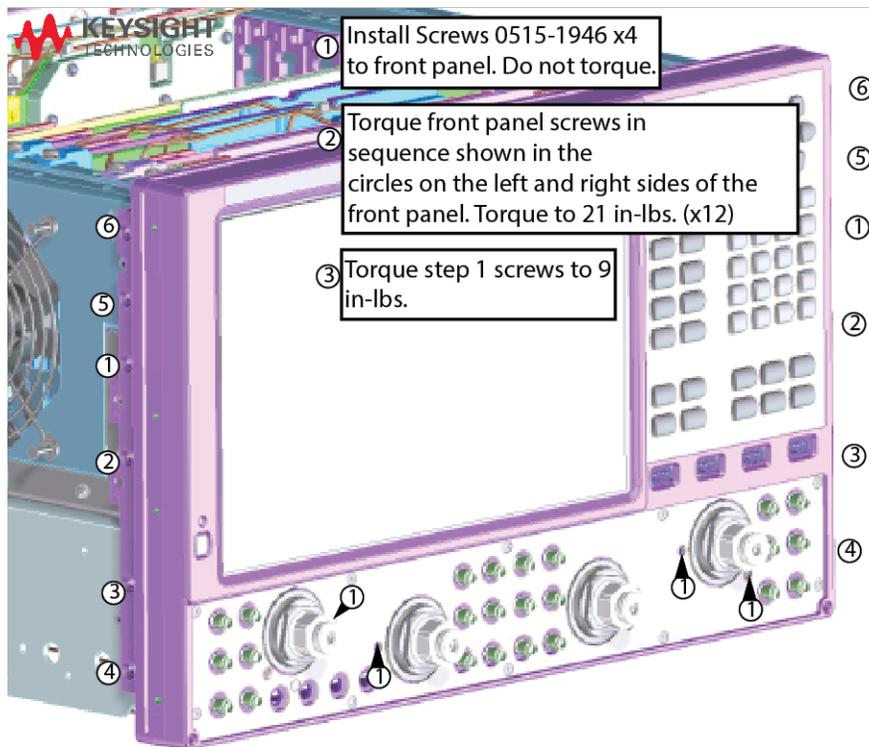
Figure 10

New Front Panel Assembly Torque Screws

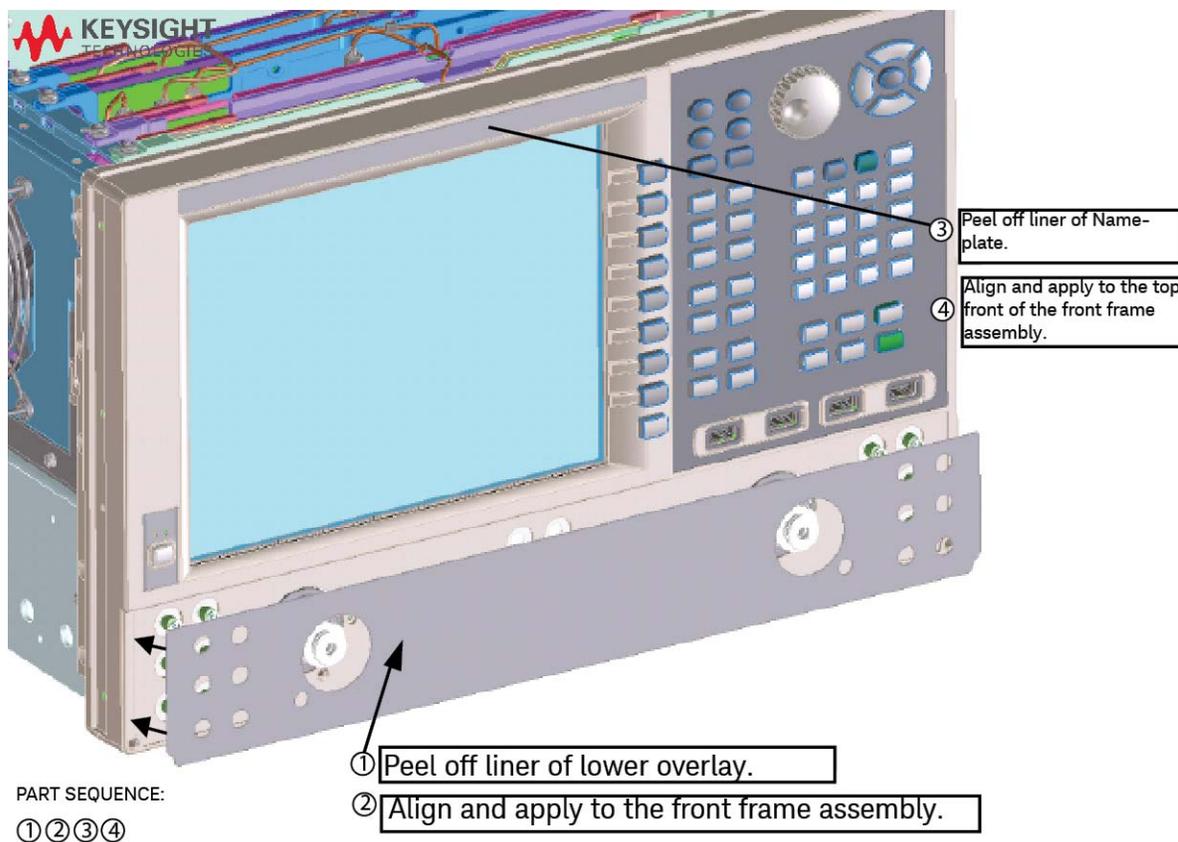
7. Install each of the overlays as follows (refer to **Figure 11**):

- Remove the protective backing to expose the adhesive.
- Carefully align the overlay to its location and gently position it.
- Once the overlay is properly positioned, press it firmly into place.

Figure 11 Front Panel Overlays Installation

There should also be a nameplate overlay included with the kit that matches your new analyzer; the same number as the old one except it will be a “B” model. There are multiple overlays provided in the kit; be sure that you use the proper one for your analyzer. If there is not an overlay that matches your analyzer, contact Keysight. Refer to **“Getting Assistance from Keysight” on page 6** of this installation note. Refer to **Figure 11 on page 41.**

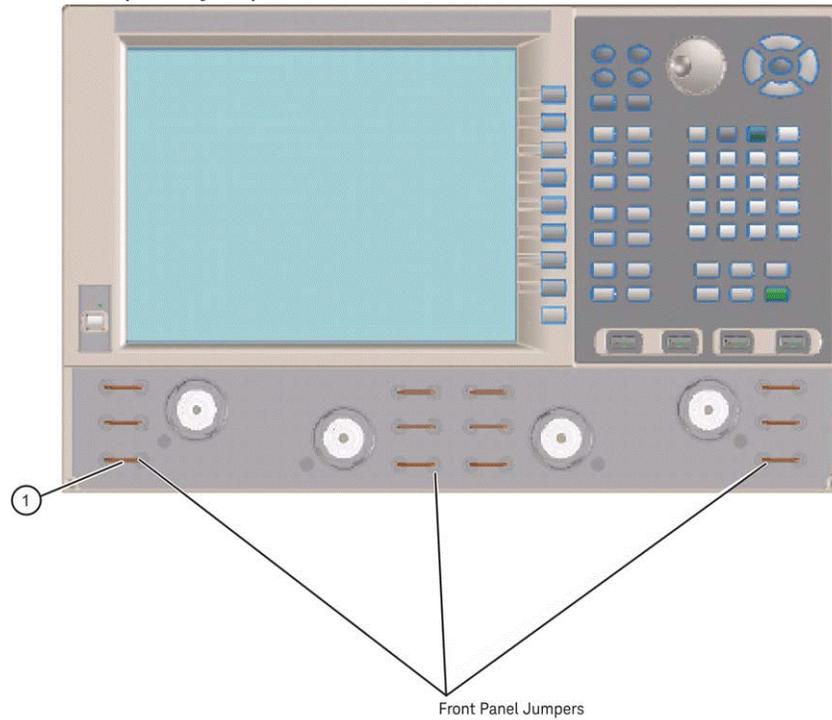
Figure 12

8. If equipped with front panel jumpers, reinstall the semi-rigid jumpers (Figure 12) on the front panel using a 5/16 inch torque wrench set to 8 in-lbs (N5227B only) and 10 in-lbs (N5221/2/4/5B).
9. If available, install the jumper covers (not shown).

Install front panel jumpers

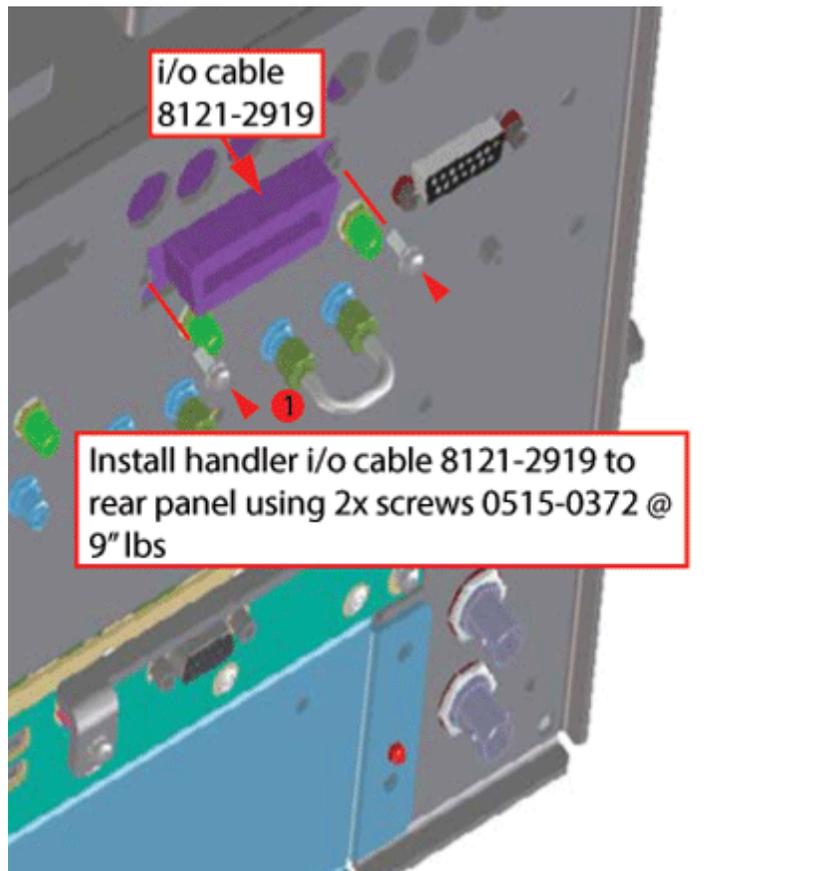
Figure 13

Install the Handler I/O Cable (8121-2919 and 0515-0372 (x2))

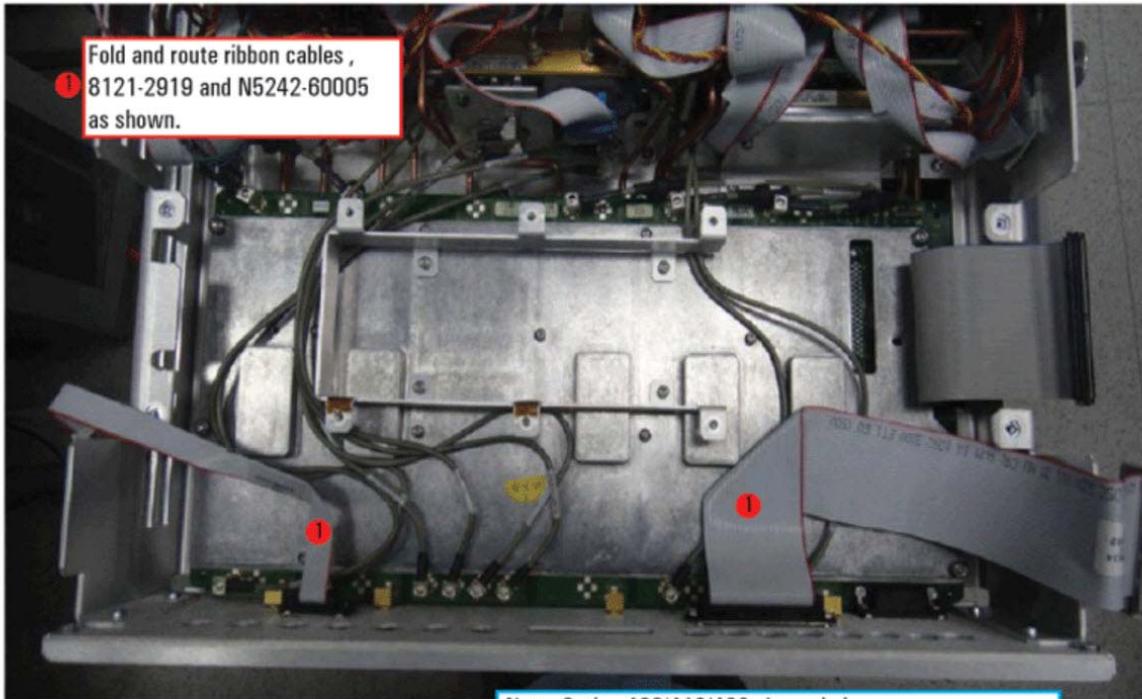
Figure 14 Fold the Handler I/O Cable (8121-2919 and N5242-60005)

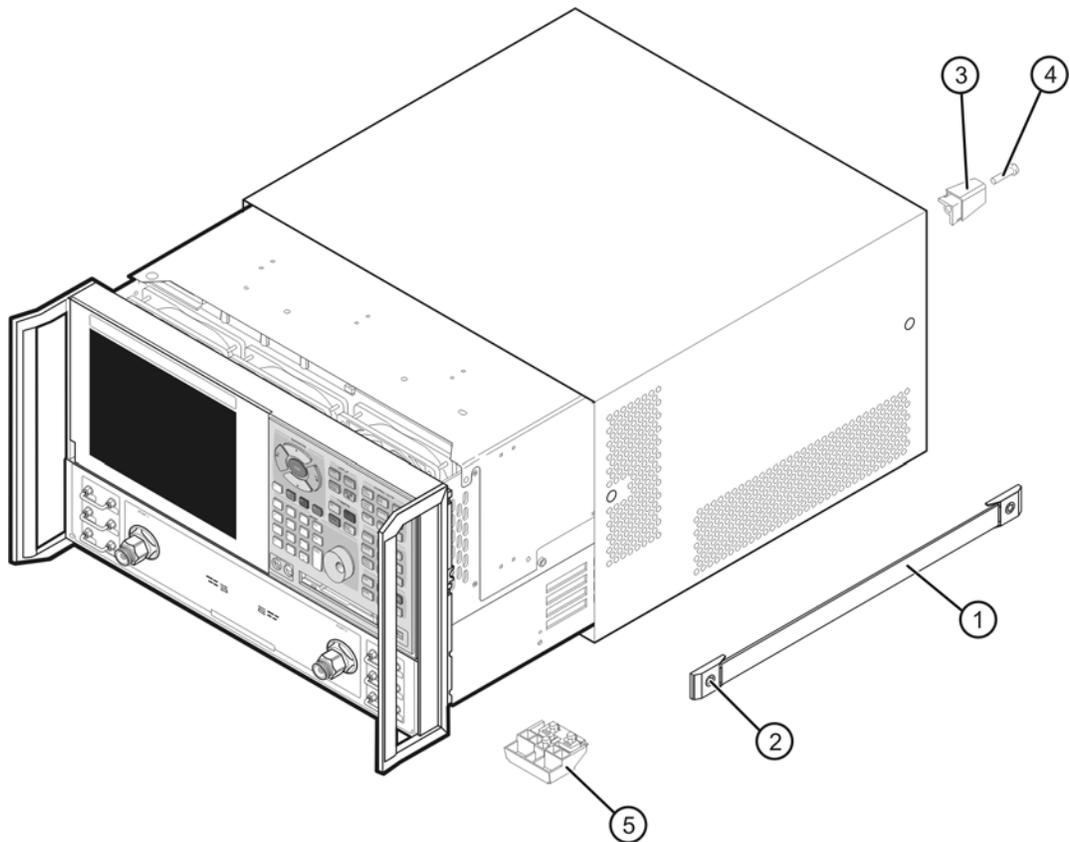
1. Slide the cover onto the frame.
2. Using a T-20 TORX driver, install the four rear panel feet (item ③) by installing the center screws (item ④).
3. Slide the four bottom feet (item ⑤) onto the cover.
4. Using a T-20 TORX driver, install the strap handles (item ①) by tightening the screws (item ②) on both ends.

Figure 15 Outer Cover Reinstallation

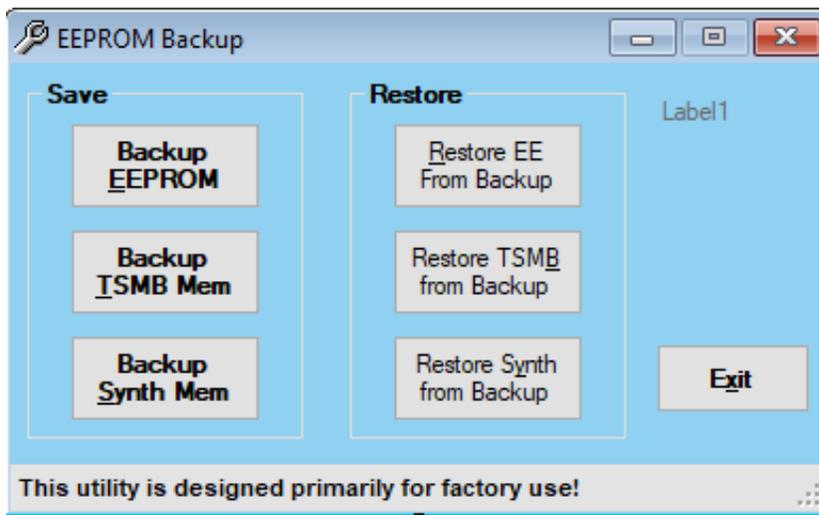
- Navigate to the EEPROM Backup Utility, located at:
  - Windows 7 -- C:\Program Files (x86)\Keysight\Network Analyzer\Service\eebackup.exe
  - Windows 10 -- C:\Program Files\Keysight\Network Analyzer\Service\eebackup.exe
- Run the program.
- Click Backup EEPROM.
- Click Backup TSMB Mem.
- Click Backup Synth Mem. (Applies to Version 7 Synthesizers Only)
- Click Exit when the program has finished.

Figure 16 EEPROM Backup Menu

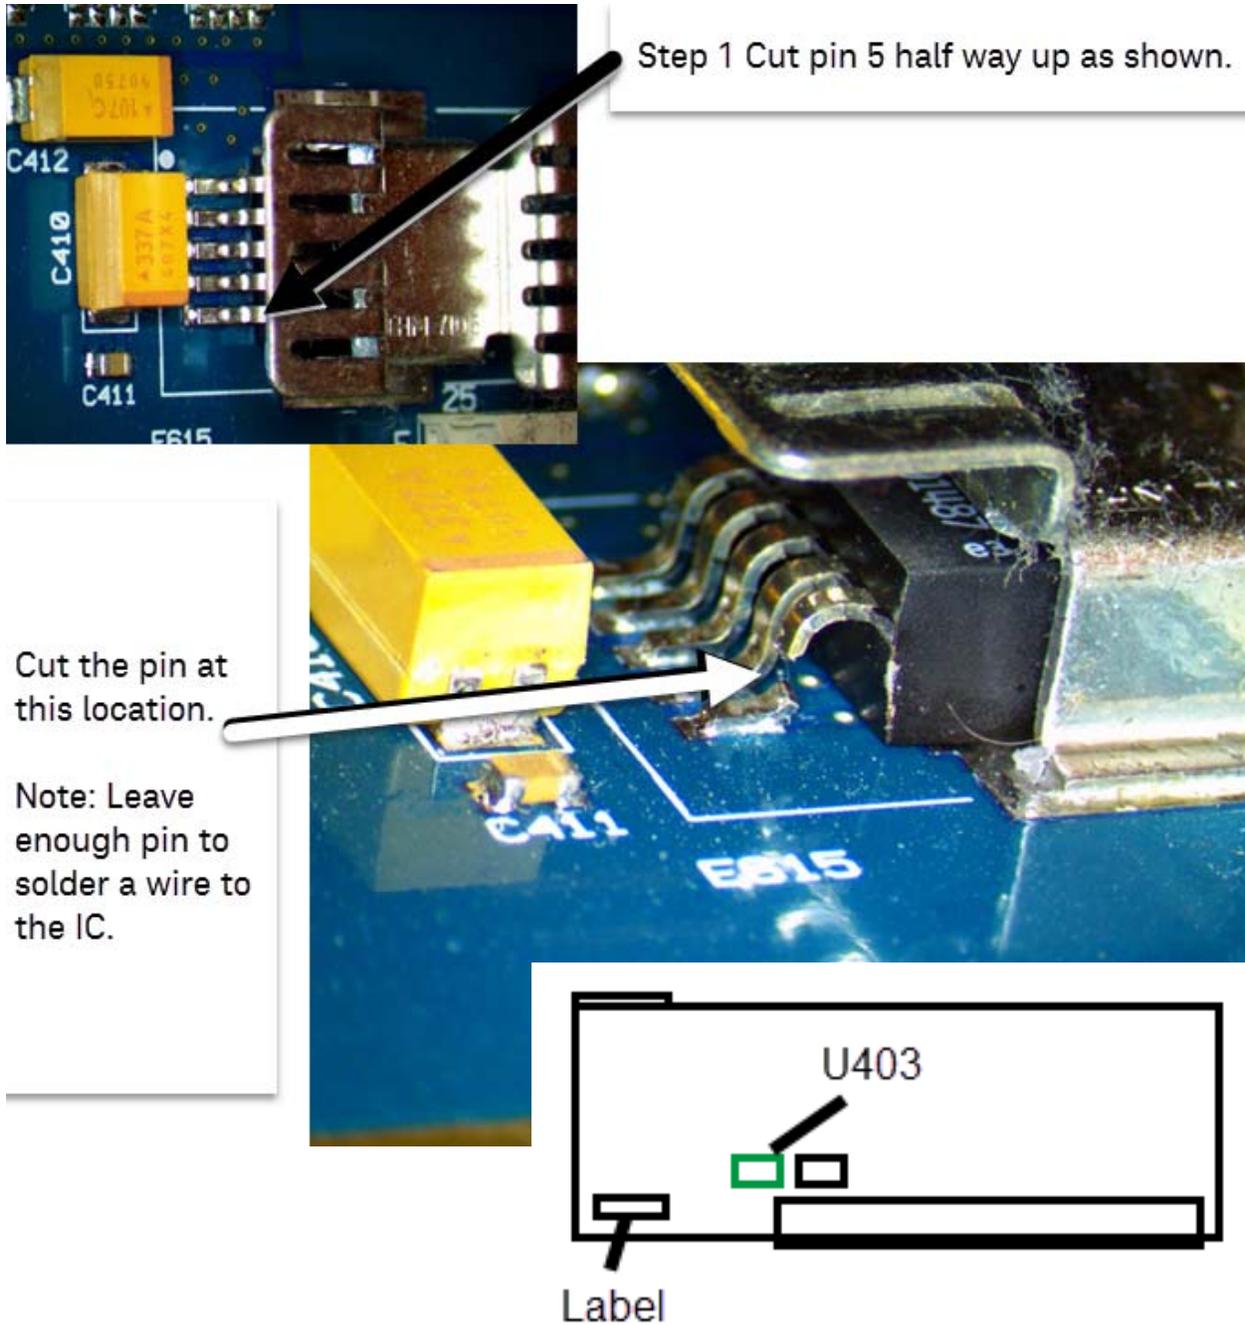
1. To remove your midplane board, refer to the Service Guide for your instrument that can be downloaded from [www.keysight.com](http://www.keysight.com).
2. Cut pin 5 on U403, so that half of the lead is left near on the IC. Refer to [Figure 1](#).

Figure A-1 Step 1 Cut pin 5 half way up as shown—Top Side View

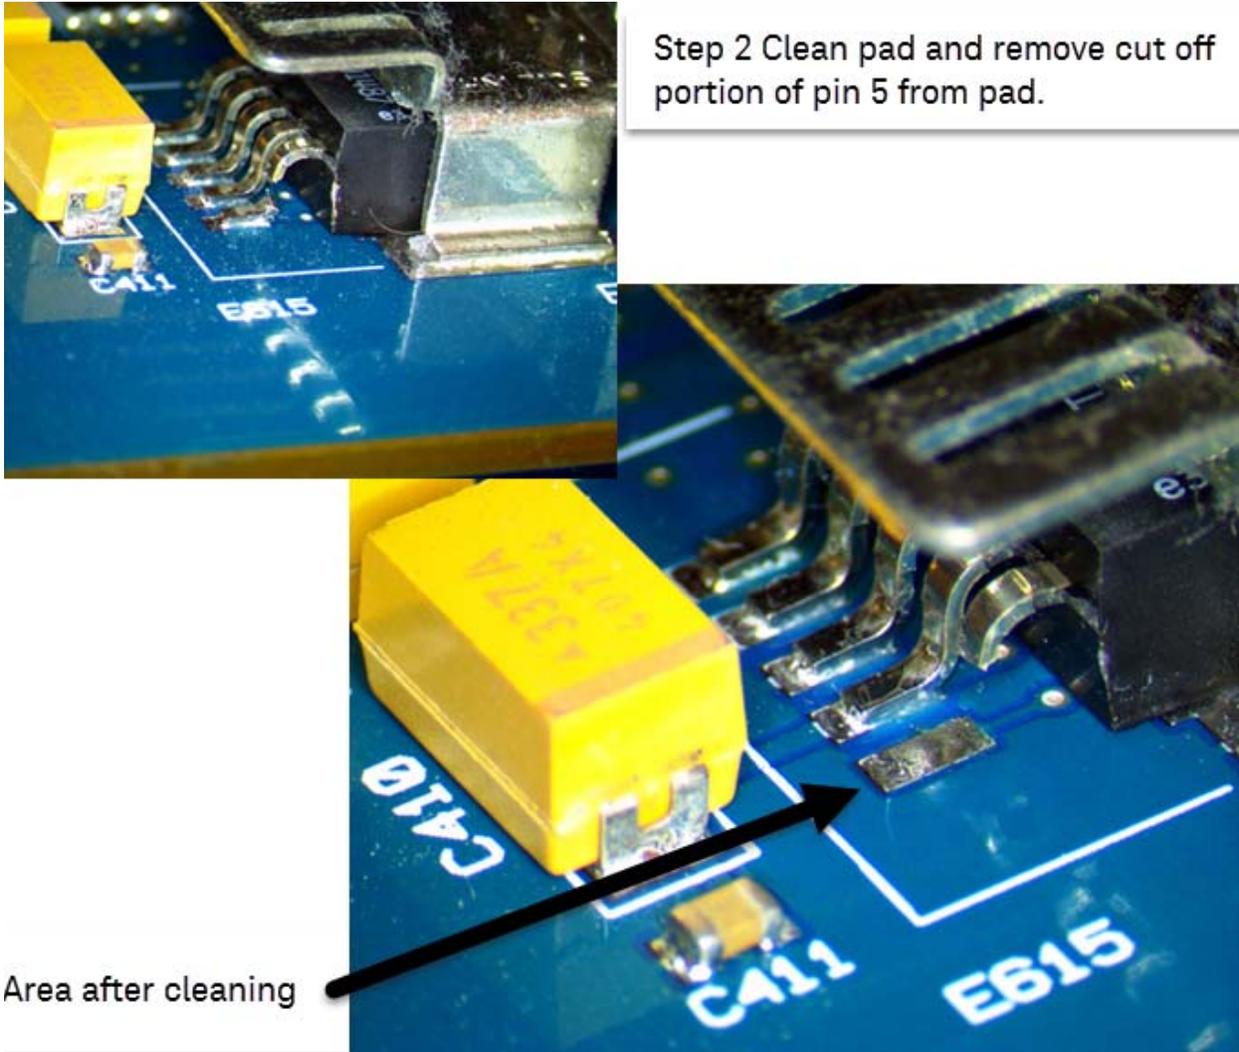
3. Clean pad and remove cut off portion of U403–pin 5 from the pad. Refer to **Figure A-2**.

Figure A-2      Cleaning the pad for pin 5–Top Side View

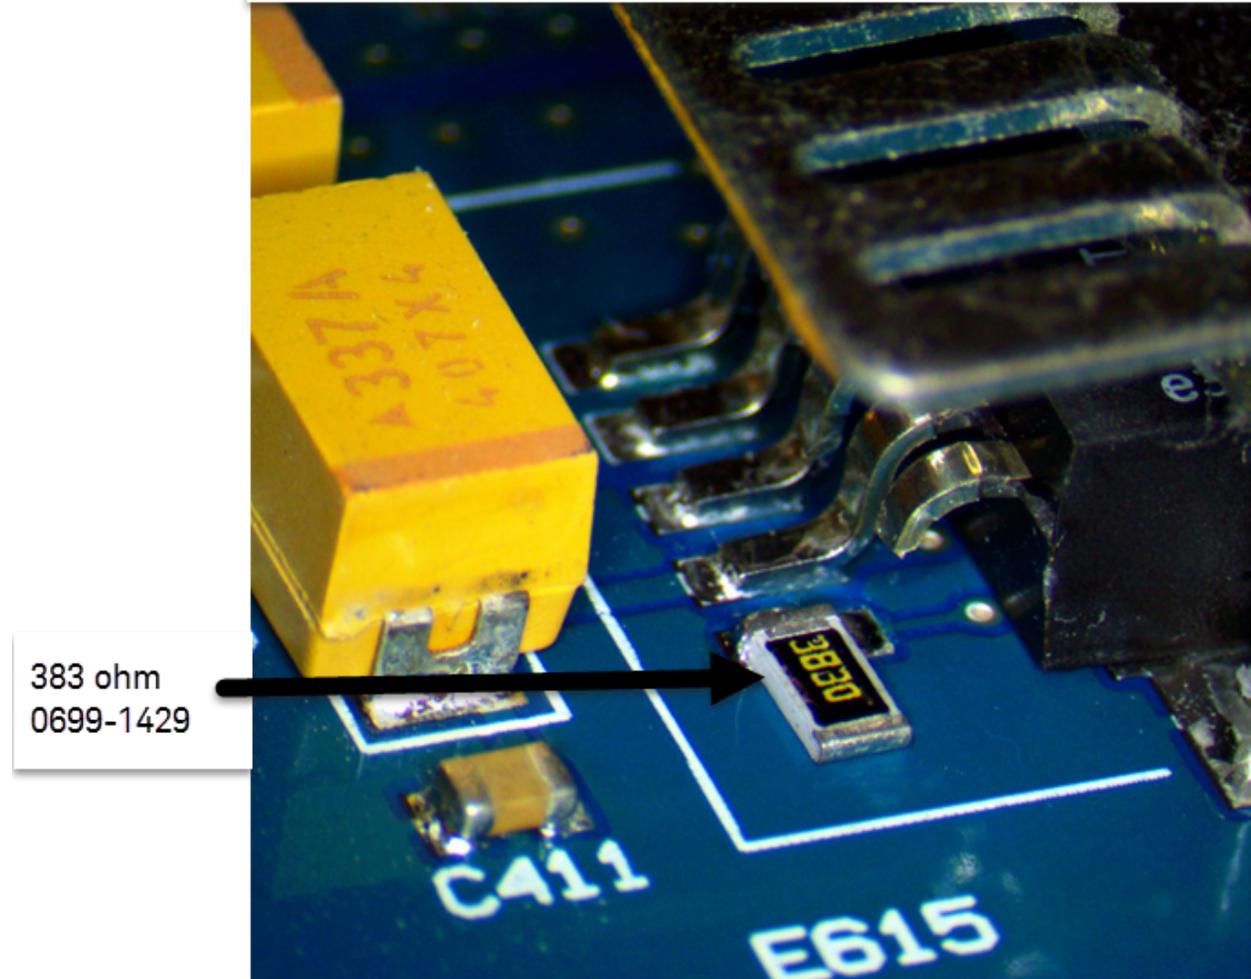
Figure A-3

4. Add 383 ohm resistor as shown. Refer to [Figure A-3](#).

Add 383 ohm resistor

Step 3 Add 383 ohm resistor as shown.

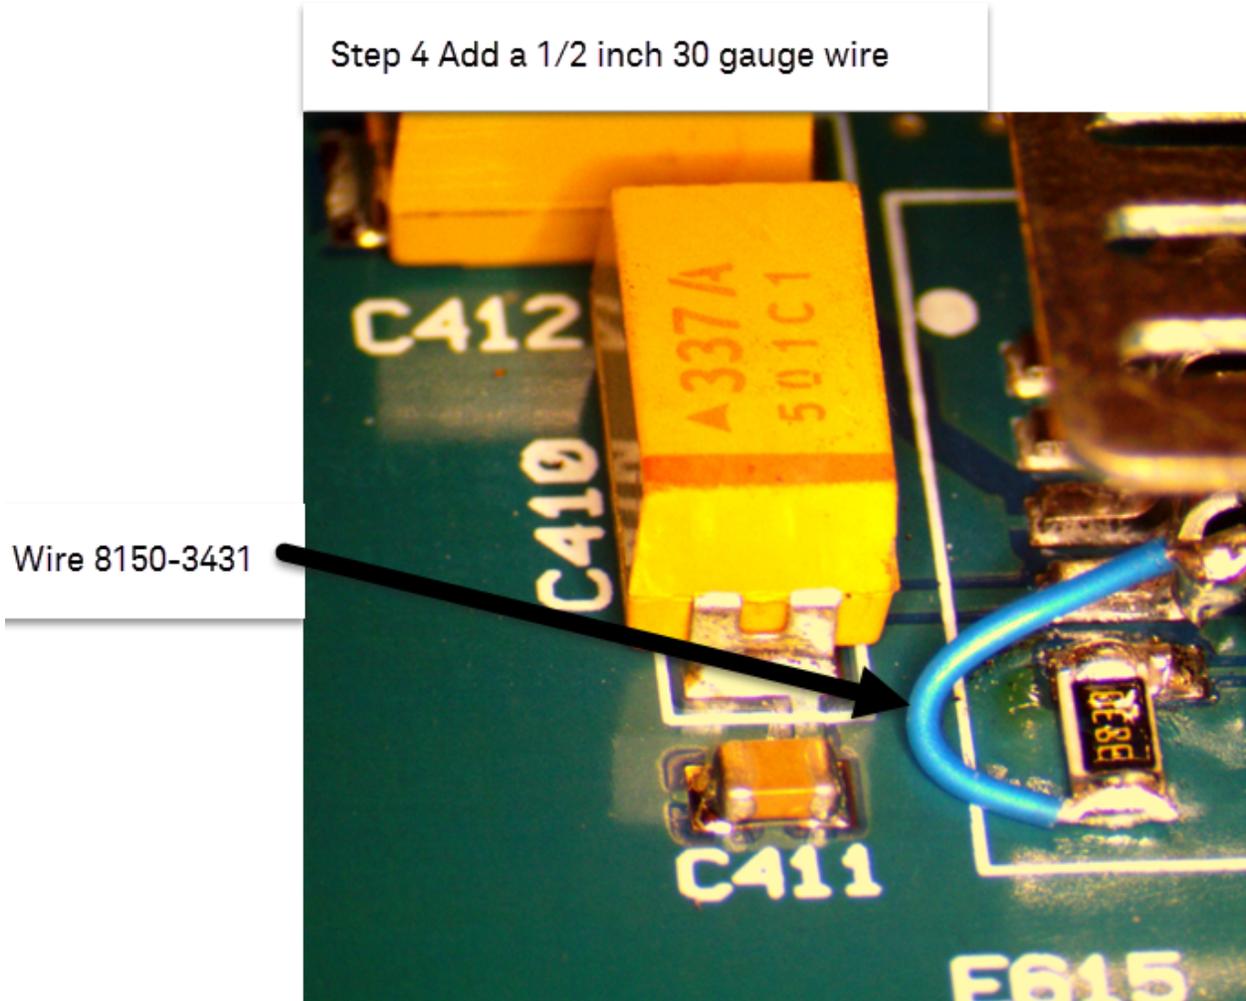
Figure A-4

5. Add a 1/2 inch 32 gauge wire. Refer to **Figure A-4**.

Add a 1/2 inch 32 gauge wire—Top SideView

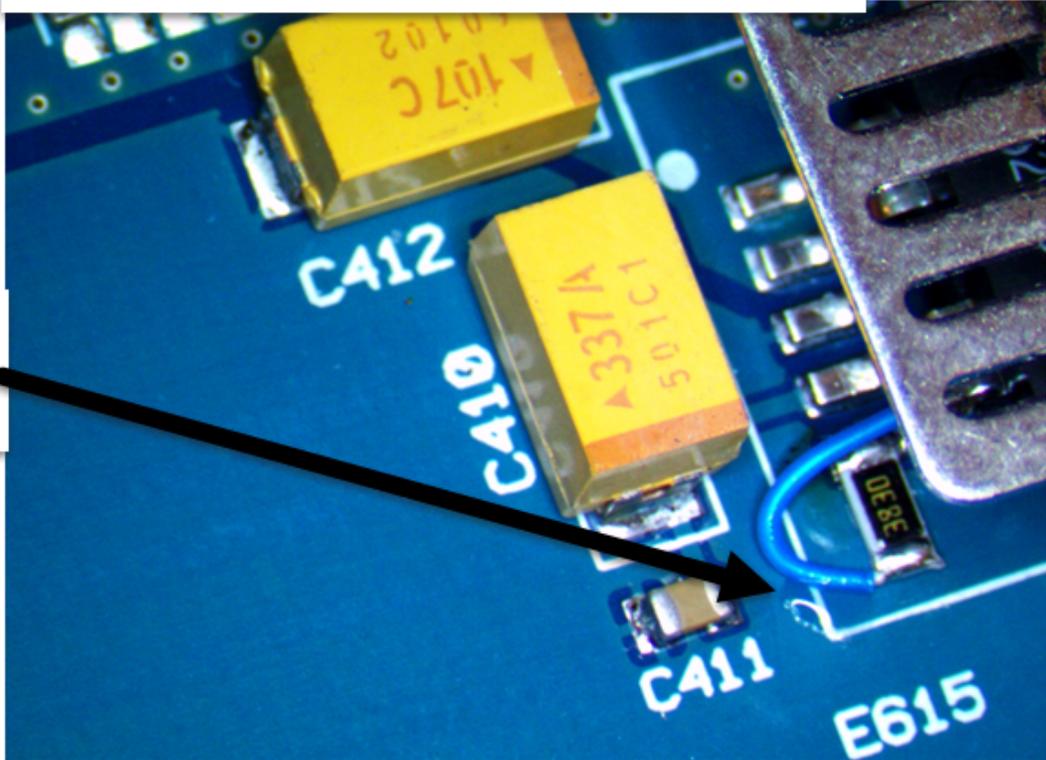
Figure A-5

6. Add glue as shown to hold the wire in place. Refer to [Figure A-5 on page 7](#).

Step 5 Add glue as shown to hold the wire in place.

Loctite 545  
0470-0954

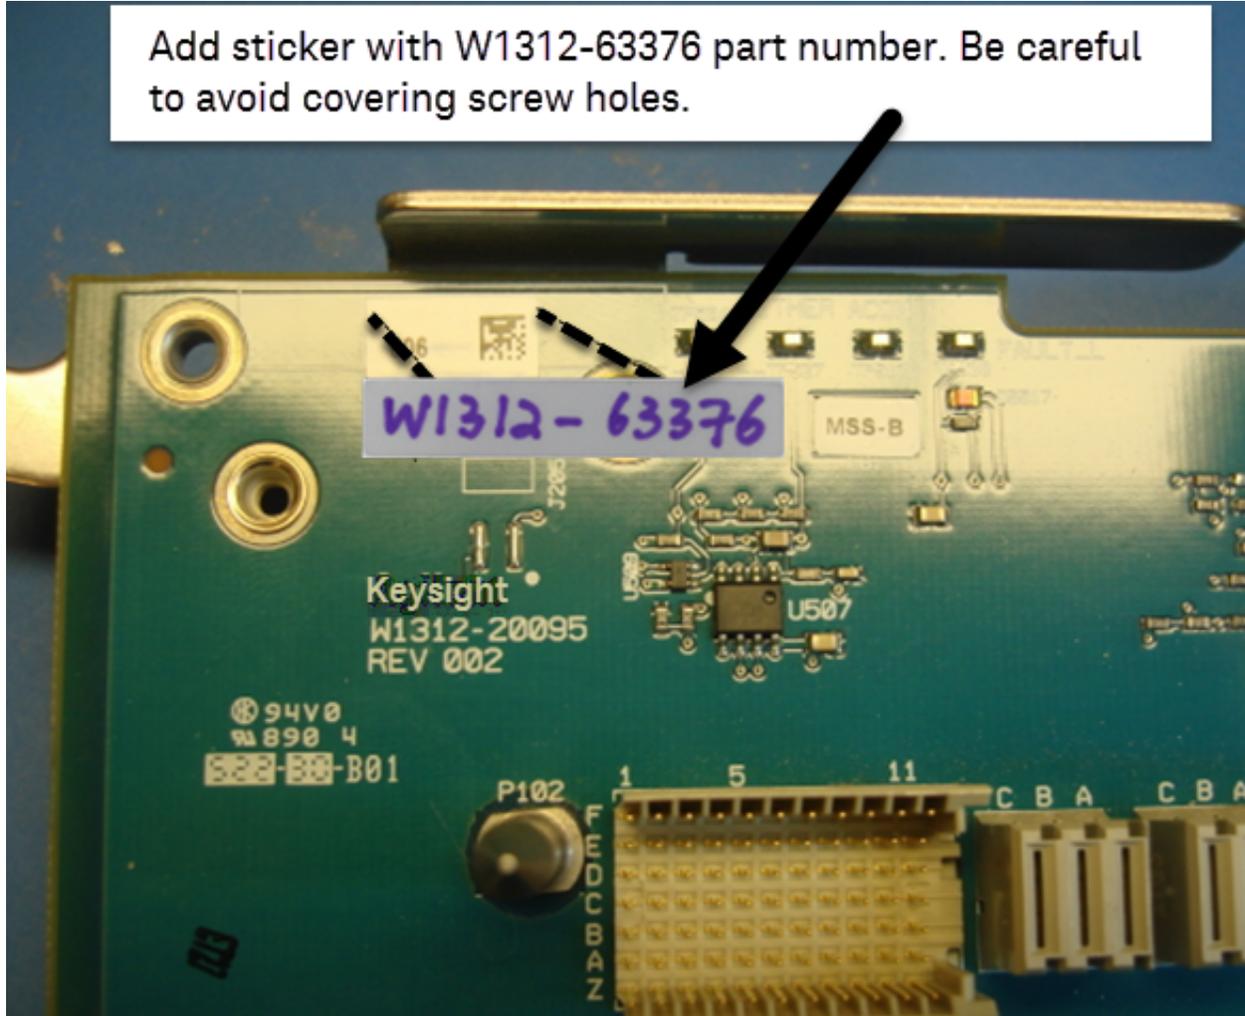
7. Add the W1312-63376 sticker. Verify that the sticker does not interfere with the PCA screw holes. Refer to [Figure A-6](#).

Figure A-6 Adding sticker to new board number W1312-63376—Top Side View

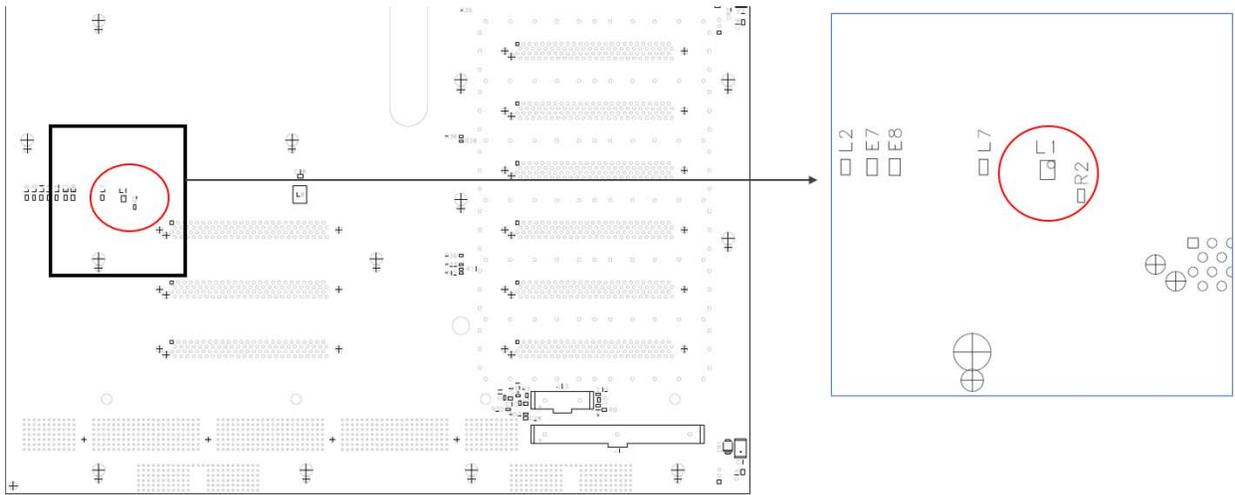
Figure 1 Locate L1 on System Motherboard

1. Locate L1 on the motherboard. Refer to **Figure 1 on page 3**.
2. Remove L1 using a surface mount soldering iron and appropriate tip or use two soldering irons. Refer to **Figure 2 on page 3**.
3. Clean motherboard traces. Refer to **Figure 2 on page 3**.
4. Prepare green wire (x3). Refer to **Figure 3 on page 4**.
5. Solder green wire x3 to L1 traces. Refer to **Figure 4 on page 5**.
6. Mark motherboard as shown with black dot. Refer to **Figure 5 on page 5**.

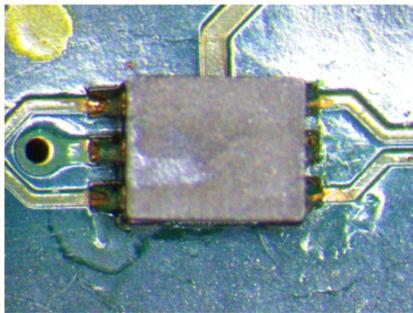
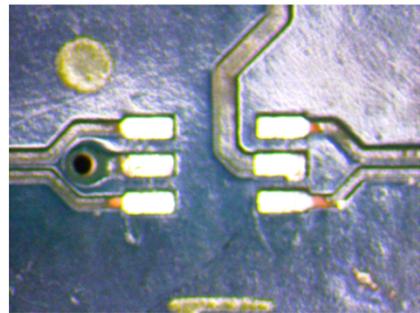
Figure 2 Remove L1 and Clean Traces

- L1 is a 6 pin part with no ground pin on the belly
- It can be removed by using two soldering irons on either side of the part

Remove L1 and clean area →
