# Keysight 2-Port/4-Port N522xA to N522xB Model PNA Upgrade Kit - Installation Guide

To Upgrade 2-Port/4-Port “A” models to  
2-Port/4-Port “B” models:

This is the Installation Note for the PNA-X N522xA Series Microwave Network Analyzers.

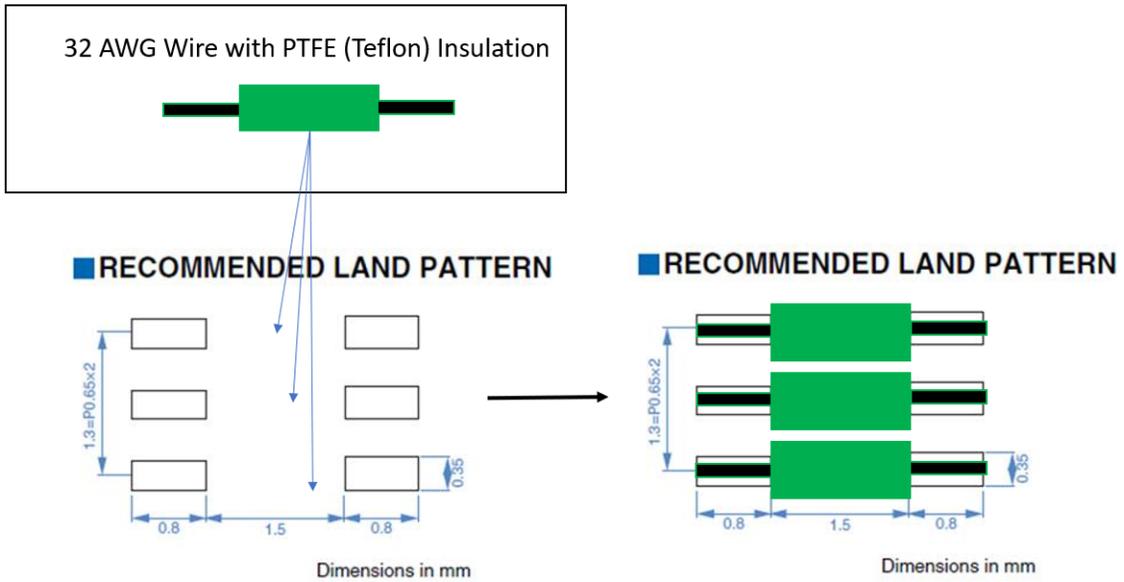
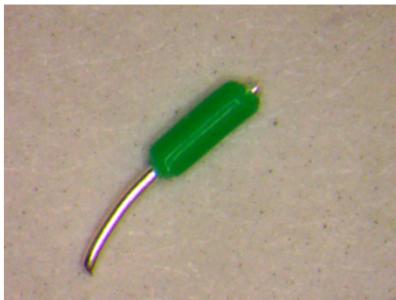
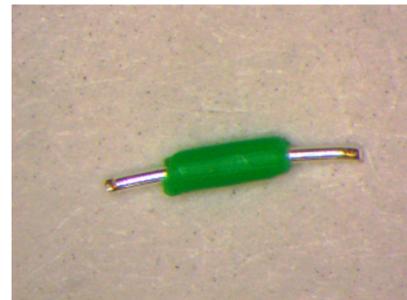
Figure 3 Prepare Green Wire (x3)

- Wire (N5240-60111) will come in with slight curve
- Insulation will not be centered

Push insulation to center  
and straighten as needed

1. Locate L1 on the motherboard. Refer to **Figure 1 on page 3**.
2. Remove L1 using a surface mount soldering iron and appropriate tip or use two soldering irons. Refer to **Figure 2 on page 3**.
3. Clean motherboard traces. Refer to **Figure 2 on page 3**.
4. Prepare green wire (x3). Refer to **Figure 3 on page 4**.
5. Solder green wire x3 to L1 traces. Refer to **Figure 4 on page 5**.
6. Mark motherboard as shown with black dot. Refer to **Figure 5 on page 5**.

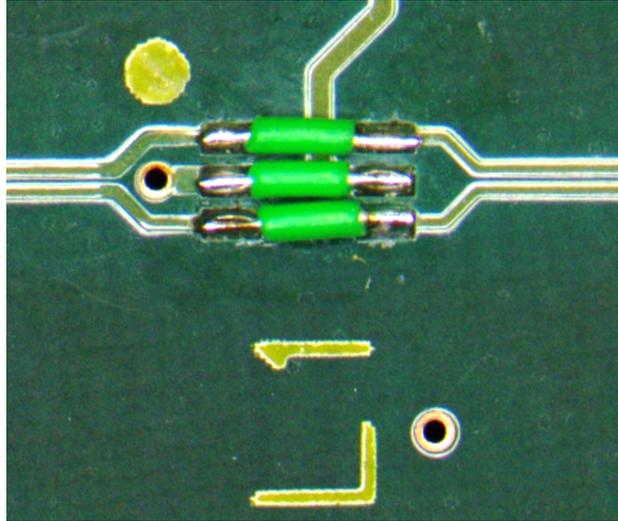
Figure 4 Solder Green Wires (x3) to Motherboard

- Start with the wire near the dot (this is the most important wire as it crosses over a ground trace).
- It is easier to pre-tin the pad before placing the wire onto it.
- The wire gets hot rapidly so one side can come loose while soldering the other.

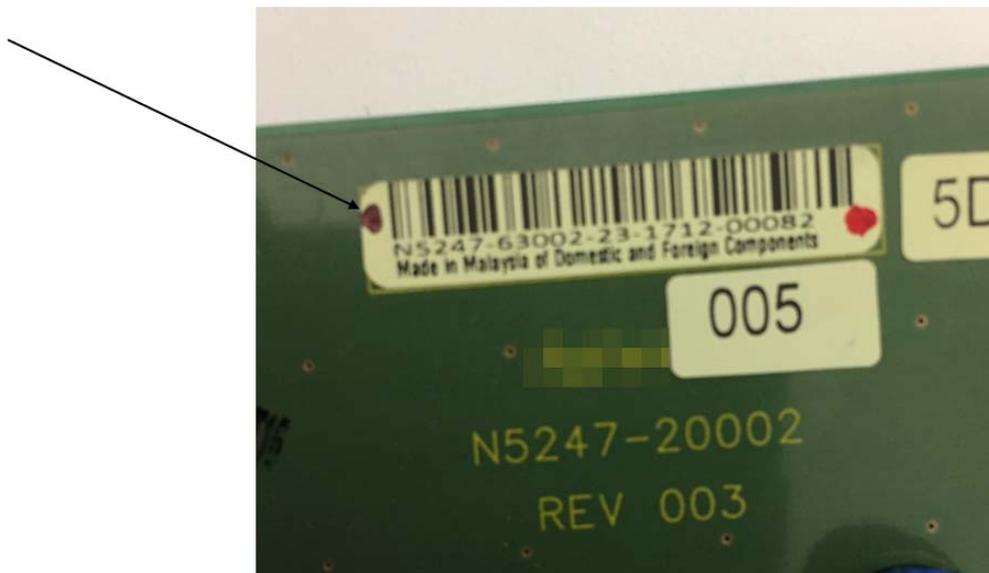
Figure 5 Mark the Motherboard Serial Number Label With a Black Dot

- Place a small black circle to the left of the serial number to show that L1 has been removed
- Make a note on the assembly document that this L1 has been removed **“L1 Removed”**

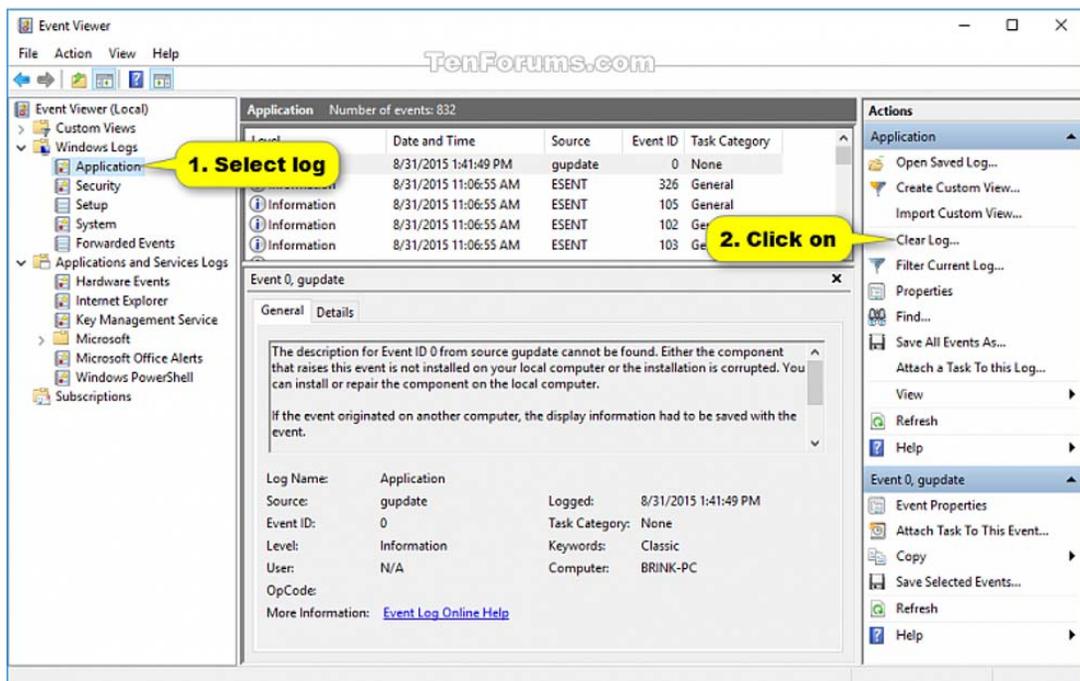
1. Press the **Win + R** keys to open the **Run** dialog box.
2. Type eventvwr.msc into **Run**, and then click/tap on **OK** to open the **Event Viewer** window.
3. Select a log (ex. **Application**) that you want to clear in the left pane of the Event Viewer, and click/tap on **Clear Log...** in the far right **Actions** pane. (i.e., see screenshot in **Figure 6, "Using the Event Viewer to Clear an Event Log,"**).

**Figure 6** Using the Event Viewer to Clear an Event Log

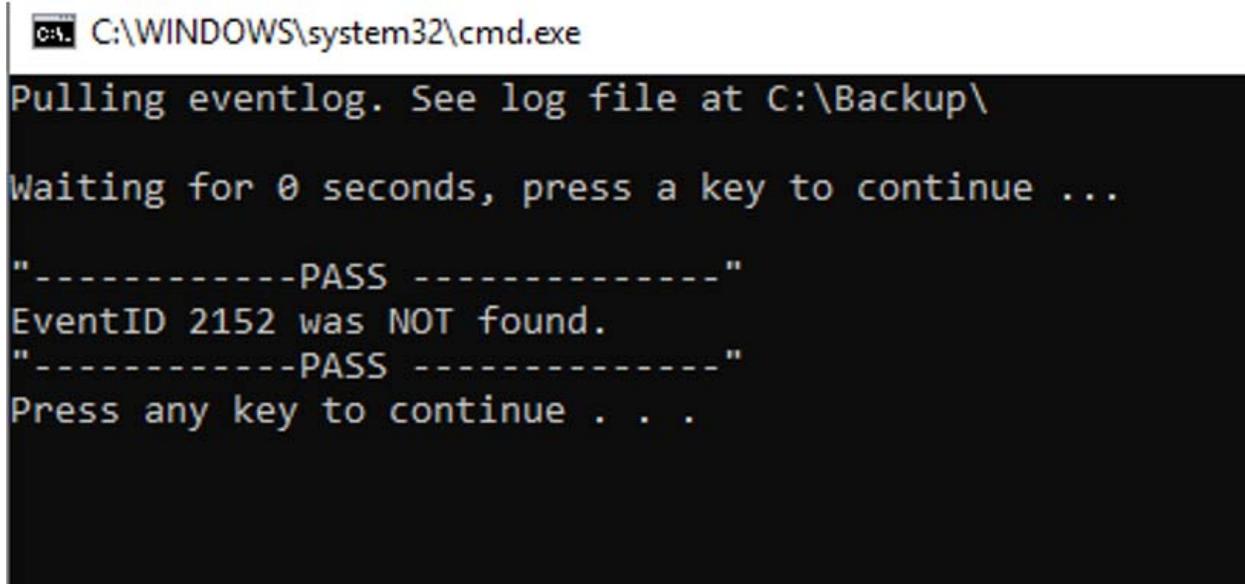
**Figure 7** CheckEventID.bat to Verify Instrument USB Drives are Error Free

```
C:\WINDOWS\system32\cmd.exe
Pulling eventlog. See log file at C:\Backup\
Waiting for 0 seconds, press a key to continue ...
"-----PASS -----"
EventID 2152 was NOT found.
"-----PASS -----"
Press any key to continue . . .
```

4. Using the Windows **Run** window, used in step 1, the \*.bat file (CheckEventID.bat) can be run to verify that there are no 2152 error events (i.e., this takes ~three seconds to run).

For a CheckEventID.bat results example, refer to **Figure 7 on page 7**.
