Keysight 53210A 350 MHz RF Counter
Keysight 53220A 350 MHz Universal Frequency Counter/Timer
Keysight 53230A 350 MHz Universal Frequency Counter/Timer

Firmware Update 3.02 Release Notes

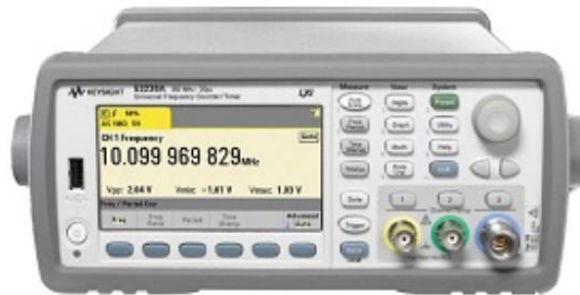
Selecting 'Control Instrument' enables selection of the control options:
