# Installation Note

## **8719DU/8720DU/8722DU Option 000 Performance Upgrade Kit for the 8719D/8720D/8722D Network Analyzers**

**Part Number 08720-90372**

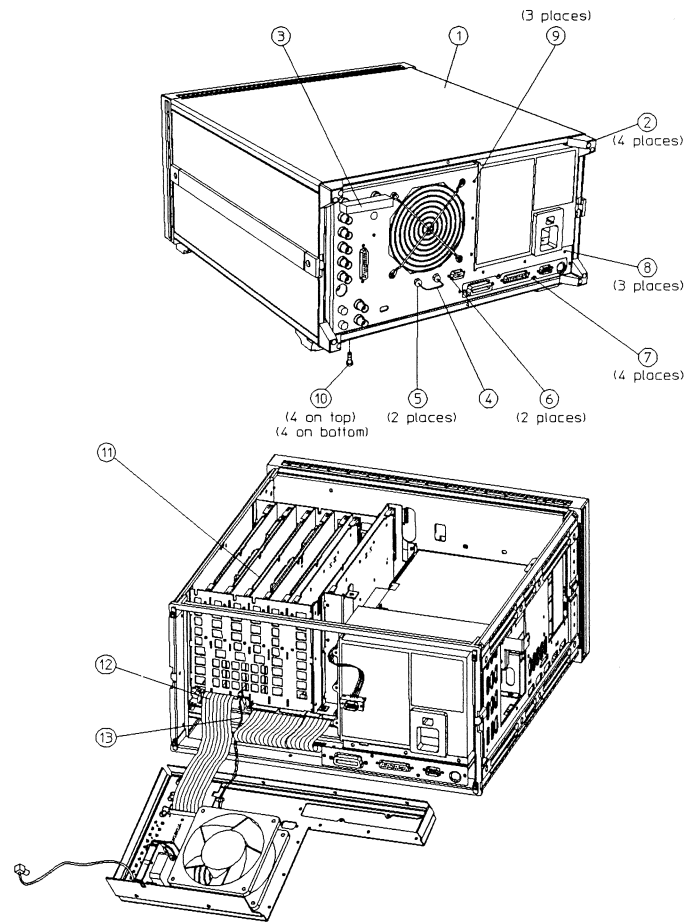
**Figure 1-1.**

Refer to Figure 1-1.

1. Disconnect the power cord.
2. Remove the four rear standoffs (item 2).
3. Loosen the top cover screw and slide the top cover off.
4. Remove the instrument bottom cover and record the keyword label(s) that are located on the exposed sheet metal next to the A7 CPU assembly. Note that each keyword is for EACH option installed in the instrument.
5. If the analyzer has option 1D5, remove the BNC jumper from the high stability frequency reference (item 3).
6. If the analyzer has option 085, remove the RF cable (item 4) and the connectors' attaching hardware (item 5).
7. Remove the hardware (item 6) that attaches the RS-232 connector to the rear panel.

8. Remove the four screws (item 7) that attach the interface bracket to the rear panel.
9. Remove the six screws (item 8) and (item 9), that attach the preregulator to the rear panel.
10. Remove the eight screws (item 10) from the rear frame: four from the top edge and four from the bottom edge.
11. Remove the screw from the pc board stabilizer and remove the stabilizer.
12. Lift the reference board (A12) from its motherboard connector and disconnect the flexible RF cable (item 11).
13. Pull the rear panel away from the frame. Disconnect the ribbon cable (item 12) from the motherboard connector, pressing down and out on the connector locks. Disconnect the wiring harness (item 13) from the motherboard.

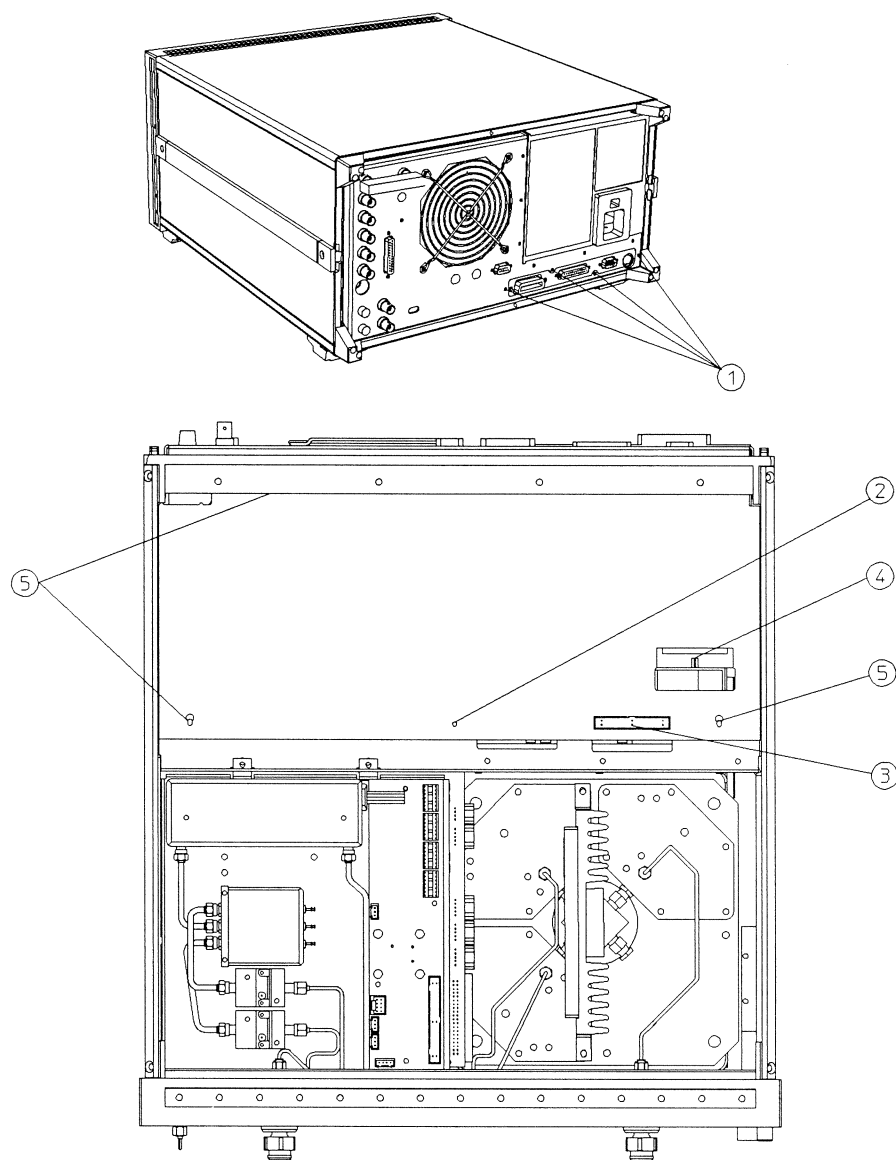
**Figure 1-2.**

Refer to Figure 1-2.

1. If the display information is not observed, as listed previously in the section titled “Verify Successful Installation,” examine all connections to the CPU board. Improper connections may be diagnosed as follows:
  - a. If the Channel 1 and Testport 1 LEDs are on but the display is blank, examine the item 4 ribbon cable connector. Refer to Figure 1-2.
  - b. If the Testport 2 LED is on but the display is blank, examine the item 3 ribbon cable connector.
