# 3070 PCB Discharge Tutorial

John Lutkus  
Keysight Technologies

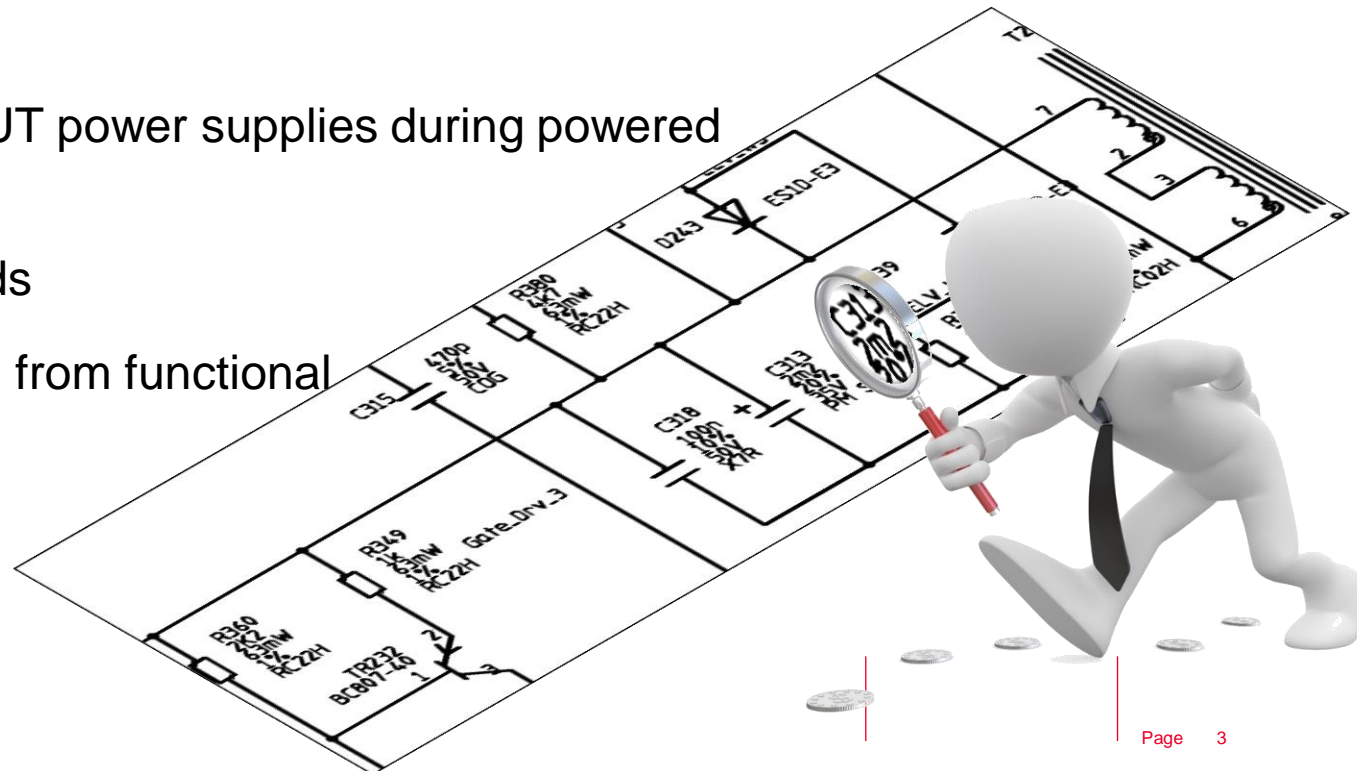
## How are charges built up?

- Applying ASRU sources during in-circuit tests (for example, testing zener diodes).
- Applying the DUT power supplies during powered testing
- Retesting boards
- Returned board from functional test

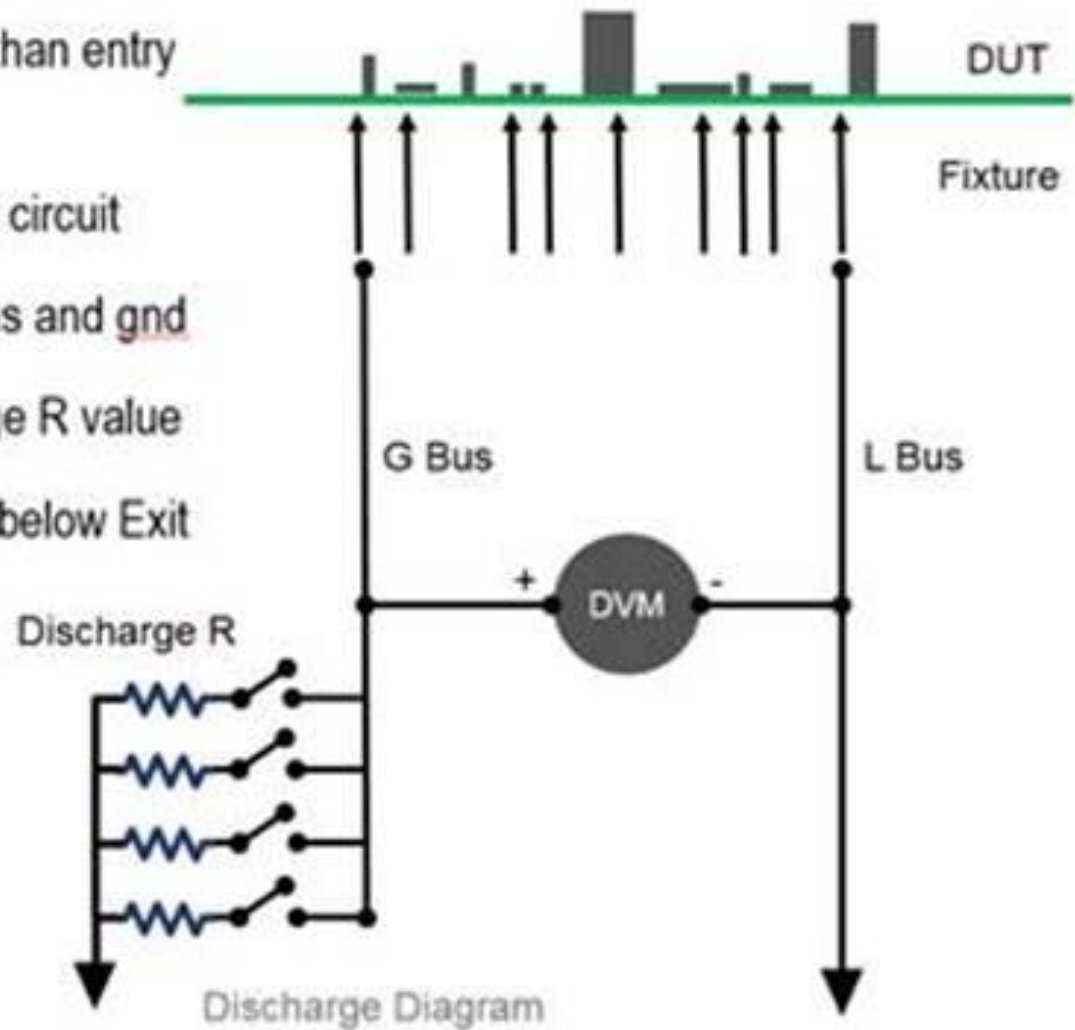
How is discharge carried out?

- Voltage on discharge nodes higher than entry level, discharge initiated
- Connect G and L bus into discharge circuit
- Connect Discharge R between G bus and gnd
- Monitor voltage and switch Discharge R value
- Release Discharge R when voltage below Exit value

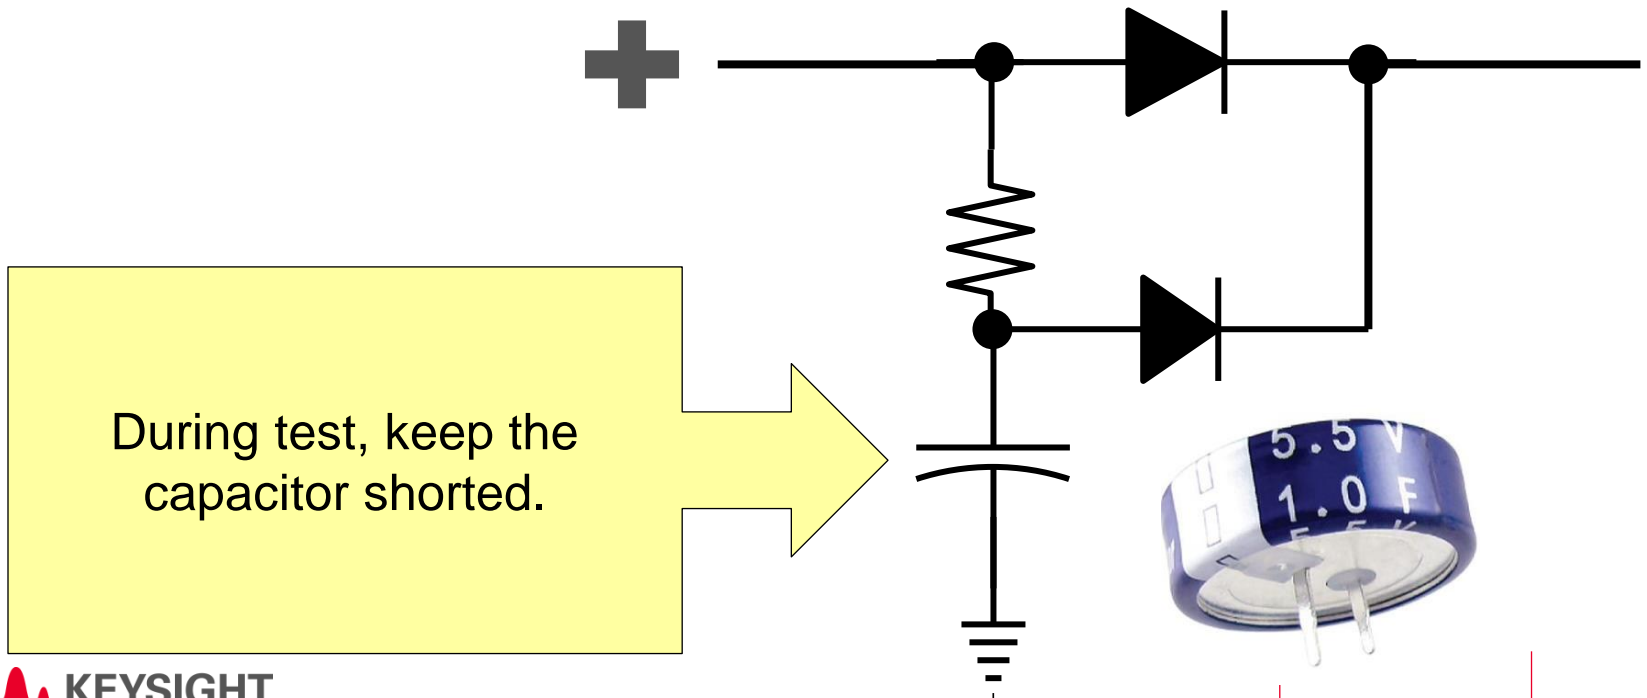
- May require many, many hours to discharge
- Don't let them get charged up!
- Develop a strategy to deal with boards that return from functional test

During test, keep the capacitor shorted.

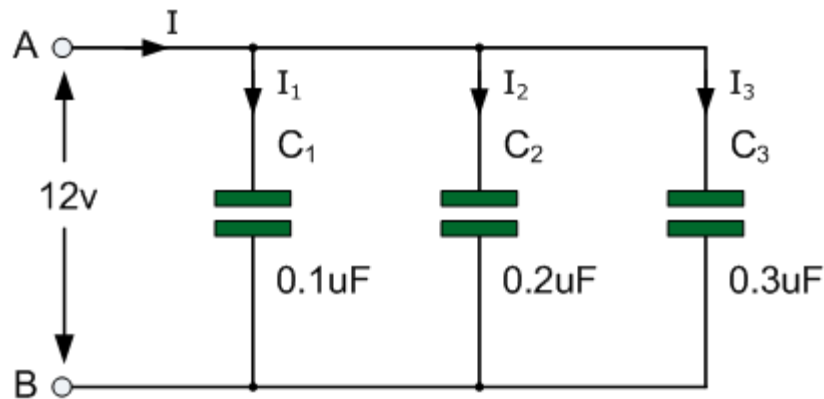
The automatically-generated routine only discharges capacitors, while an inductor (or any other device) on the board under test has significant internal capacitance.

- Enter this information to the “board” file before generating the “.discharge” file, or manually modify the “.discharge” file.
- Model all capacitances in “board”.

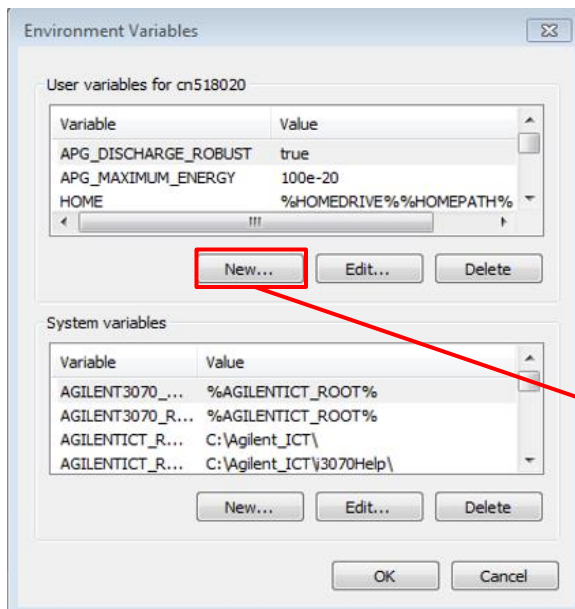
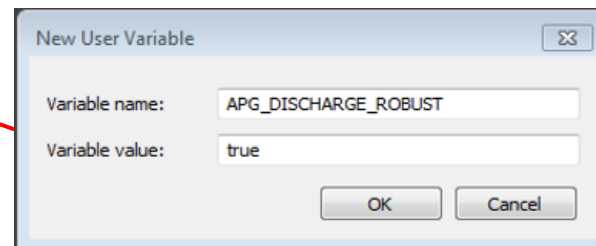
- Click “New...” tab and a new a window pops up, enter “APG\_DISCHARGE\_ROBUST” as “Variable name:”, and enter “true” for “Variable value:”. Click “OK→OK→OK” to close all the windows.
- Restart i3070 software and launch IPG or run ‘ ipg on “.discharge” ‘. Open the new “.discharge” file and you will see the change.
