# Keysight 2-Port/4-Port N524xA to N524xB and N5264A to N5264B Model PNA-X Upgrade Kit - Installation Guide

To Upgrade 2-Port/4-Port “A” models to 2-Port/4-Port “B” models

This is the Installation Note for the PNA-X N524xA Series Microwave Network Analyzers and N5264A Microwave Receiver.

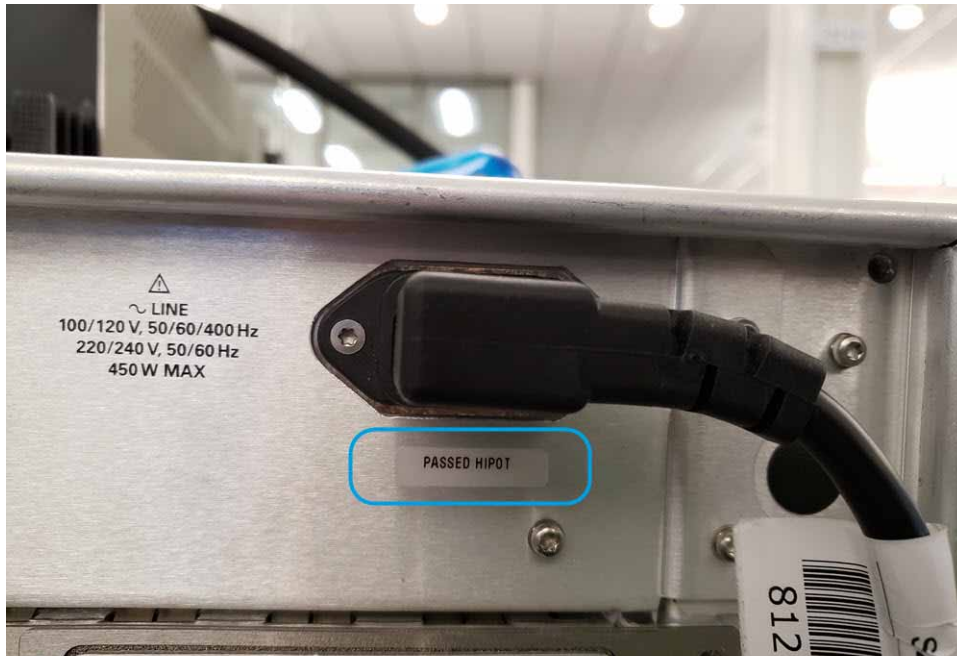
Figure 2

Hi-Pot Sticker on the Power Supply Cover

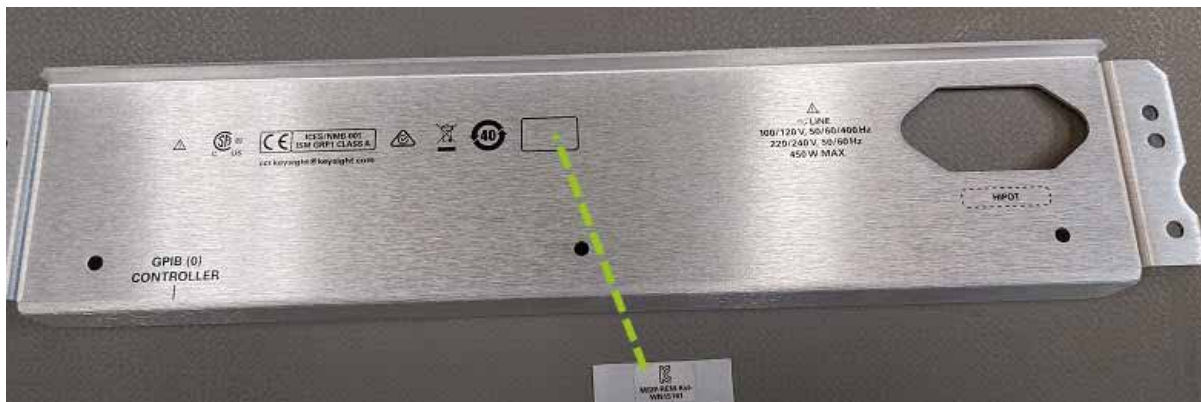
Figure 5

Install the KCC label (N5240-80041)

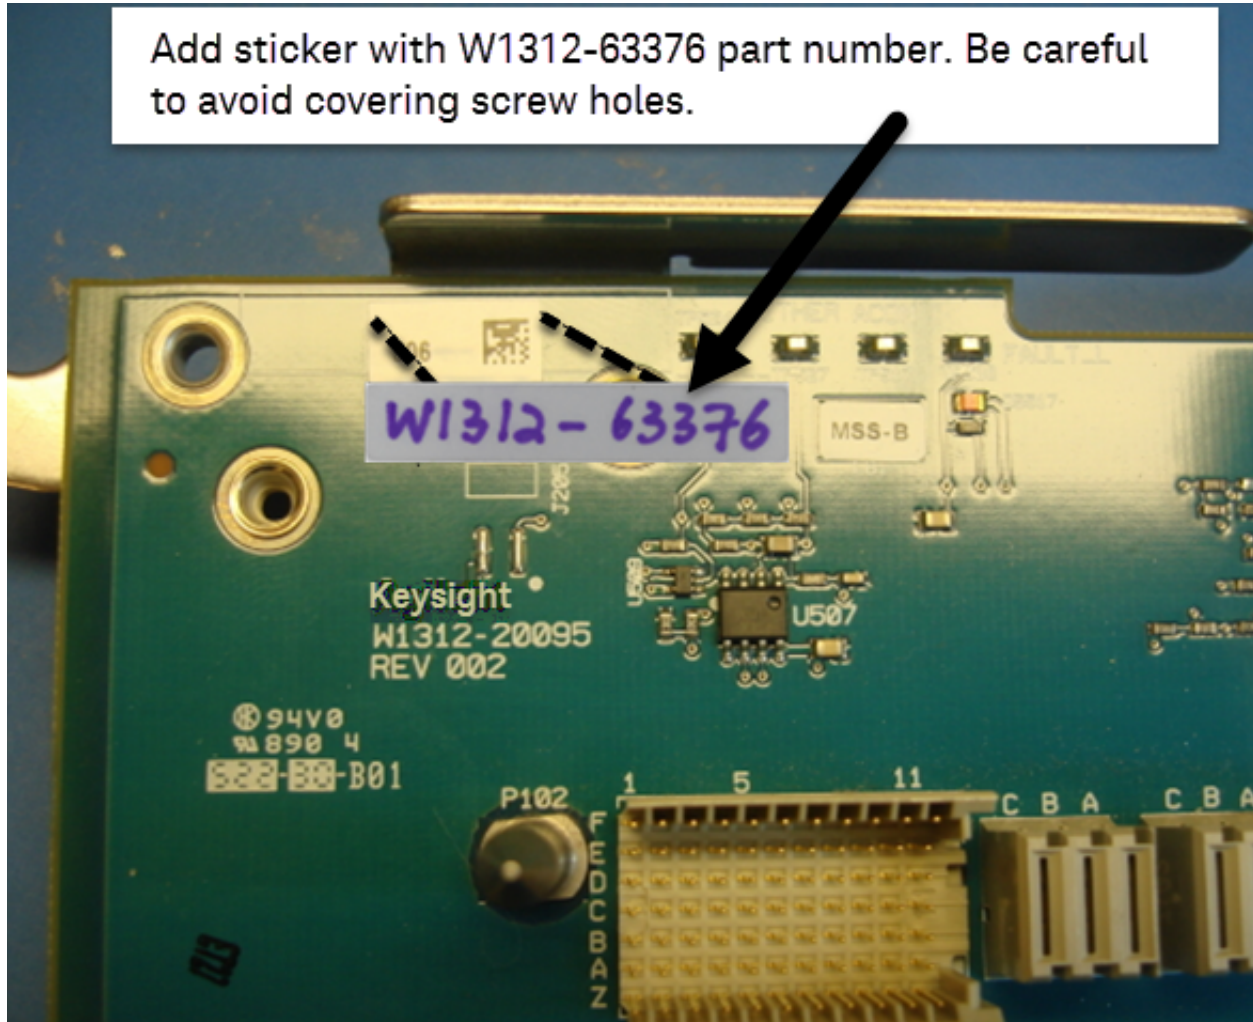
7. Add the W1312-63376 sticker. Verify that the sticker does not interfere with the PCA screw holes. Refer to [Figure 0-6](#).

Figure 0-6 Adding sticker to new board number W1312-63376—Top Side View

This section is only required if the Midplane board is not a W1312-63376 part number. If your midplane board does not require this modification, skip this process and continue to the **“Step 13. Install the Dress Panel on the New Front Panel Assembly” on page 44.** After this section is completed, your midplane board will be a W1312-63376 midplane board. Refer to **Figure 0-6 on page 76.**

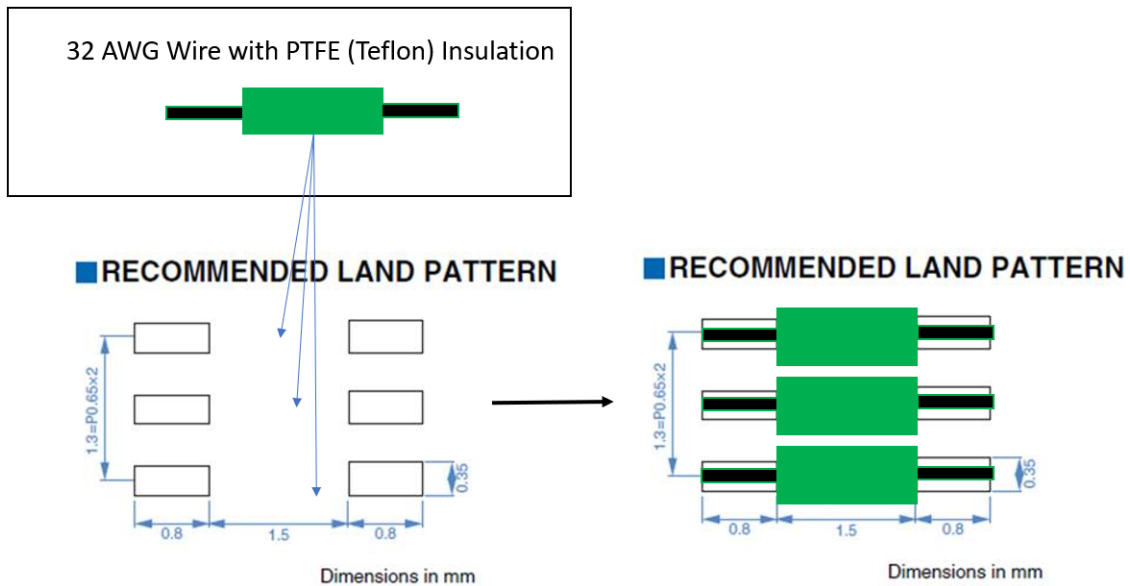
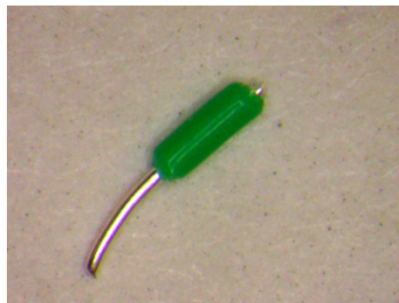
Figure 0-3 Prepare Green Wire (x3)

Push insulation to center  
and straighten as needed

1. Locate L1 on the motherboard. Refer to [Figure 0-1 on page 81](#).
2. Remove L1 using a surface mount soldering iron and appropriate tip or use two soldering irons. Refer to [Figure 0-2 on page 81](#).
3. Clean motherboard traces. Refer to [Figure 0-2 on page 81](#).
4. Prepare green wire (x3). Refer to [Figure 0-3 on page 82](#).
5. Solder green wire x3 to L1 traces. Refer to [Figure 0-4 on page 83](#).

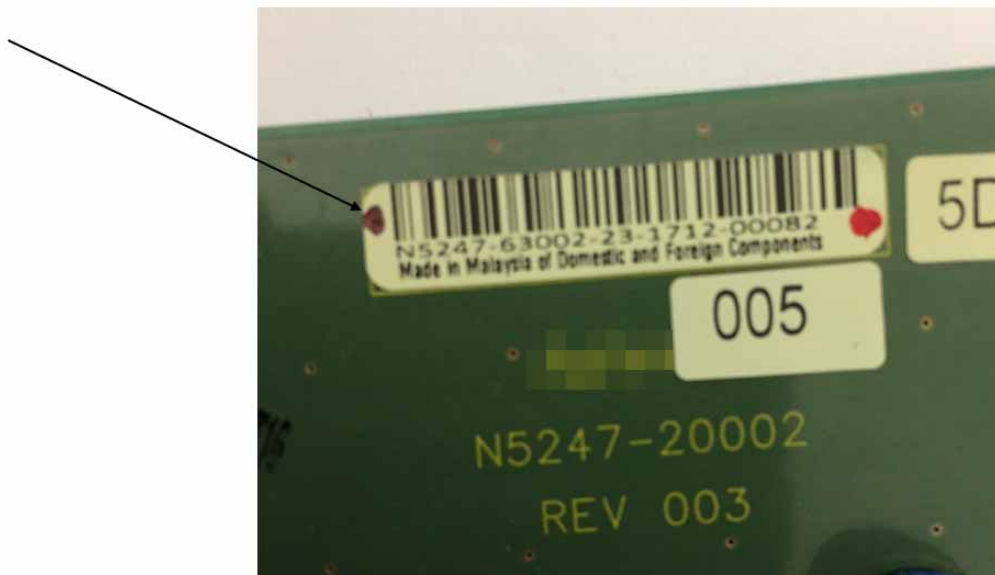
Figure 0-5 Mark the Motherboard Serial Number Label With a Black Dot

- Place a small black circle to the left of the serial number to show that L1 has been removed
- Make a note on the assembly document that this L1 has been removed **“L1 Removed”**

6. Mark motherboard as shown with black dot. Refer to **Figure 0-5 on page 83**.

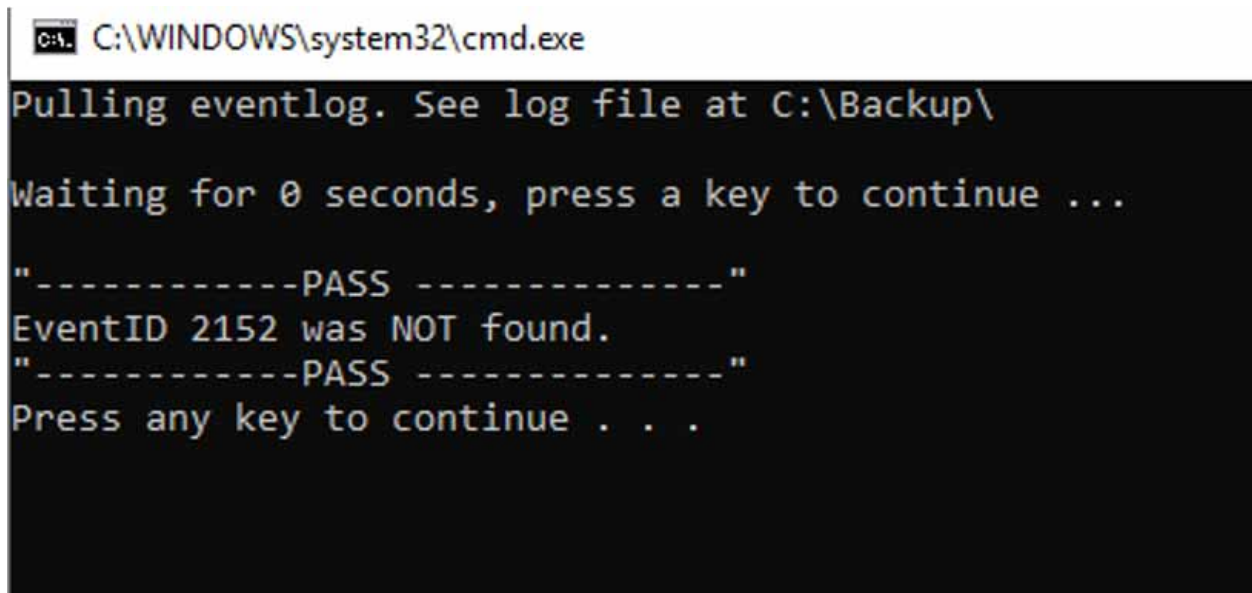
**Figure 0-7** CheckEventID.bat to Verify Instrument USB Drives are Error Free

```
C:\WINDOWS\system32\cmd.exe
Pulling eventlog. See log file at C:\Backup\
Waiting for 0 seconds, press a key to continue ...
-----PASS -----
EventID 2152 was NOT found.
-----PASS -----
Press any key to continue . . .
```

For a CheckEventID.bat results example, refer to [Figure 0-7 on page 85](#).
